SCOTTISH ASSOCIATION OF UNIVERSITY DIRECTORS OF ESTATES

September 2018

RESTORING CONFIDENCE: THE NEED FOR A FOCUS ON QUALITY

Prof. John Cole CBE RIBA

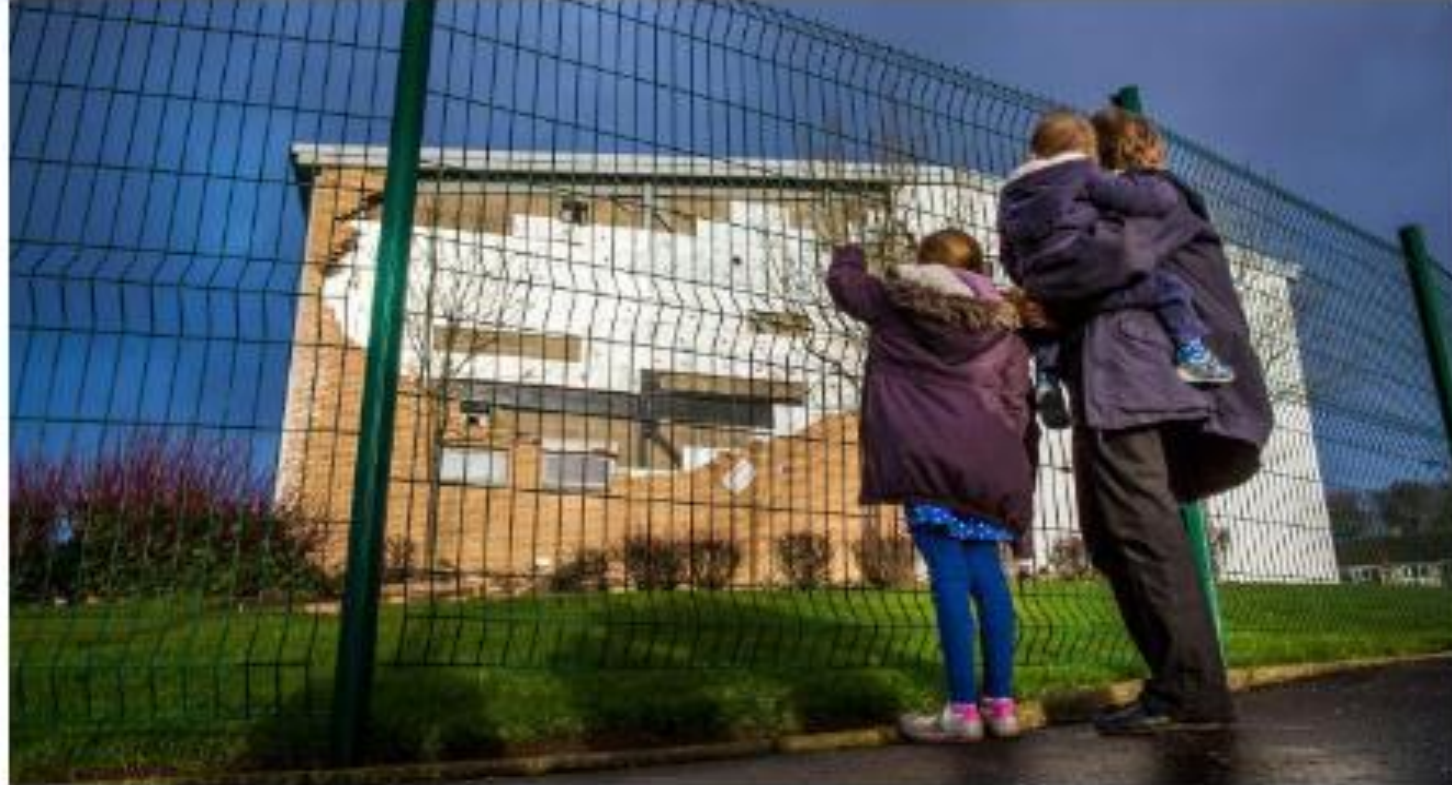
Concerns over safety were raised following the collapse of a wall at Oxbgangs Primary in Edinburgh last January
TIMES PHOTOGRAPHER JAMES GLOSSOP

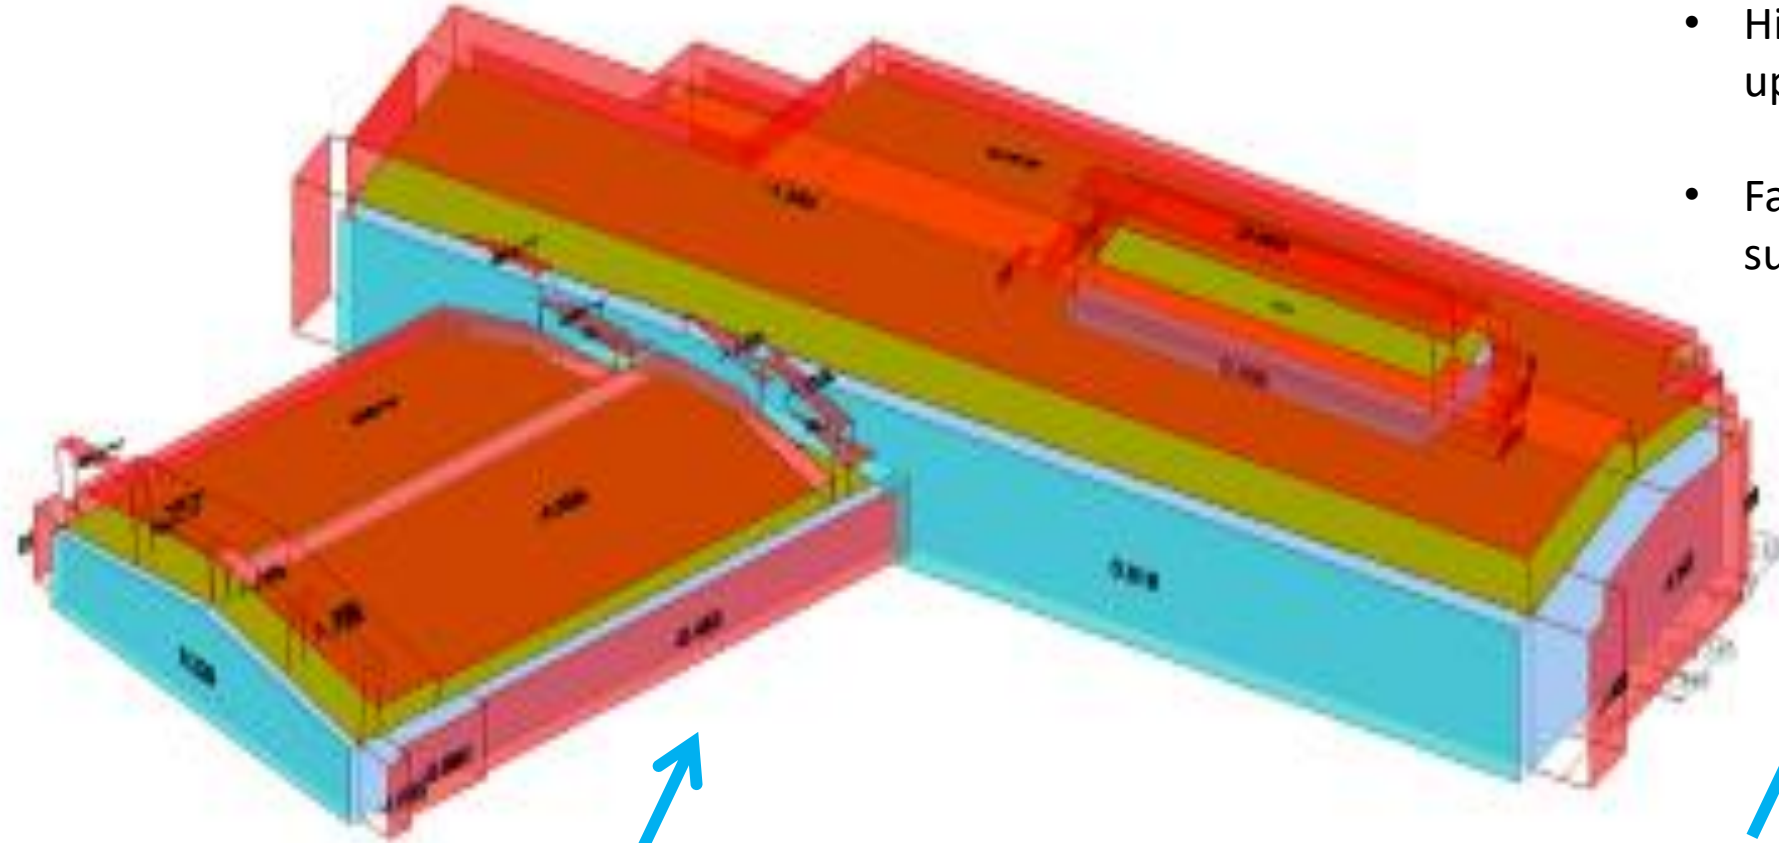
- Highest negative pressures on upper LHS of the gable that fell.
- Failed panels subjected to suction force of up to 1 tonne

South-West Wind
Design speed 90mph
Actual speed 69mph

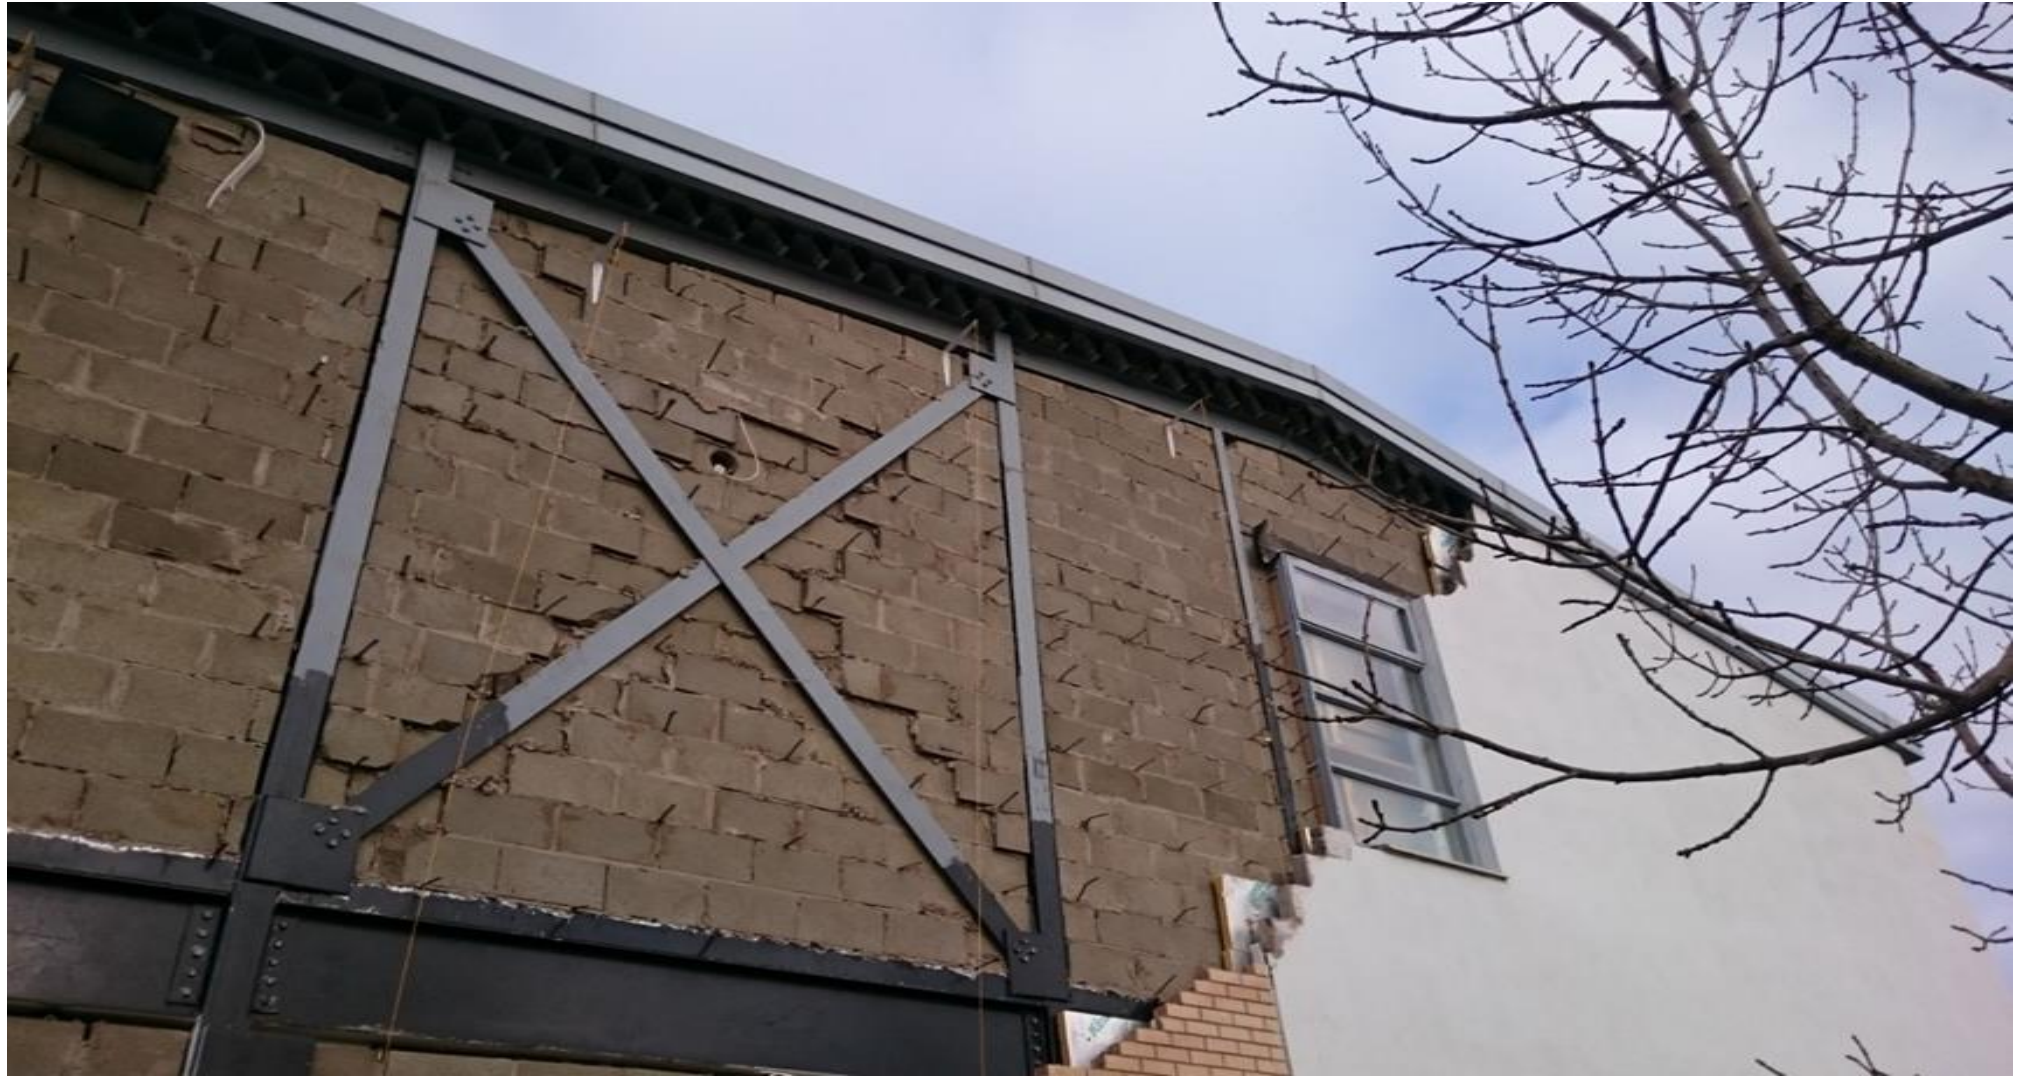
- Width of cavity to the collapsed wall assessed to range between 15mm to 40mm wider than specified 120mm;
- Measurements of wall ties left in the inner leaf after collapse showed over 50% of these insufficiently long to provide minimum embedment of 50mm in outer leaf
- In bay containing diagonal steel bracing, blockwork to inner leaf was reduced from 140mm to 100mm locally around the bracing increasing cavity width to 160mm and making 50 mm embedment either side impossible with 250 mm tie
- Report recommended precautionary investigations of the remaining walls in the school

Bay with diagonal steel bracing showing part of blockwork reduced from 140 mm to 100 mm increasing width of cavity to 160 mm although the same 250 mm long wall ties were used

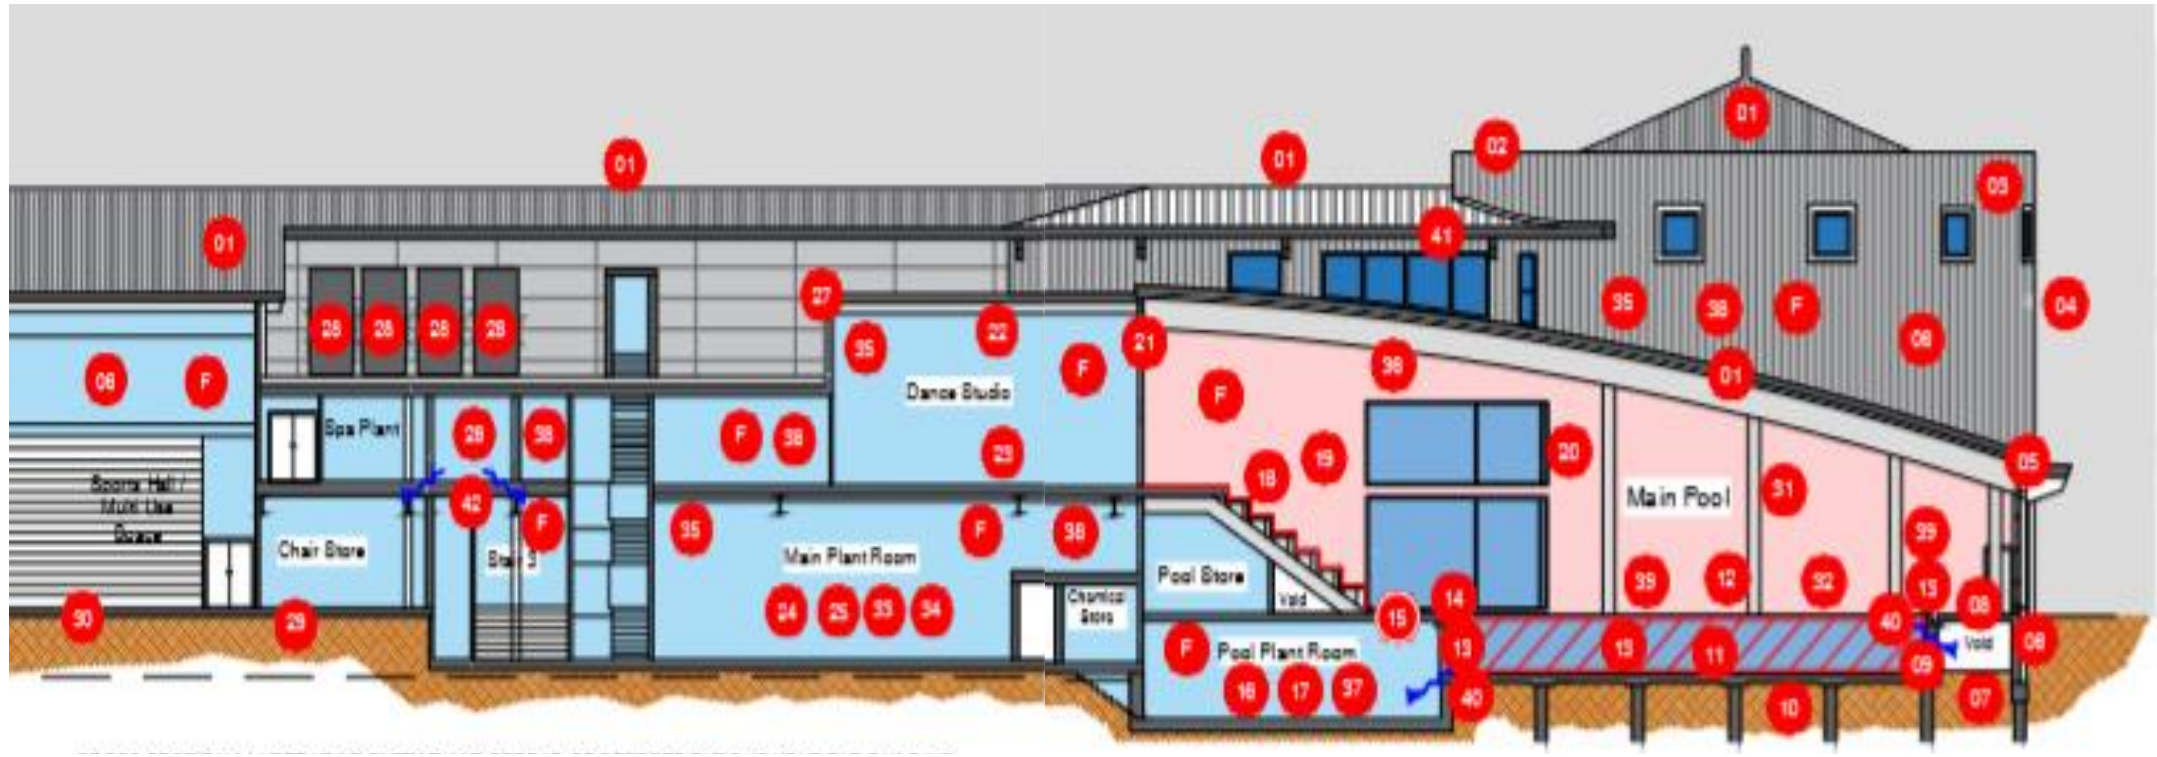
SECTION SHOWING RANGE OF LATENT DEFECTS DISCOVERED IN DUMFRIES LEISURE CENTRE

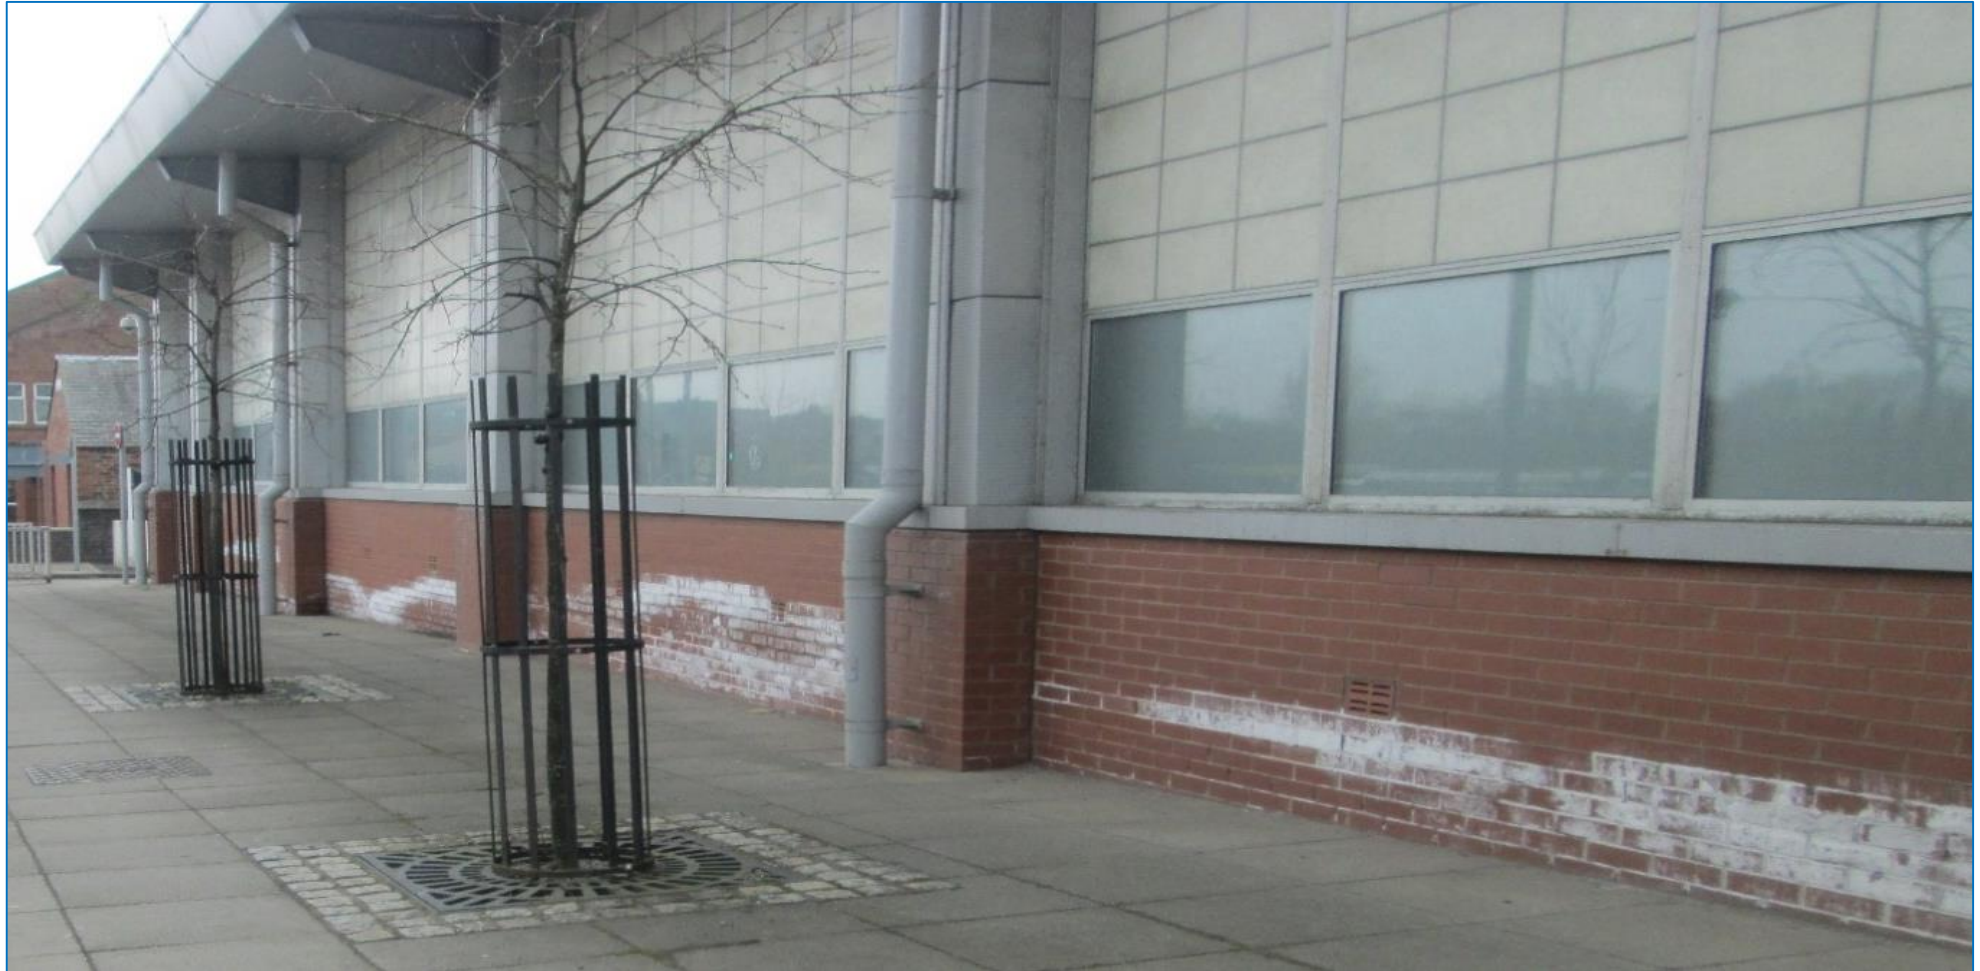
Street elevation of DG One building showing efflorescence due to constantly saturated wall

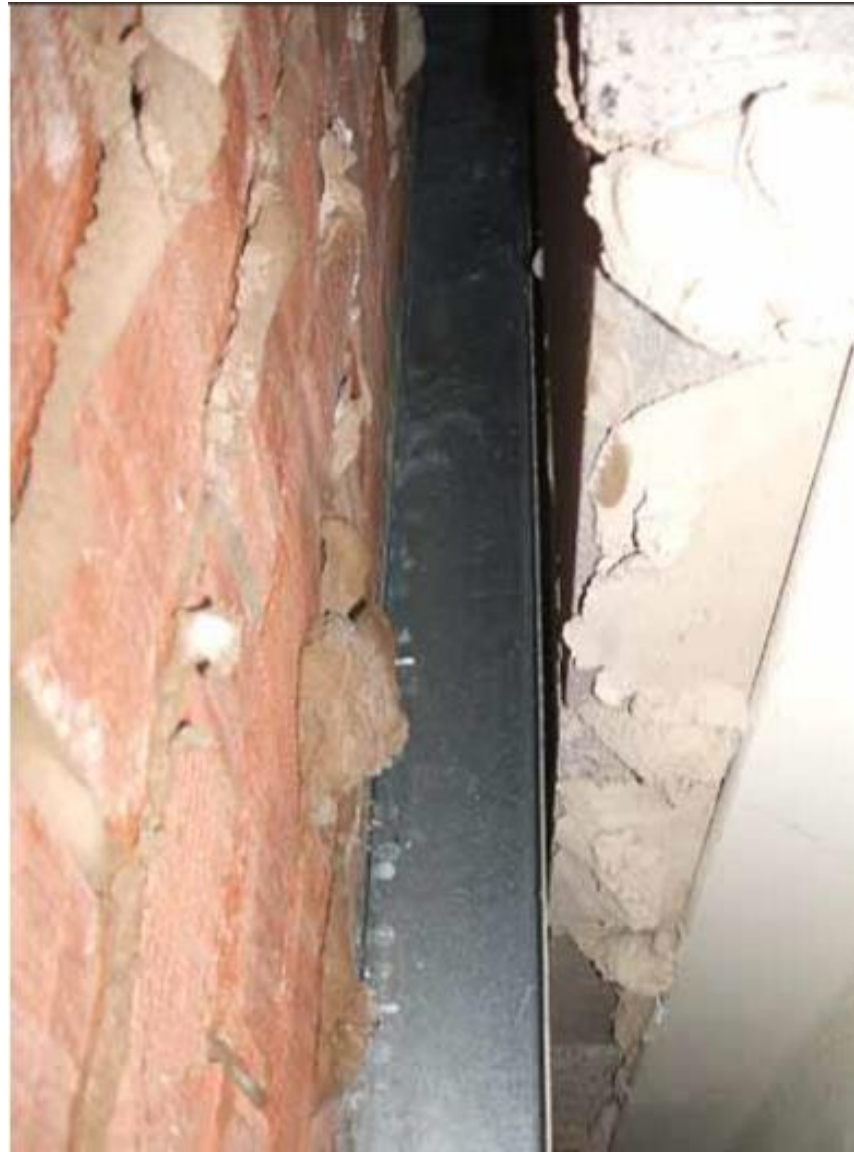
Isolated pieces of insulation below floor level but none above and through corner where cold bridge occurs at steel column

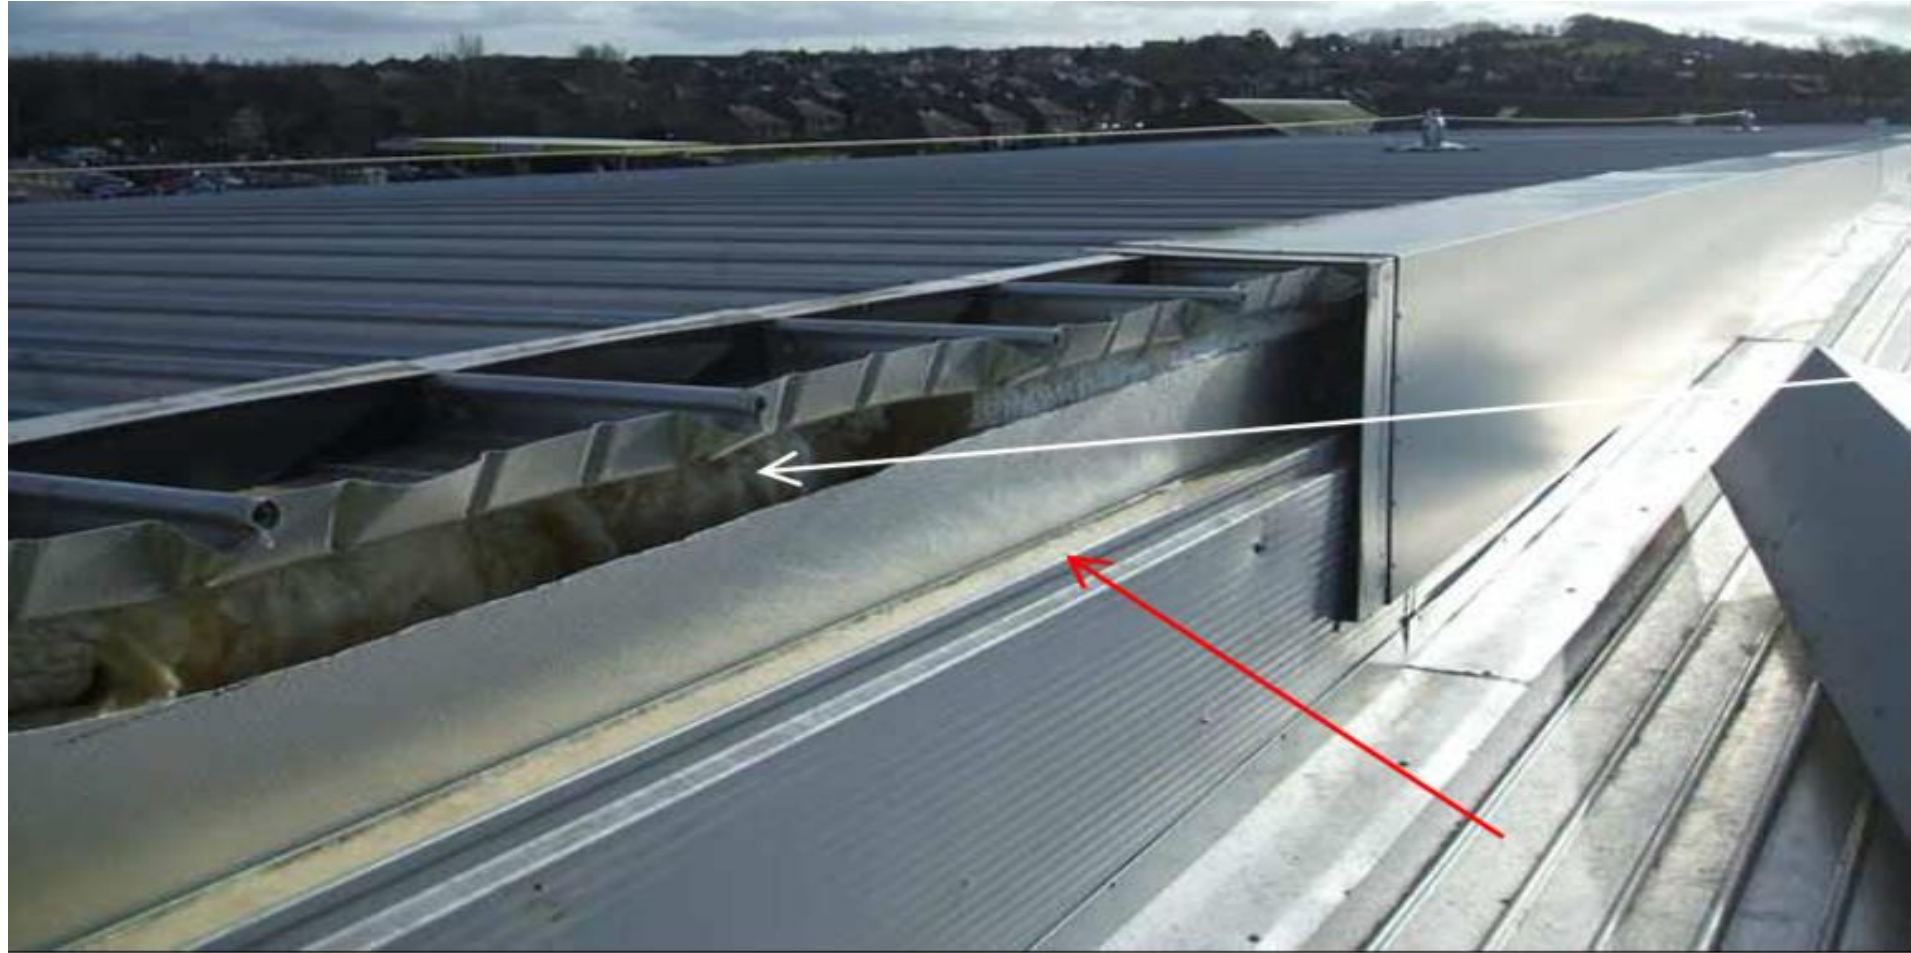
External wall Insulation missing

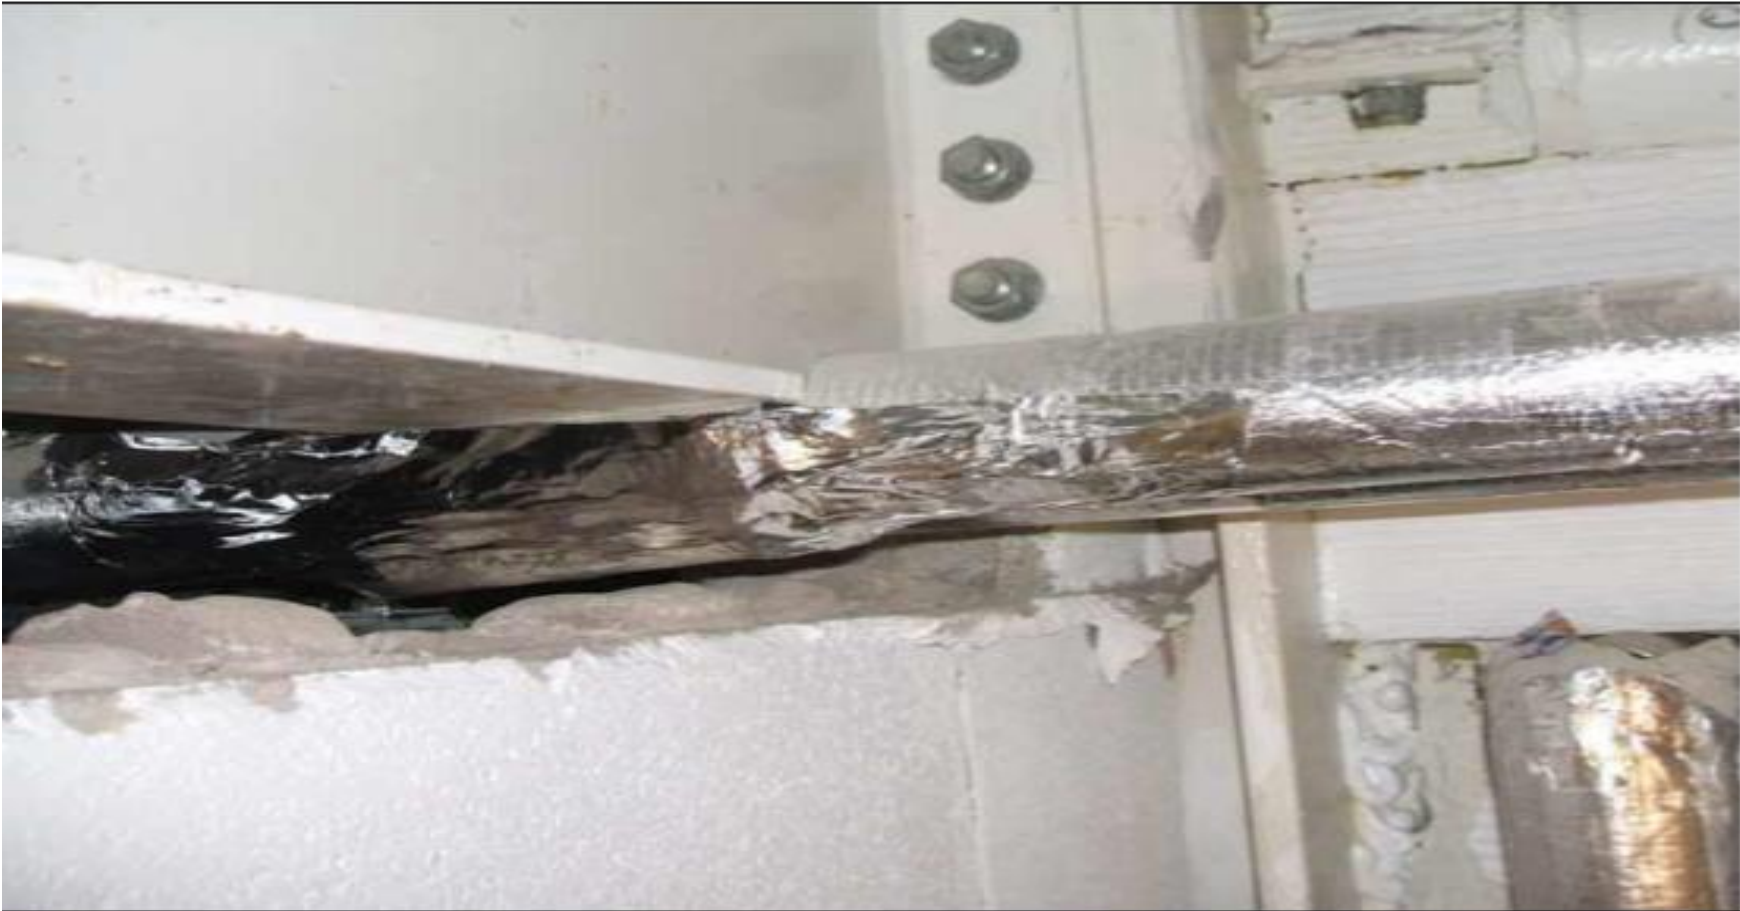
Unsealed hole as services pass through 1-hour fire resisting wall

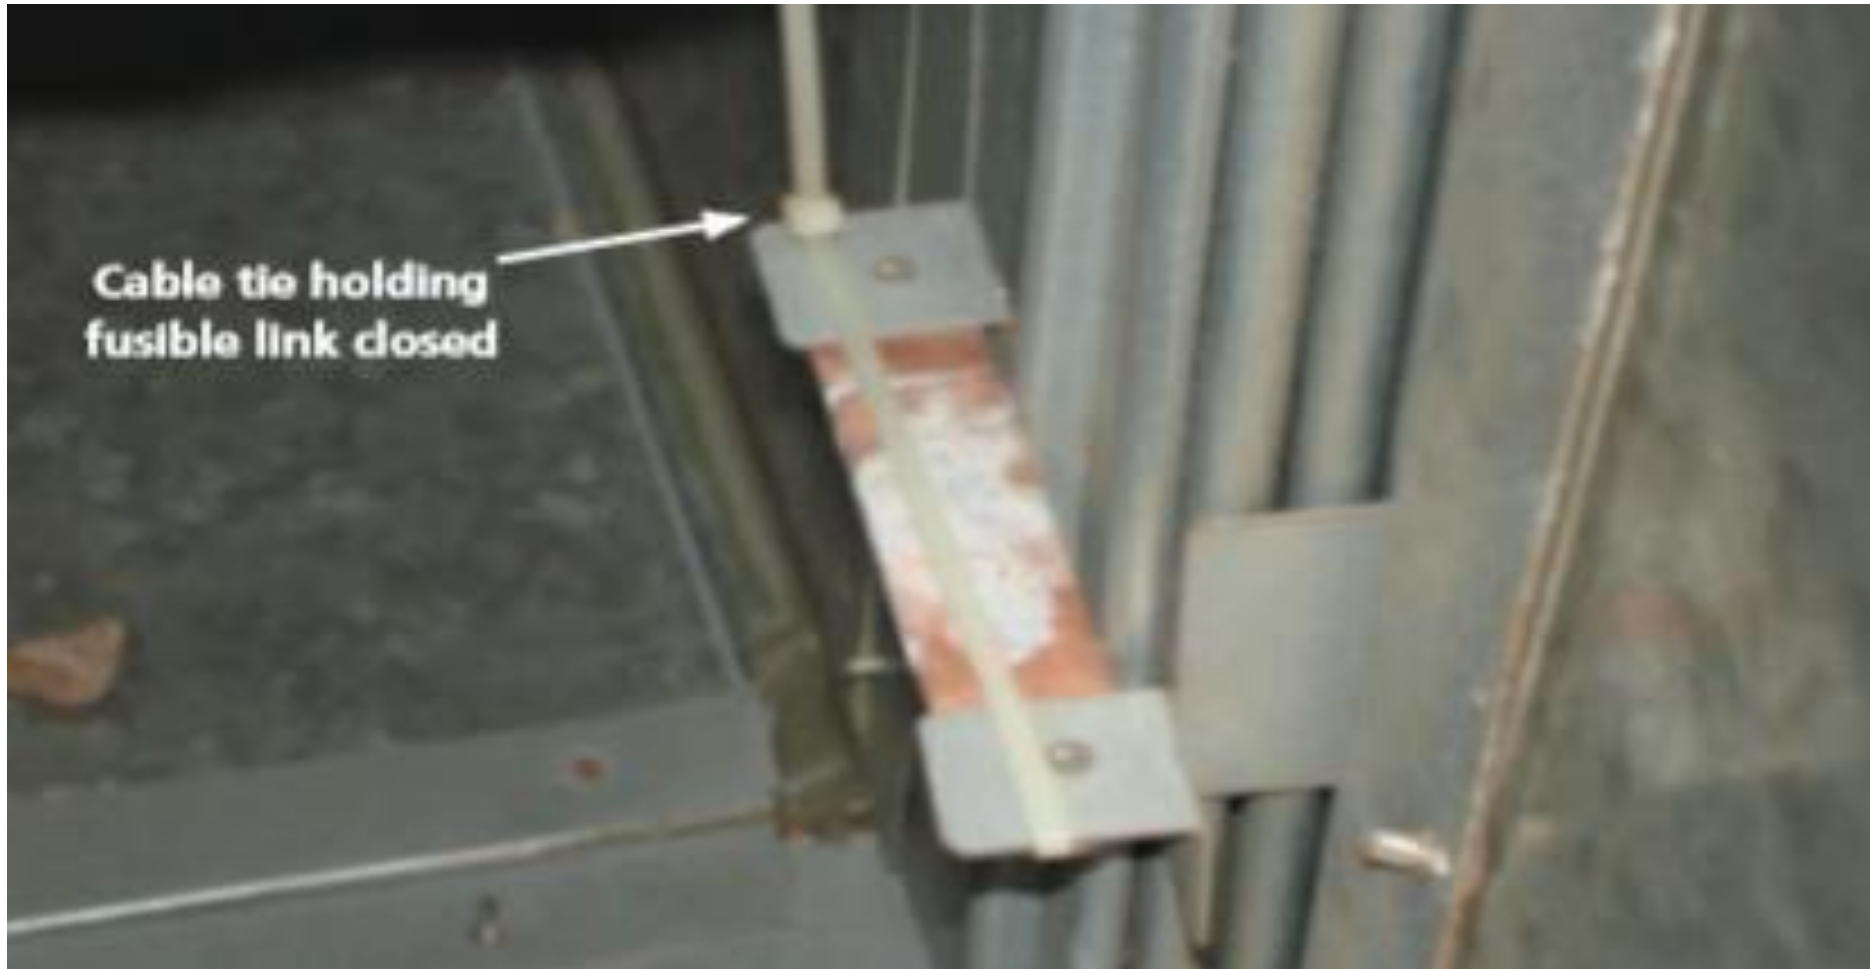
Cable tie used in transit found still in position after several years preventing fire-damper from operating

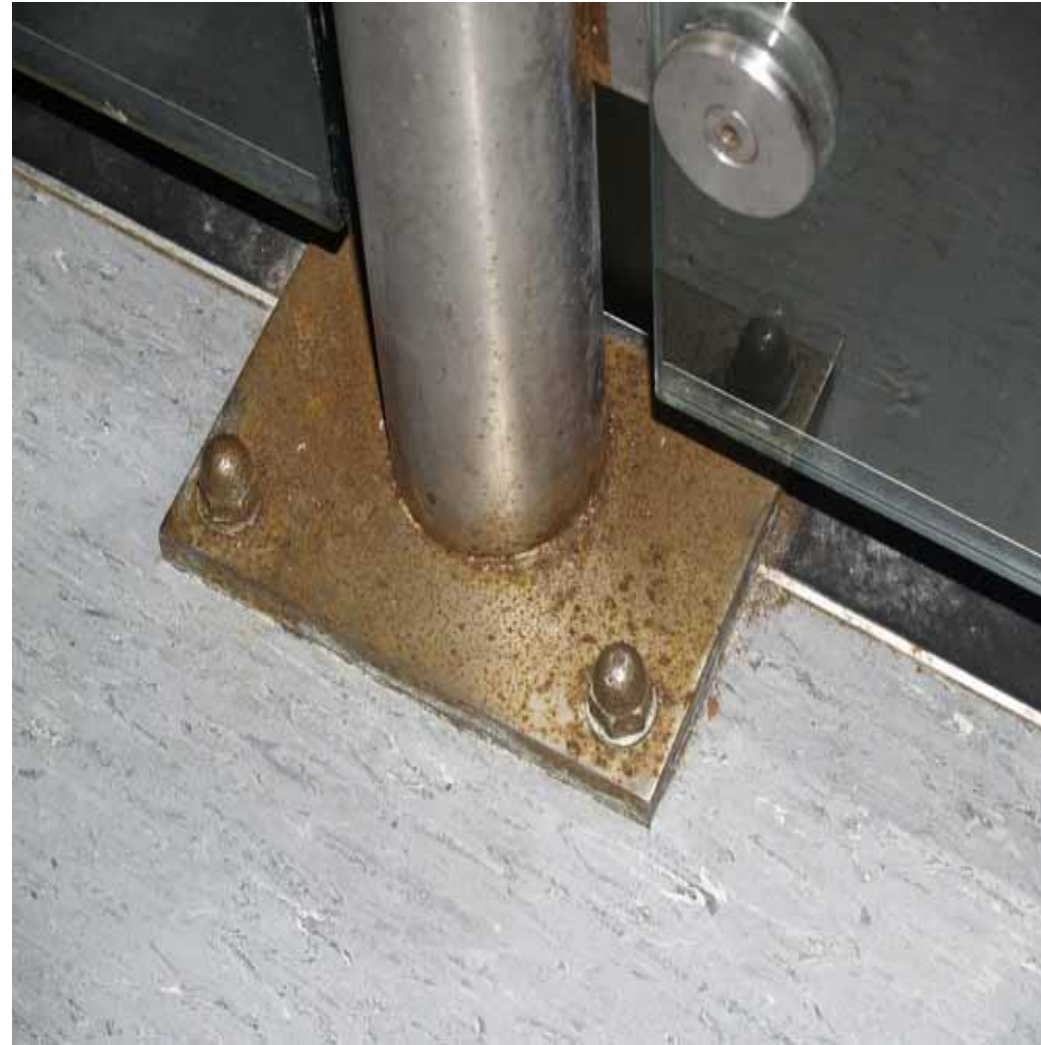
Examples of corrosion to steel fittings throughout the wet area found to be 304 grade steel as opposed to specified grade 316

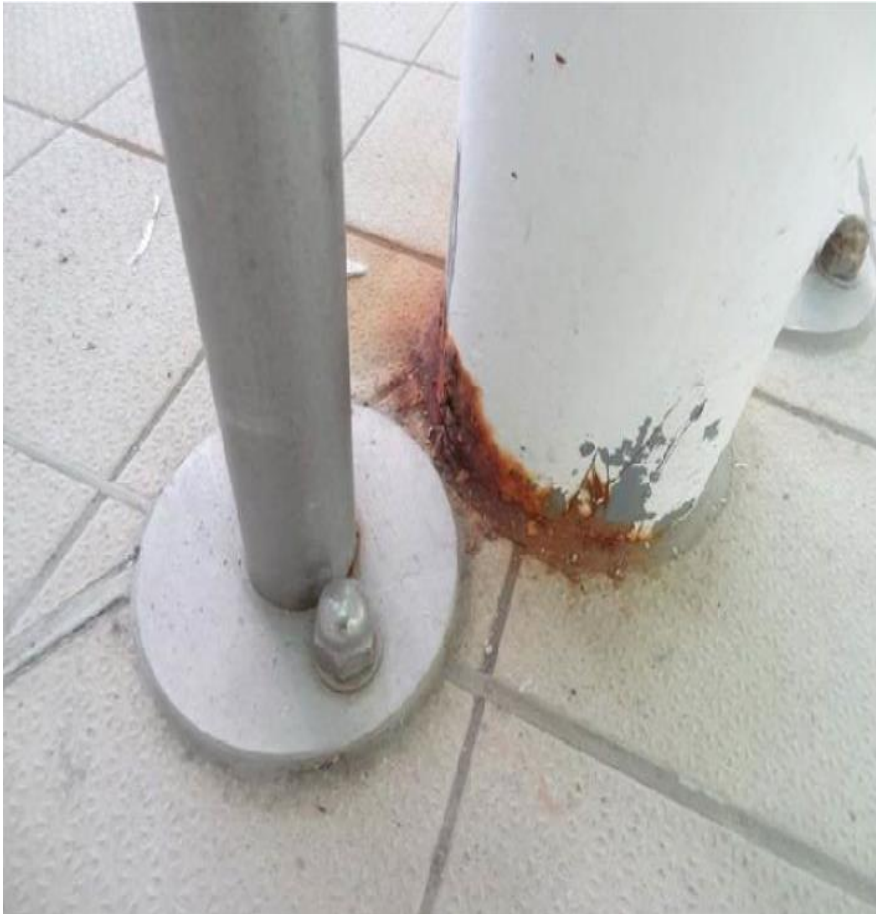
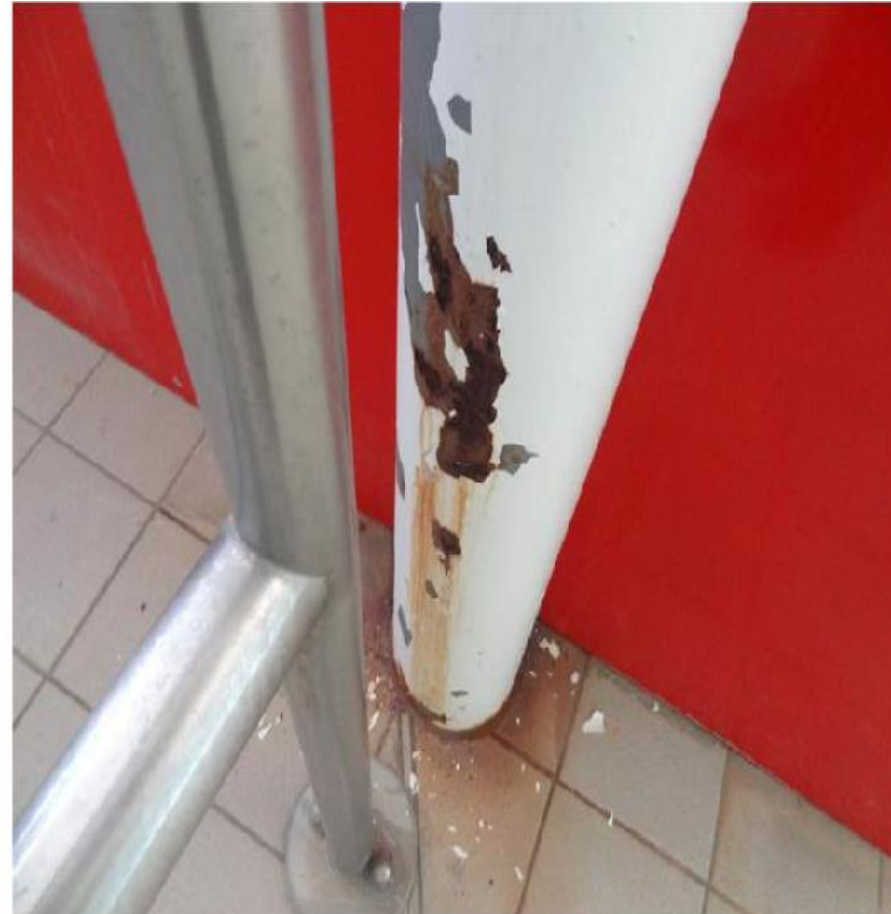
Corrosion of metal fittings throughout building

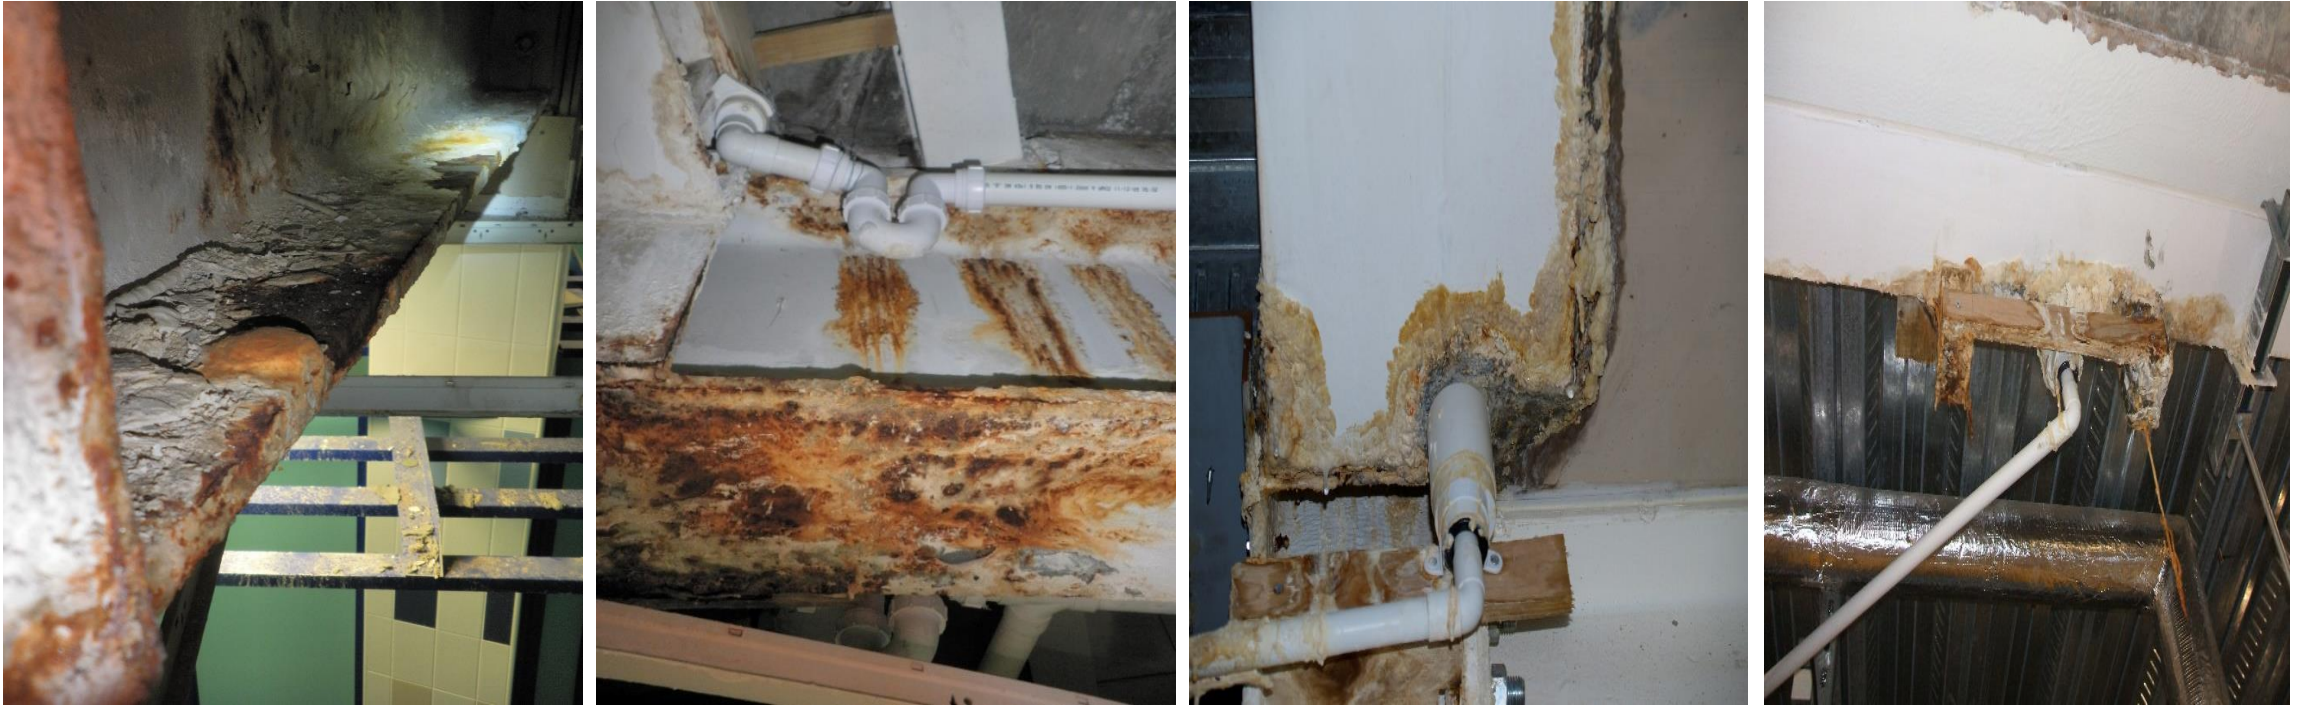
Impact of leaks from first floor area and corrosion to structural steelwork immediately below

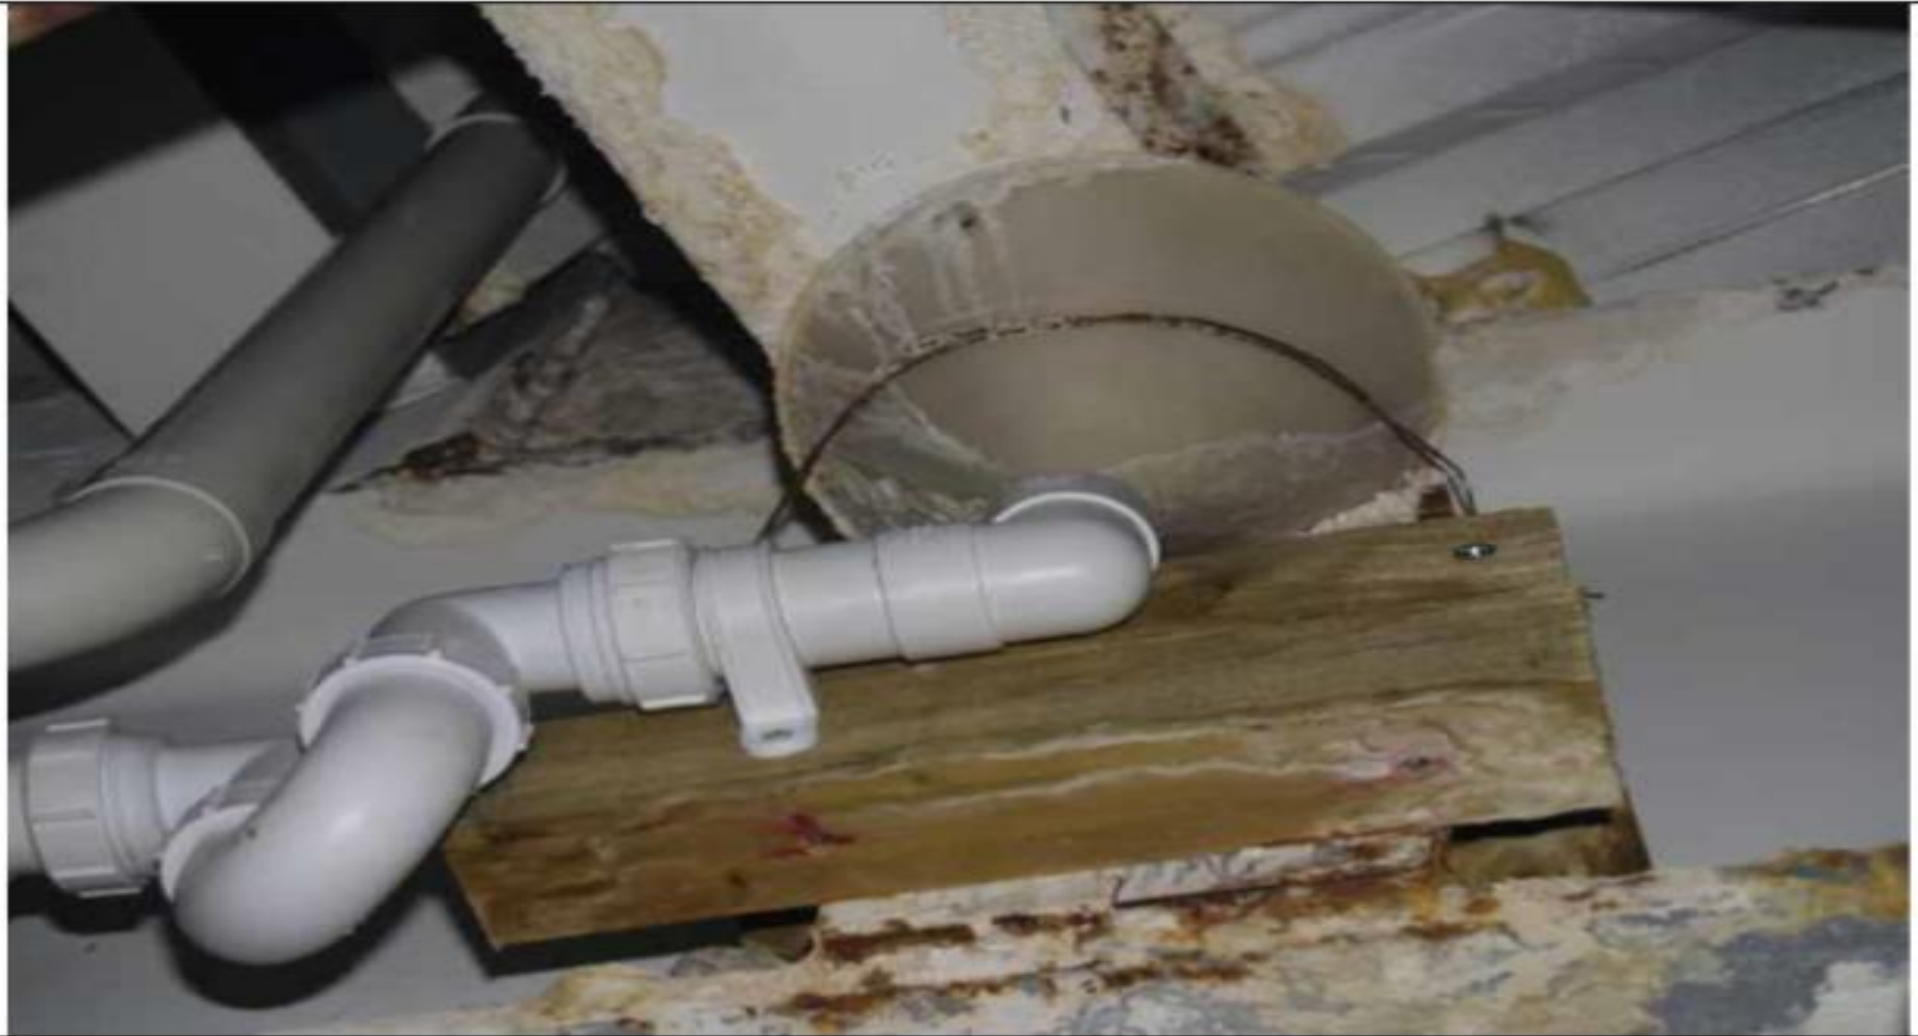
Domestic funnel wired in place by the contractor as catch vessel for major leak in ceiling void above changing area. Wire corroded and timber untreated

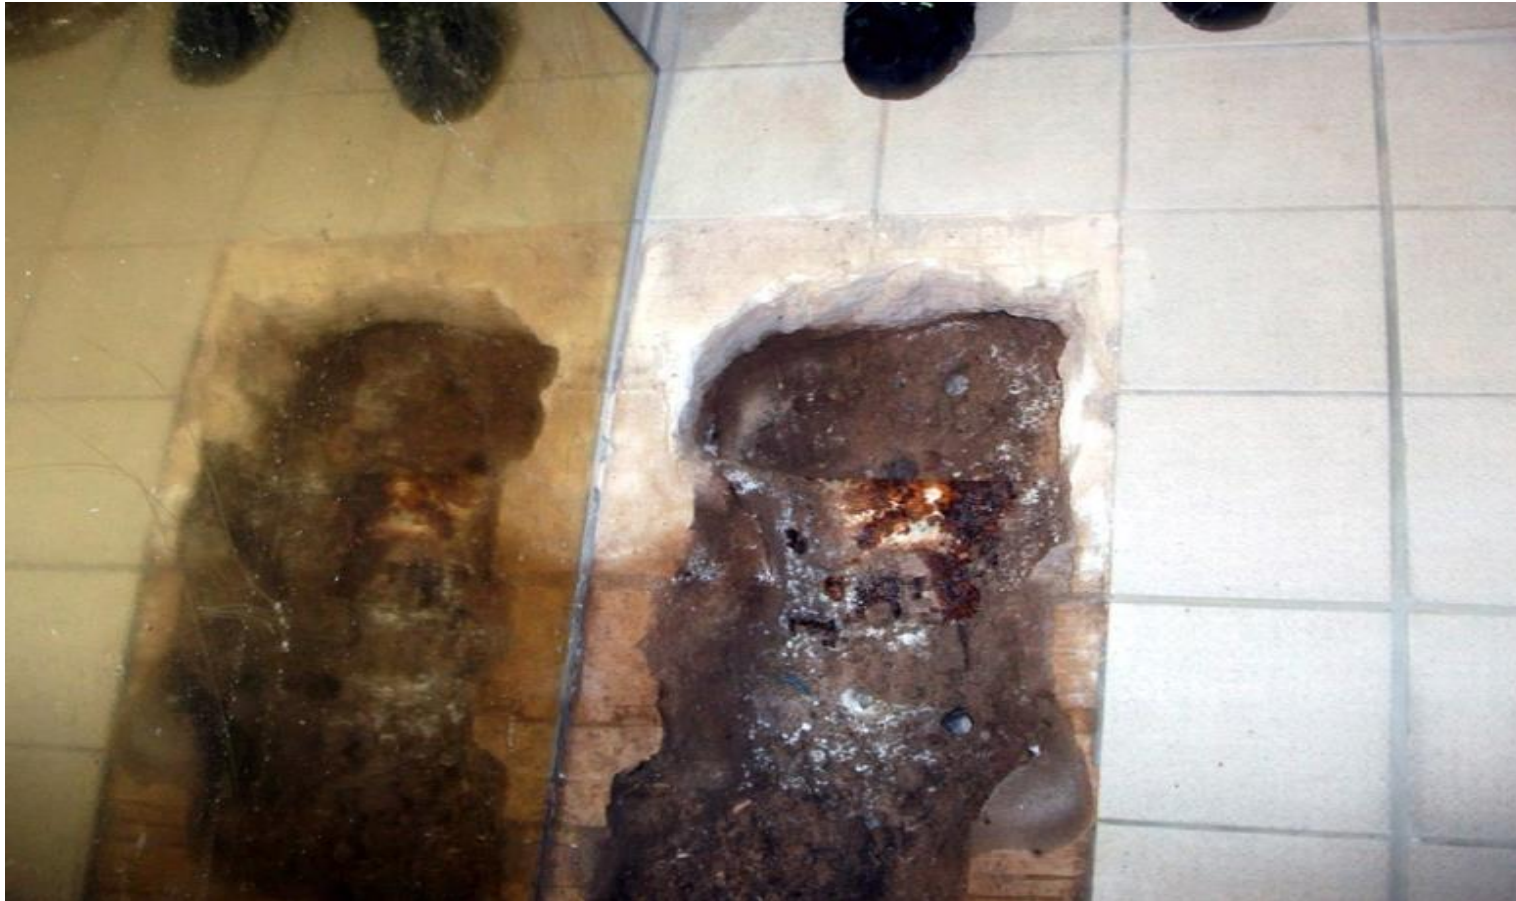
A corroded steel beam (*and its reflection in a mirror*) in the screed below an opened section of tiling.
