SCOTTISH ASSOCIATION OF UNIVERSITY DIRECTORS OF ESTATES

September 2018

RESTORING CONFIDENCE: THE NEED FOR A FOCUS ON QUALITY

Prof. John Cole CBE RIBA

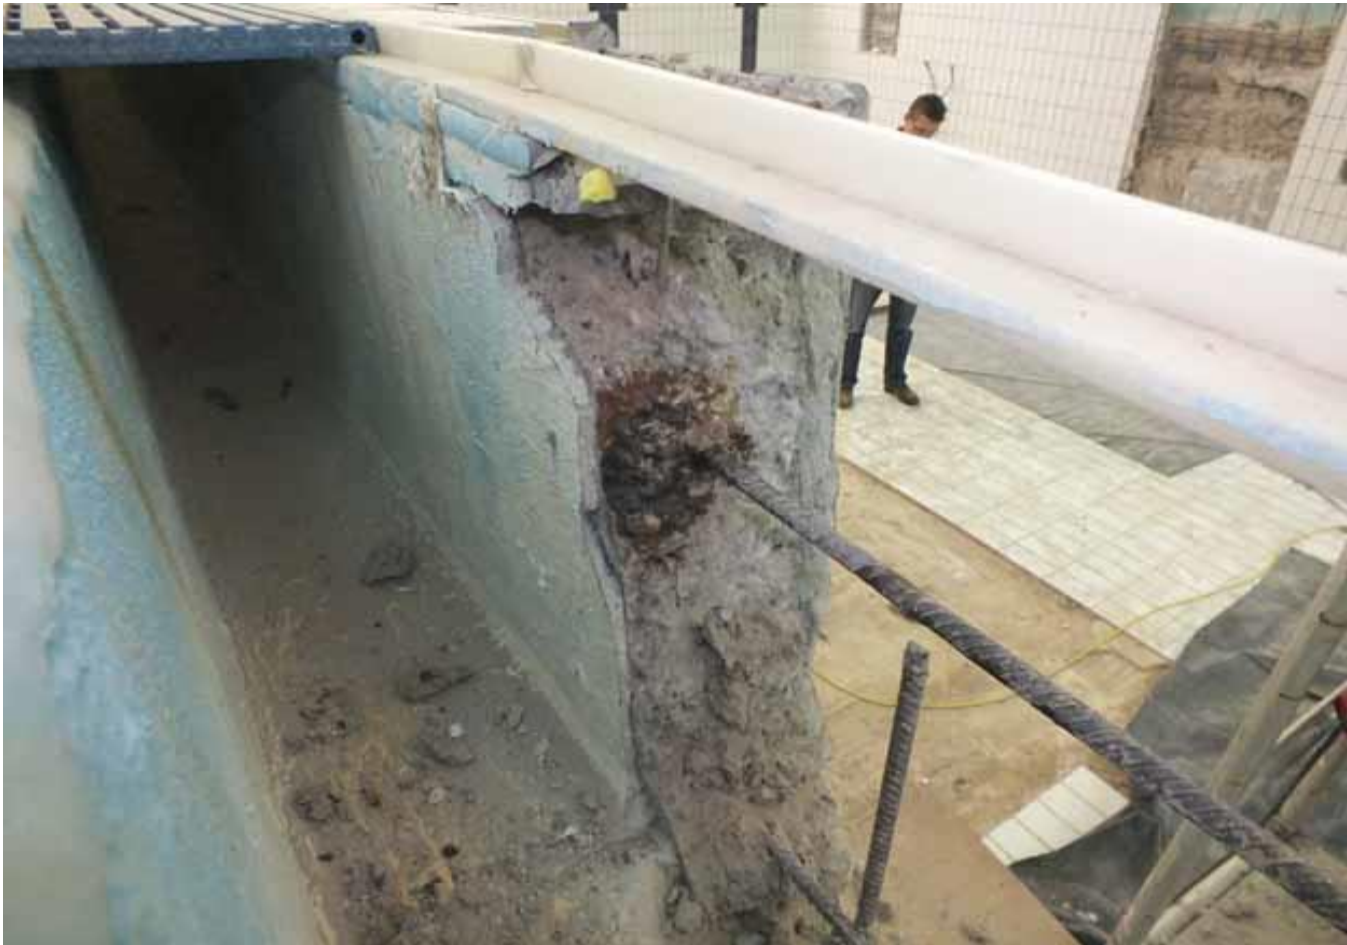
Corrosion of steel reinforcement and staining of surrounding concrete in pool walls. Above is an example of a corroded bar removed from the pool tank wall showing depleted section as a result of corrosion

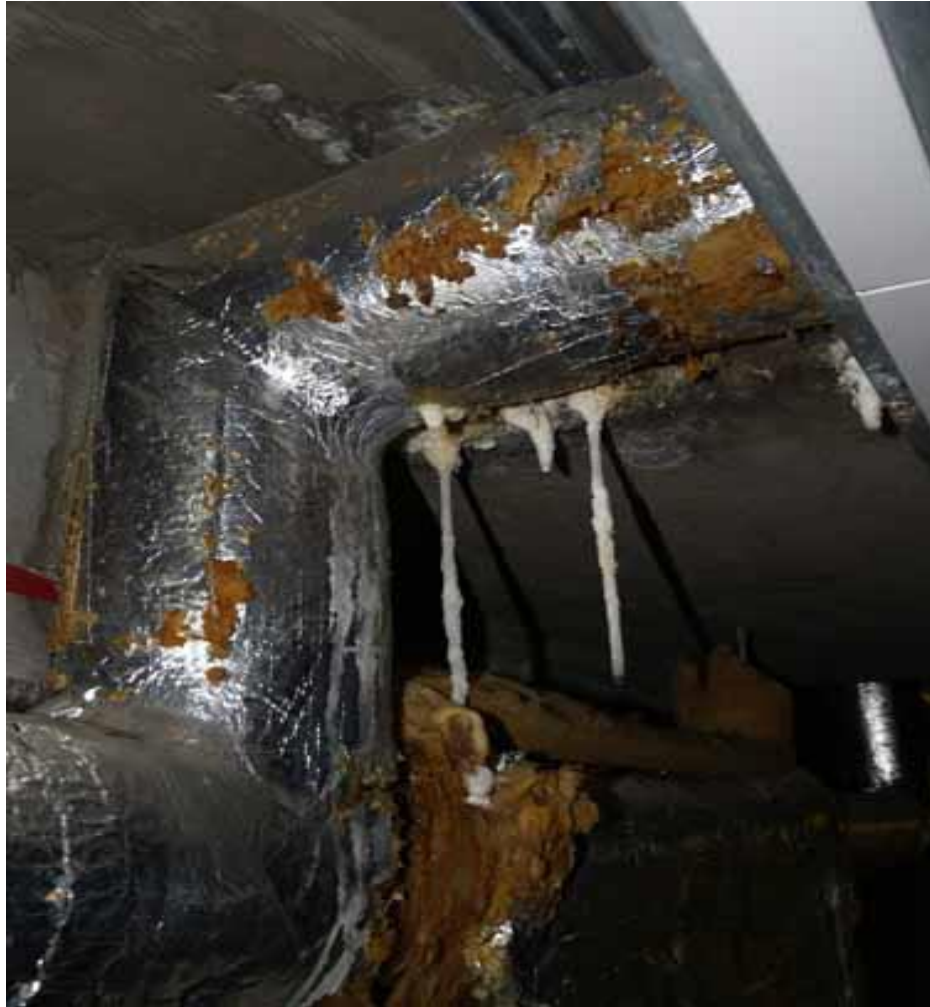
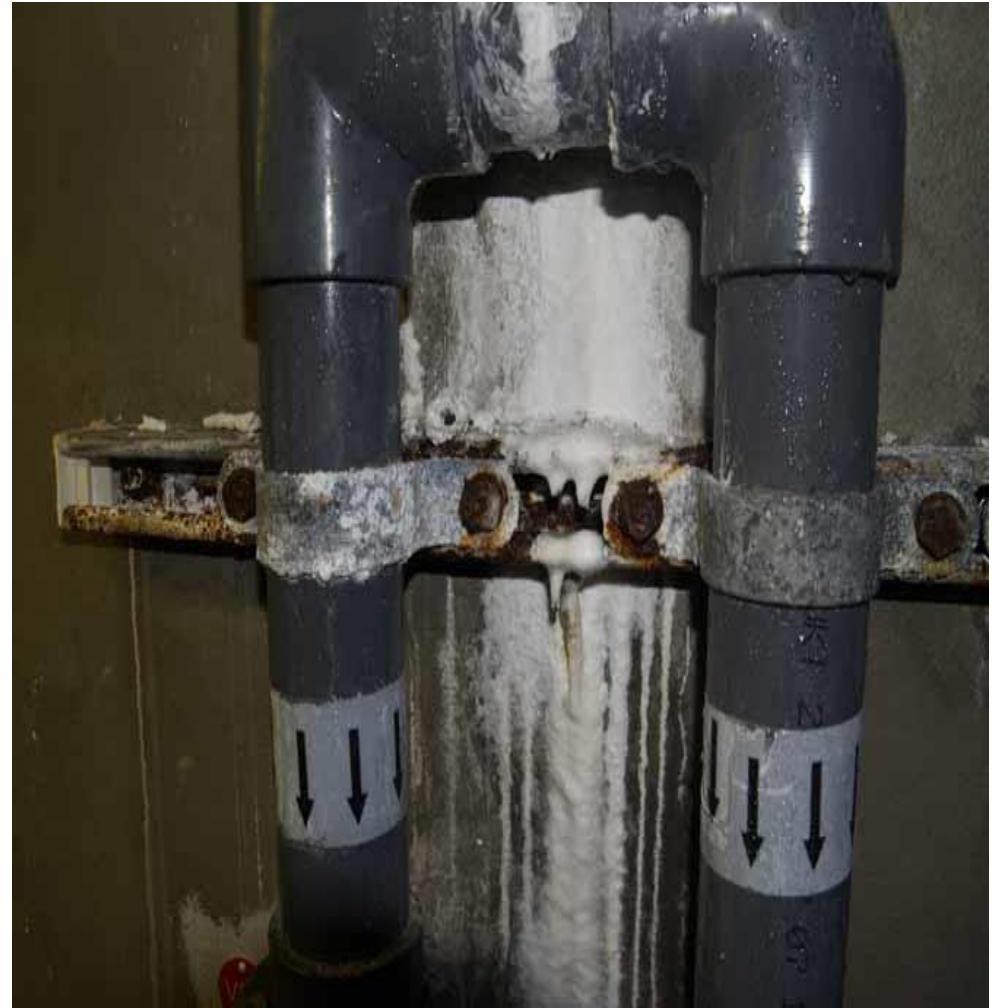
Examples of damage to pipe insulation and to galvanised fittings in plant room

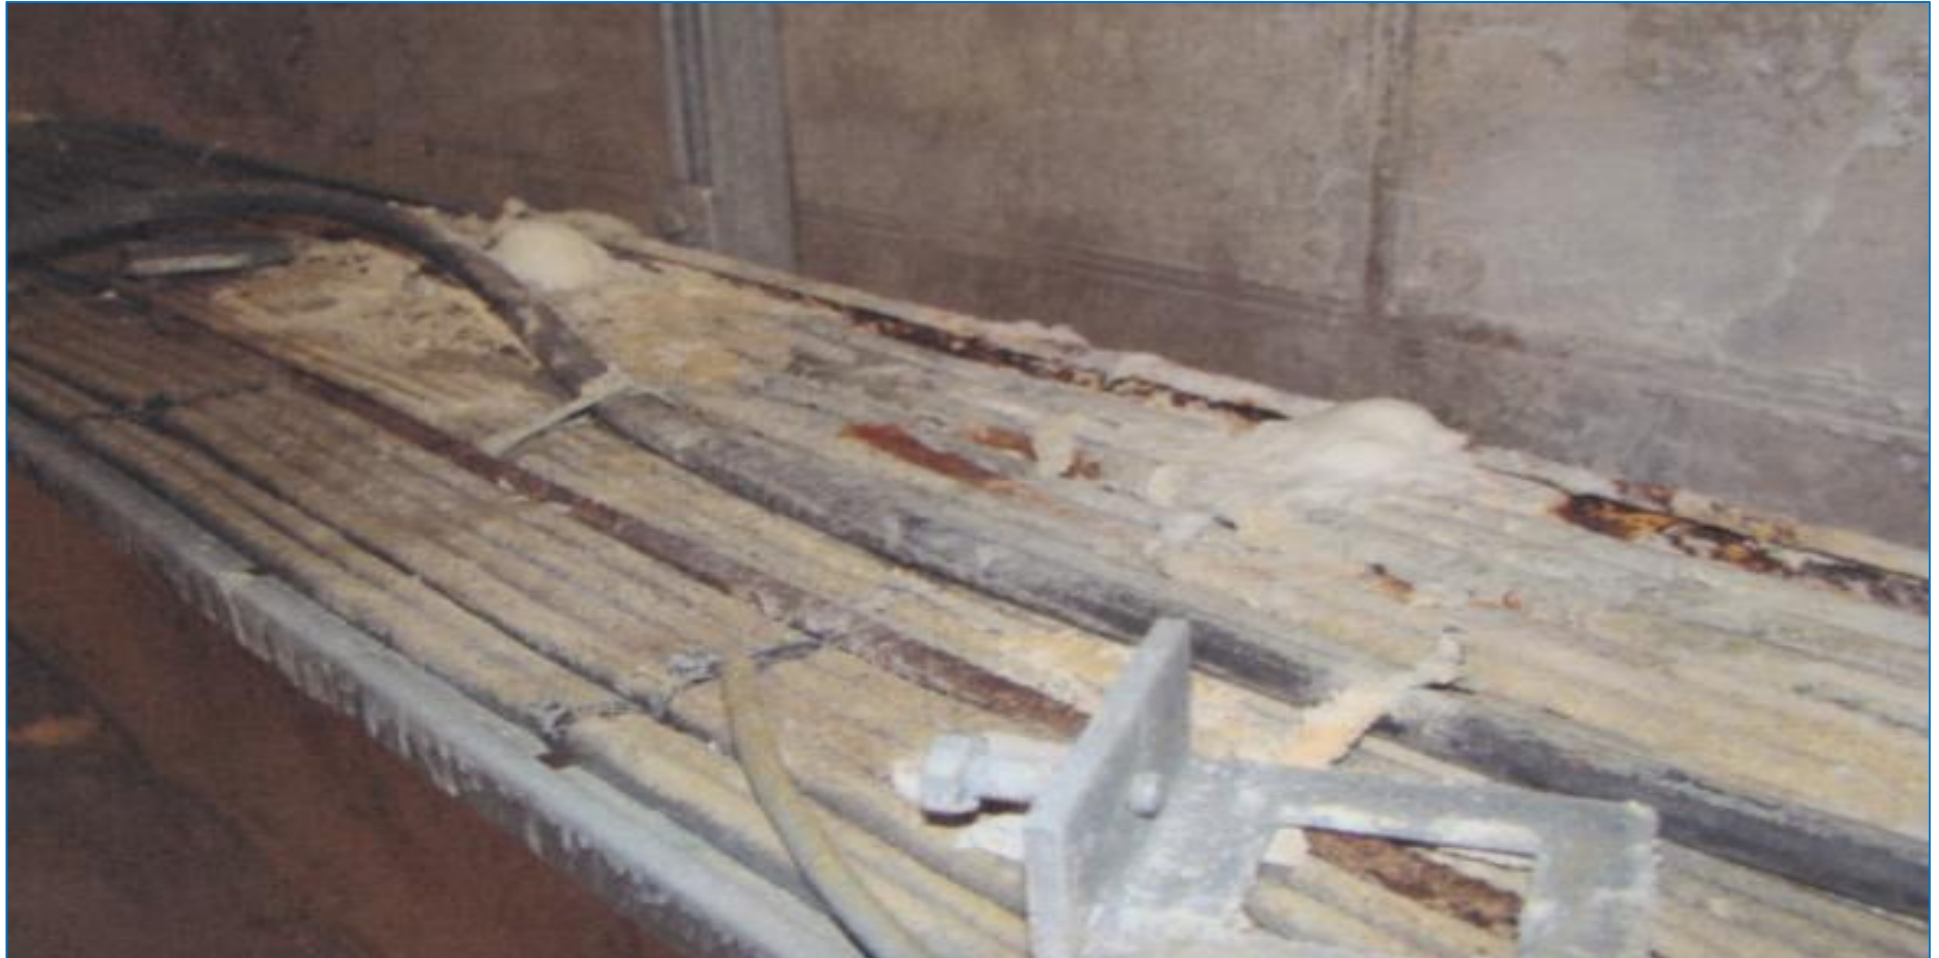
Severe corrosion evident to electrical and mechanical services from leaking pool chemicals and condensation

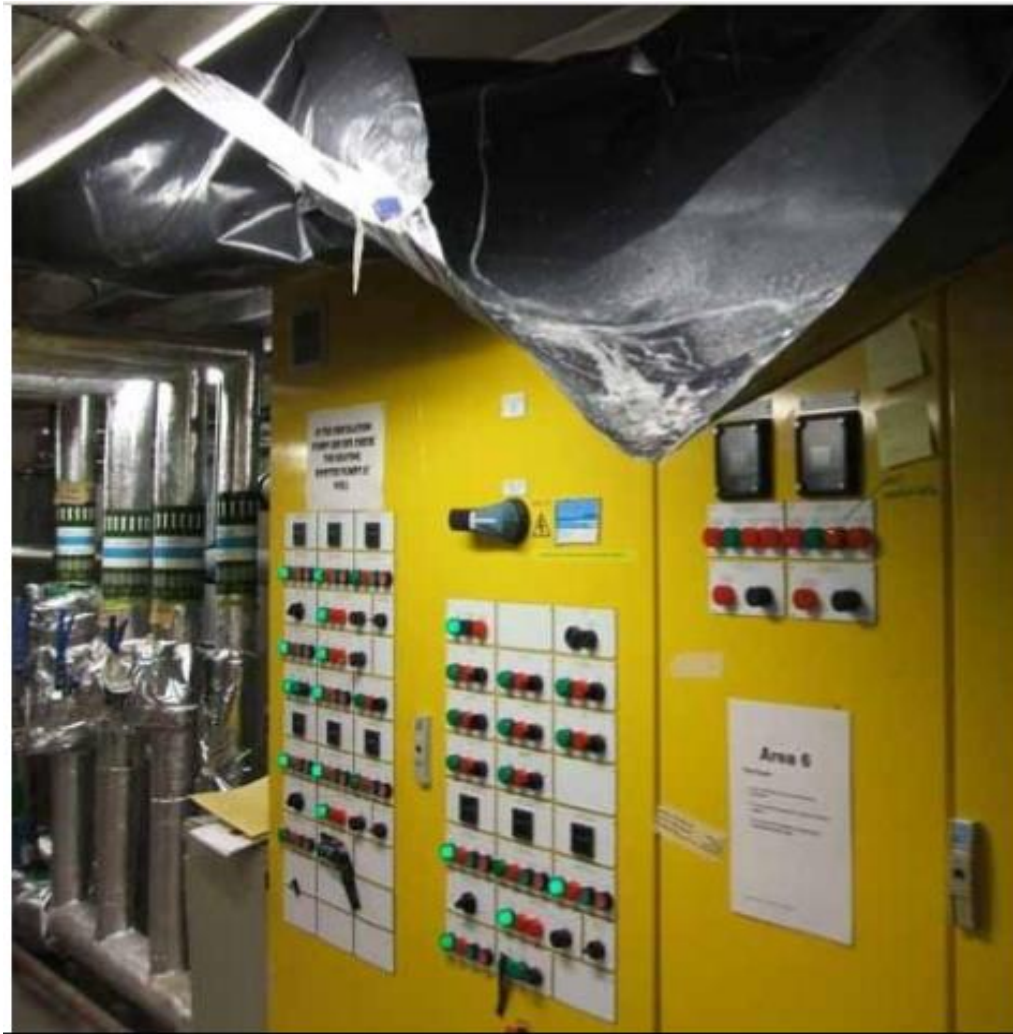
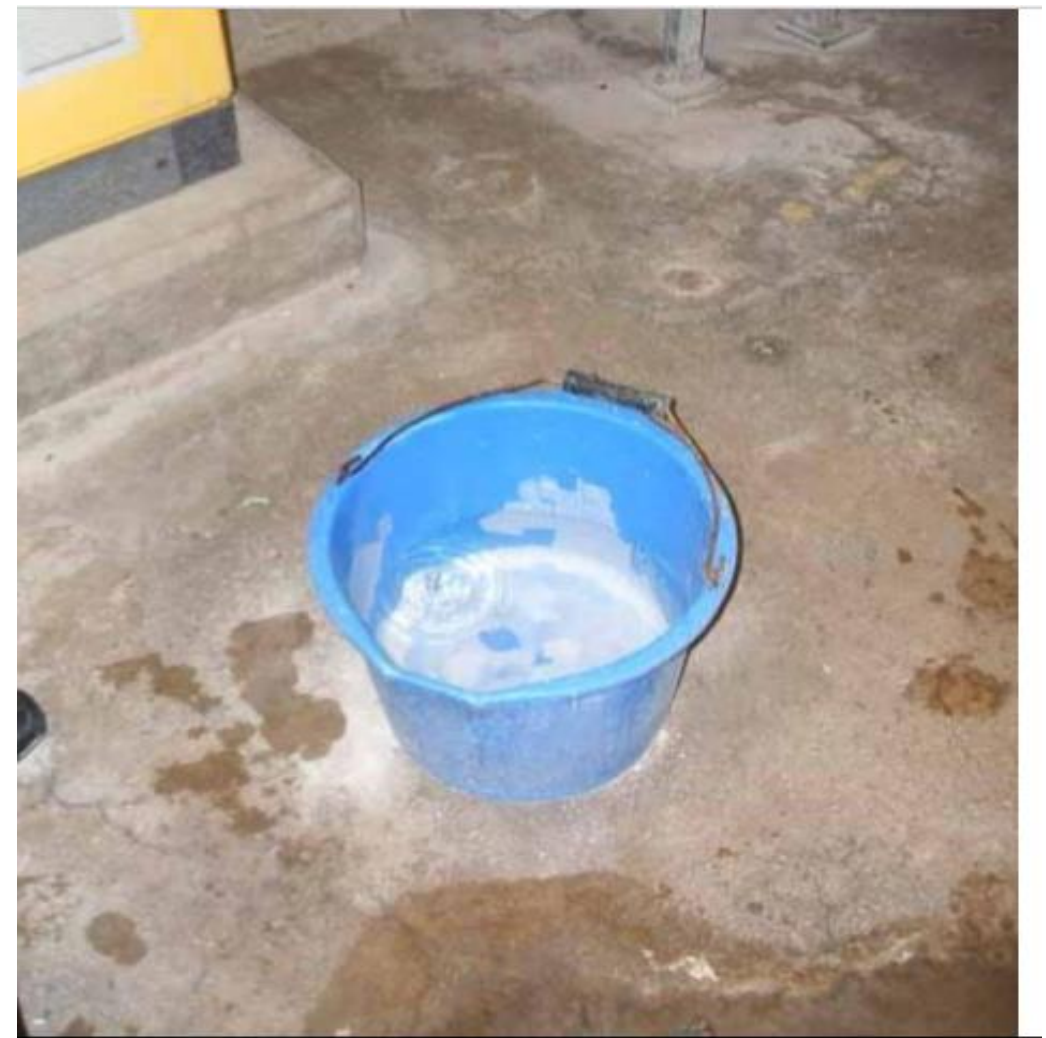
Polythene sheeting protecting electrical switchgear from overhead water leakage caught in carefully positioned bucket

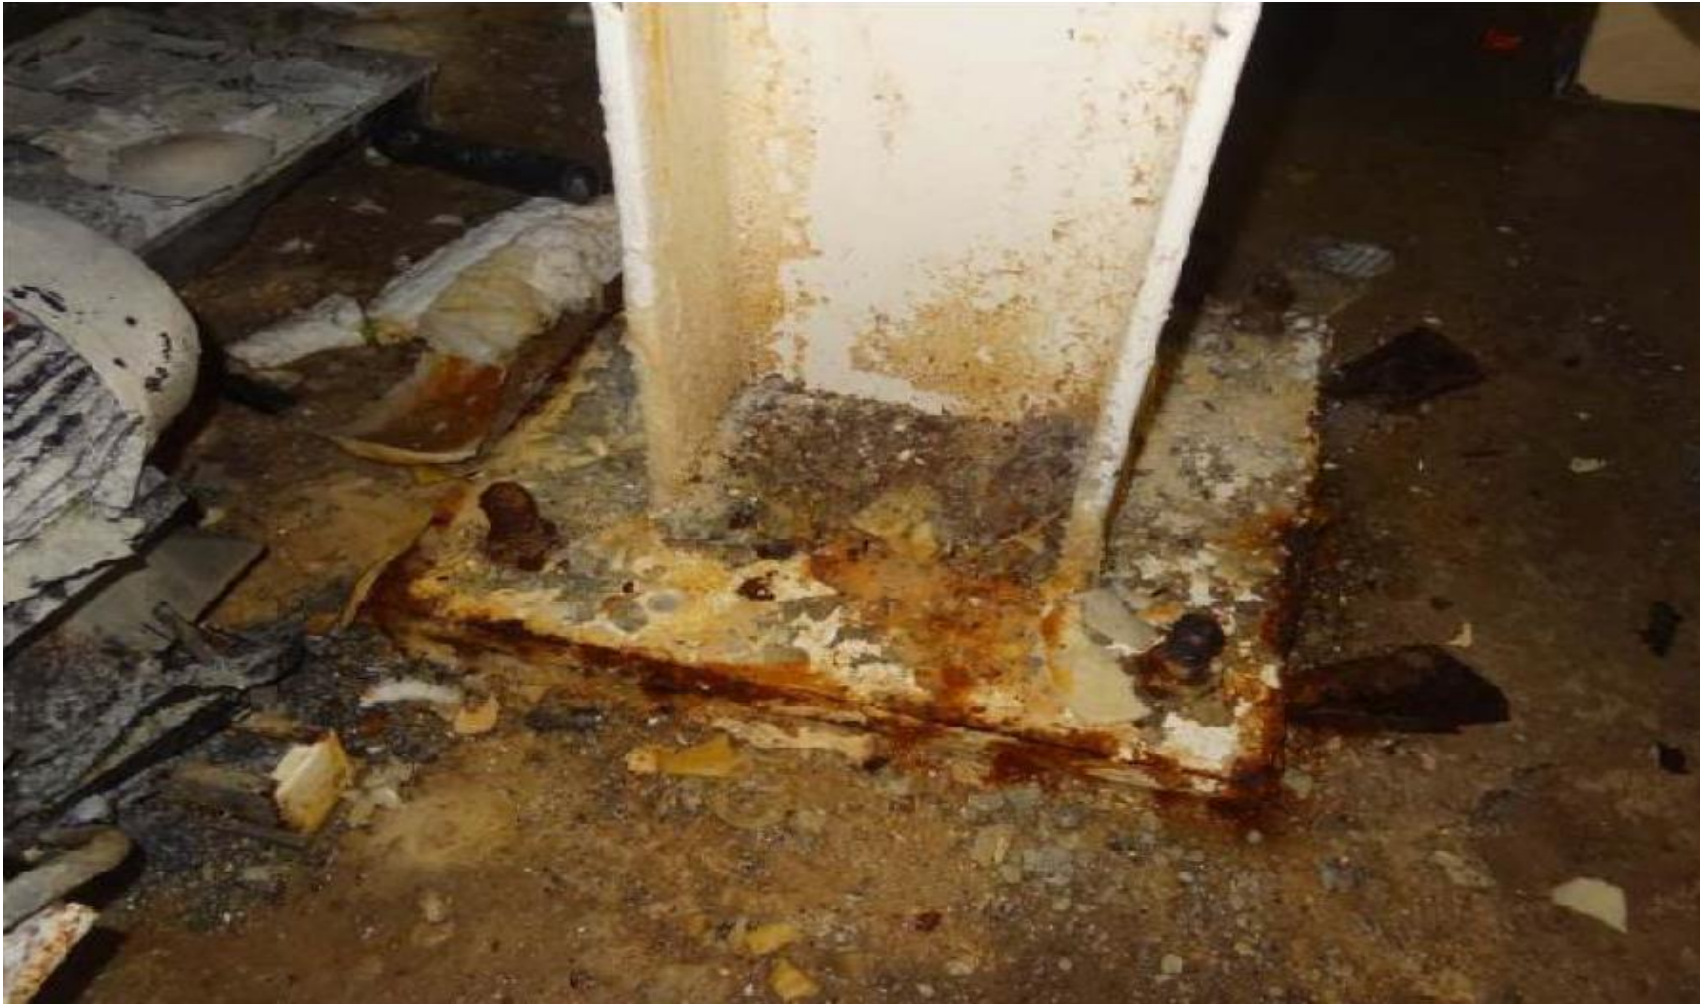
Corroded base of steel column in main plantroom

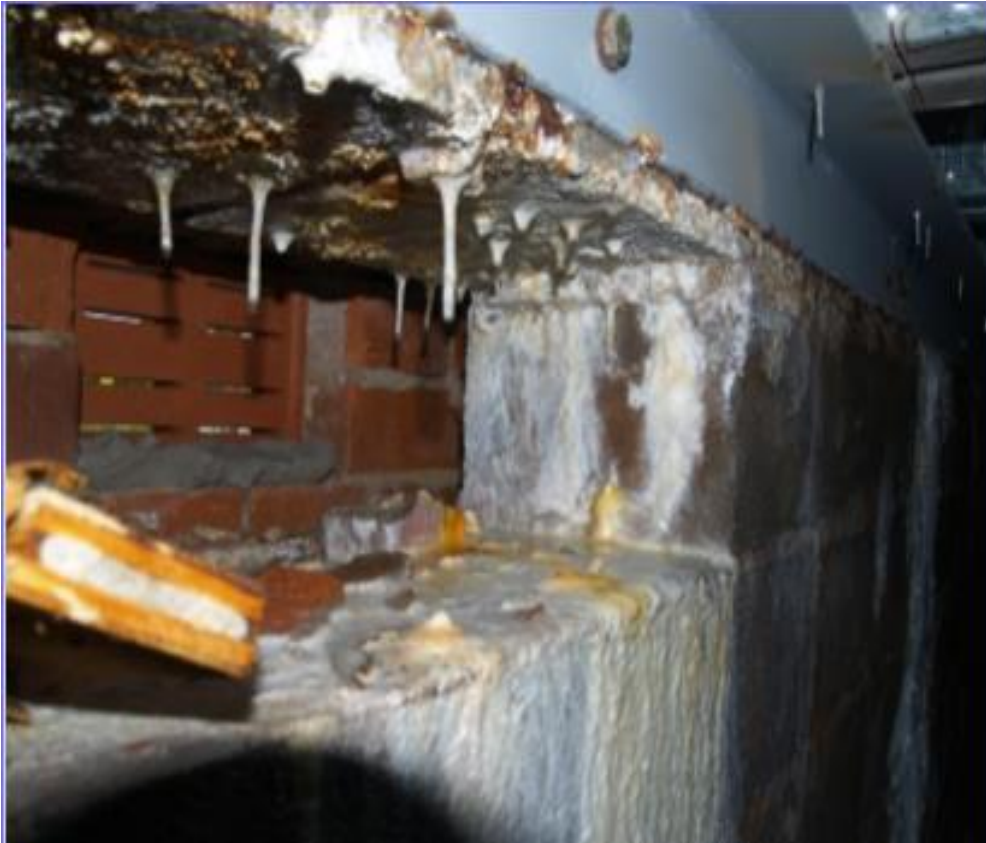
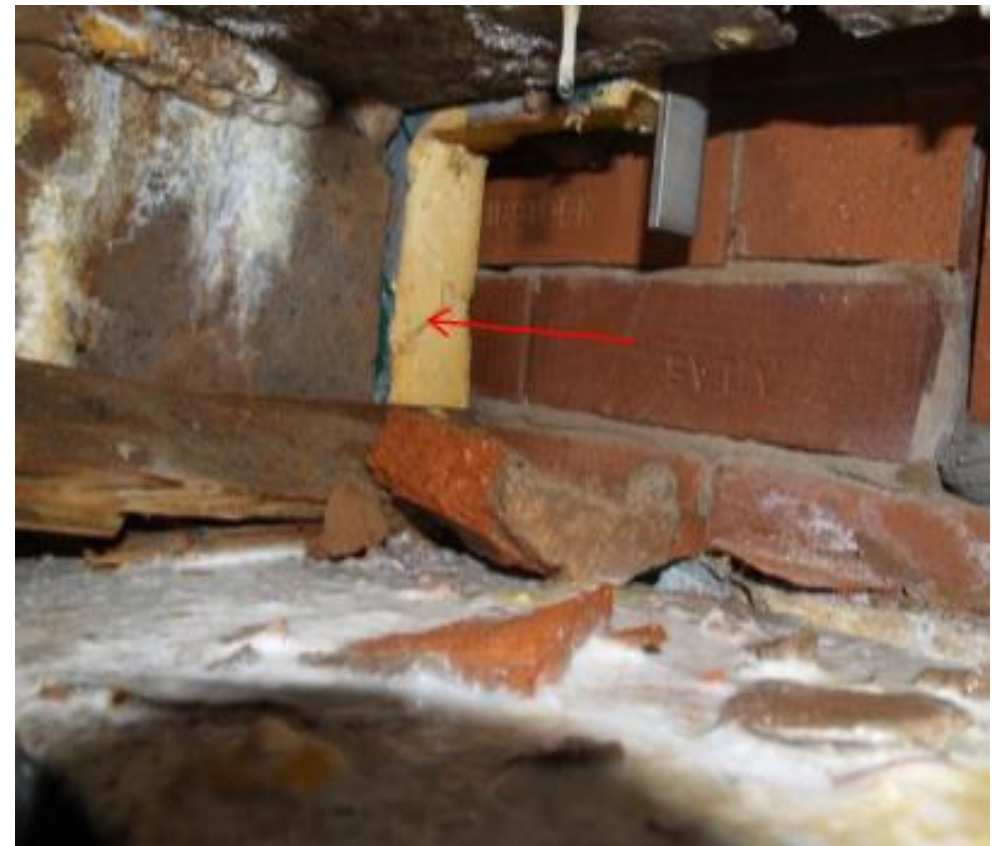
Saturated damp and efflorescence in void under pool area

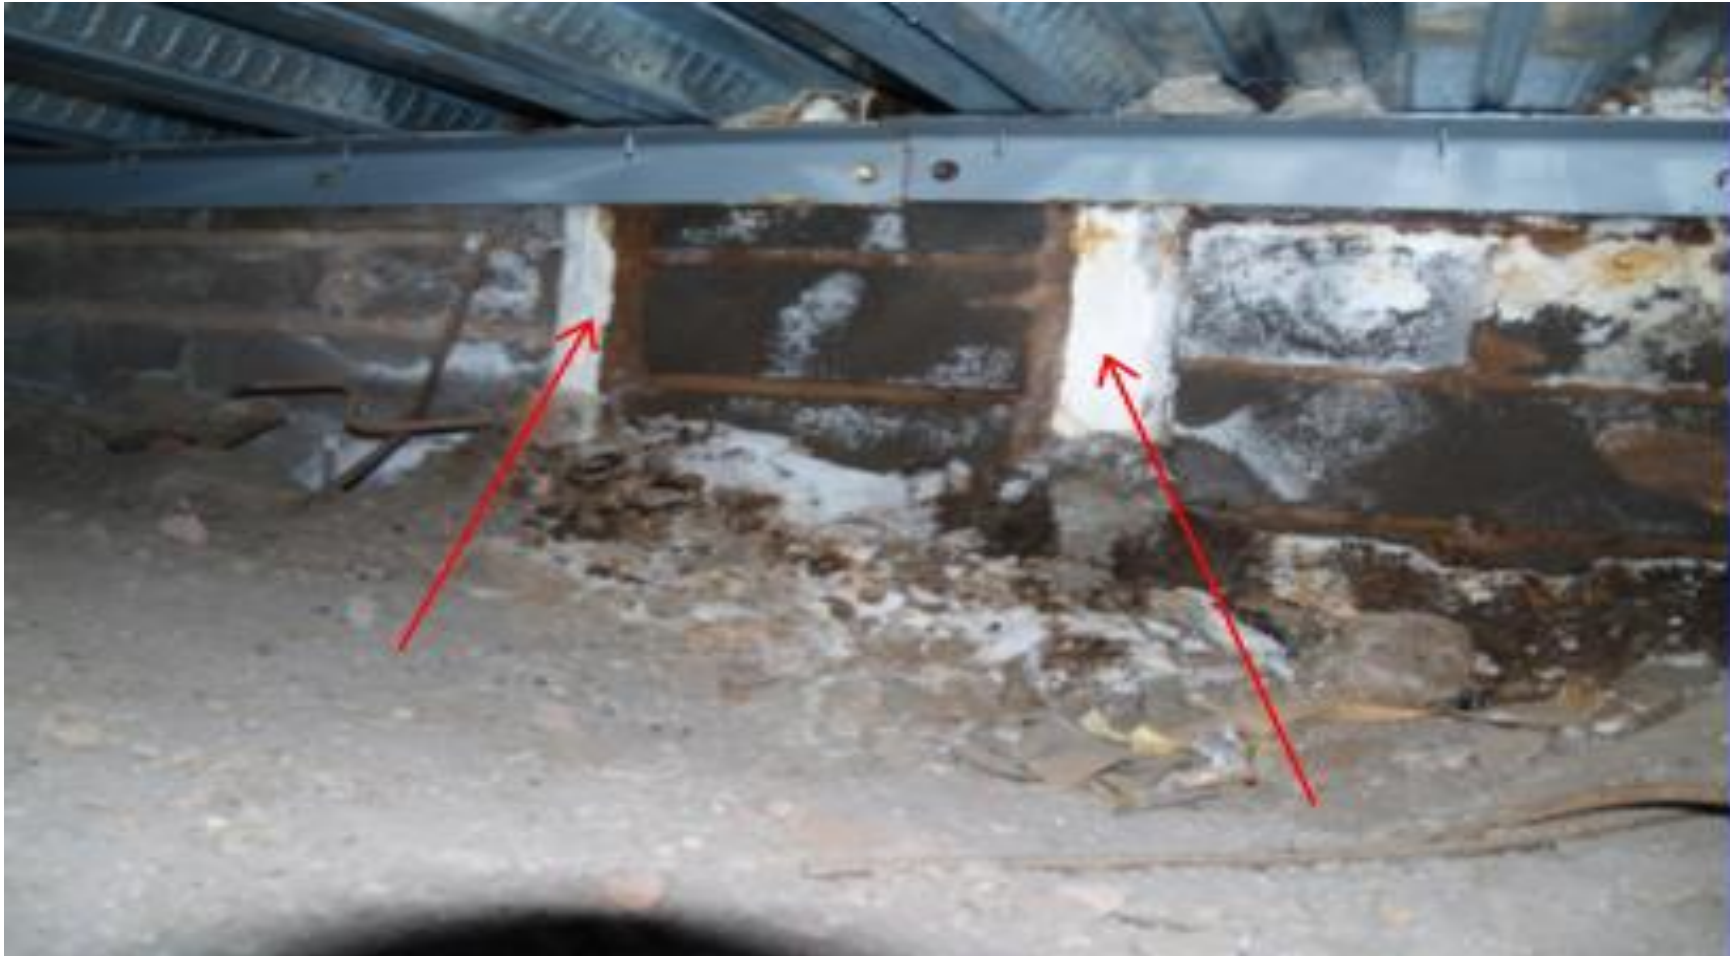
Steel columns indicated with red arrows are rusted and corroded

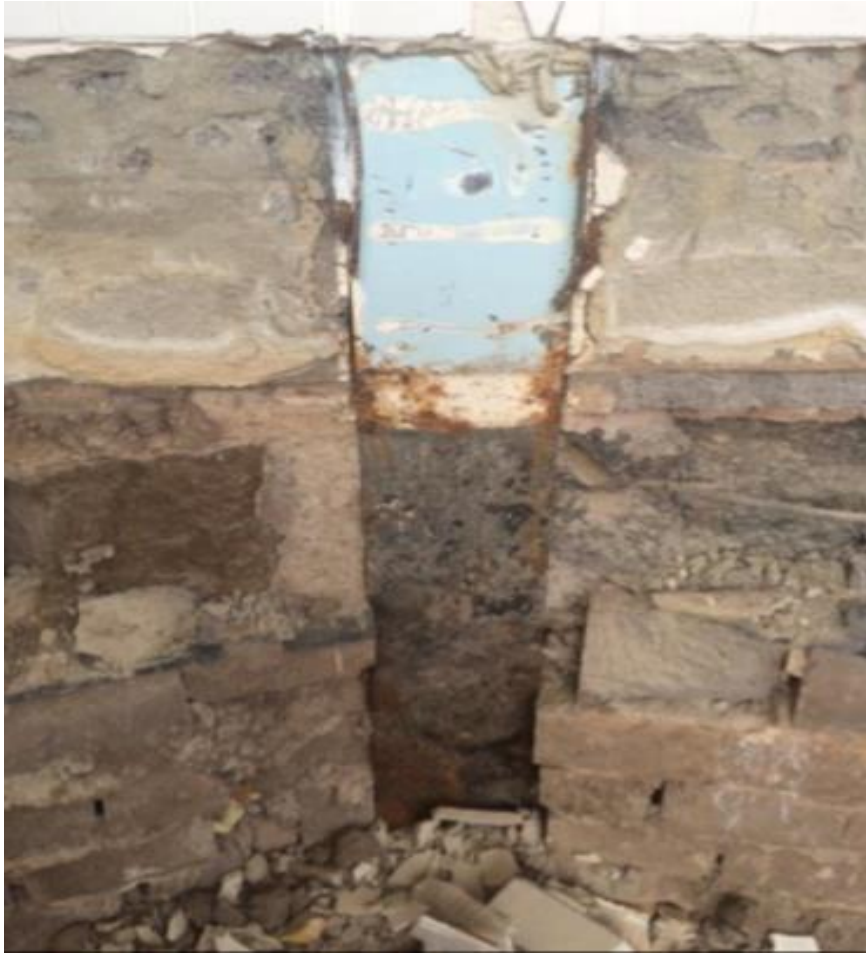
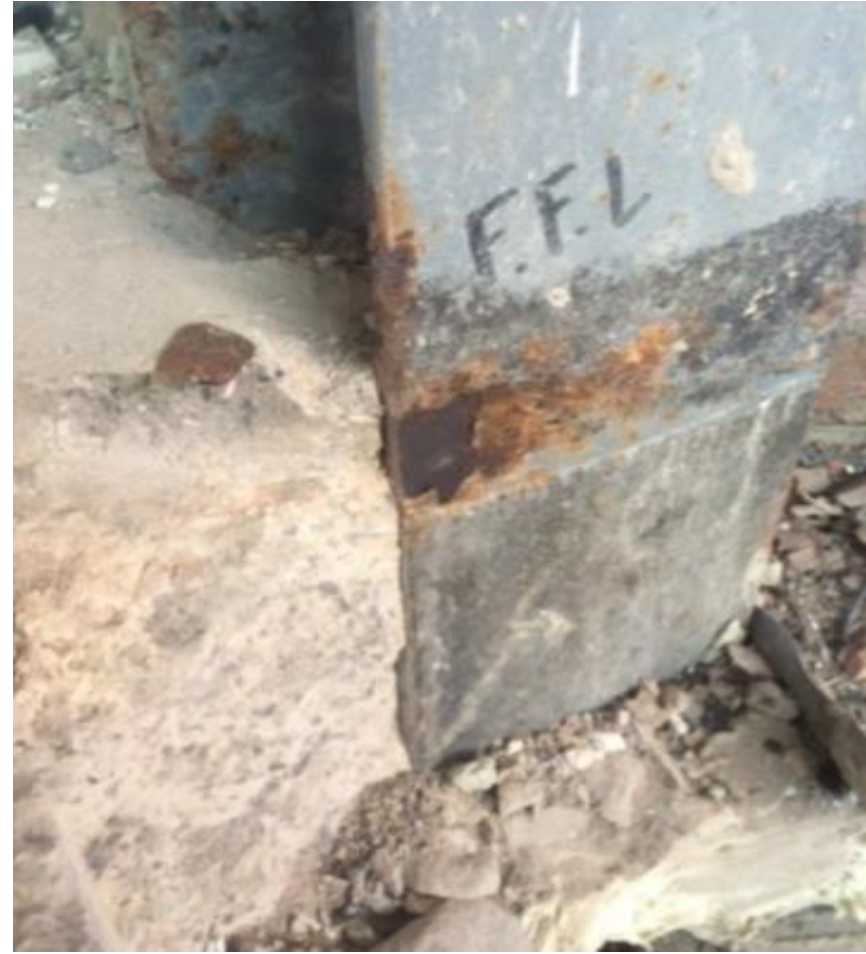
Corroded underfloor sections of steel columns

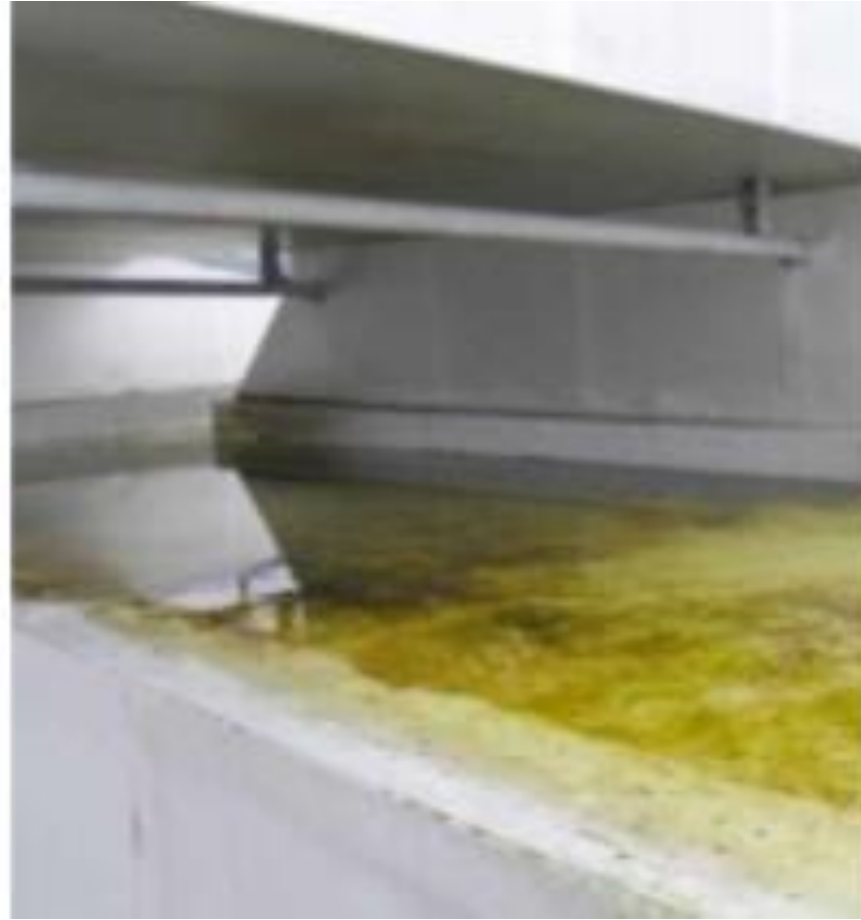
Discharge from dance studio roof directly onto pvc membrane and ponding due to ineffective drainage

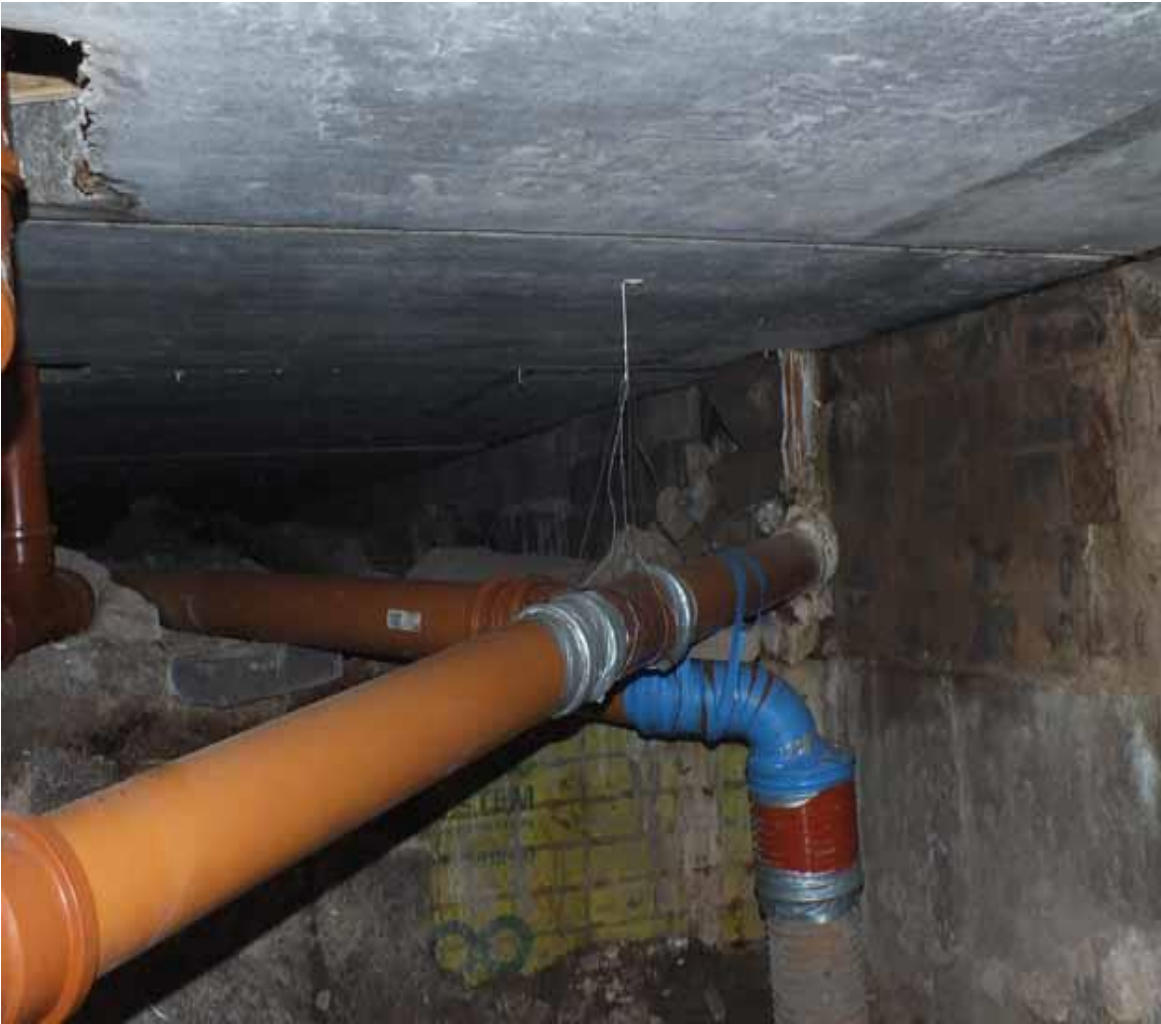
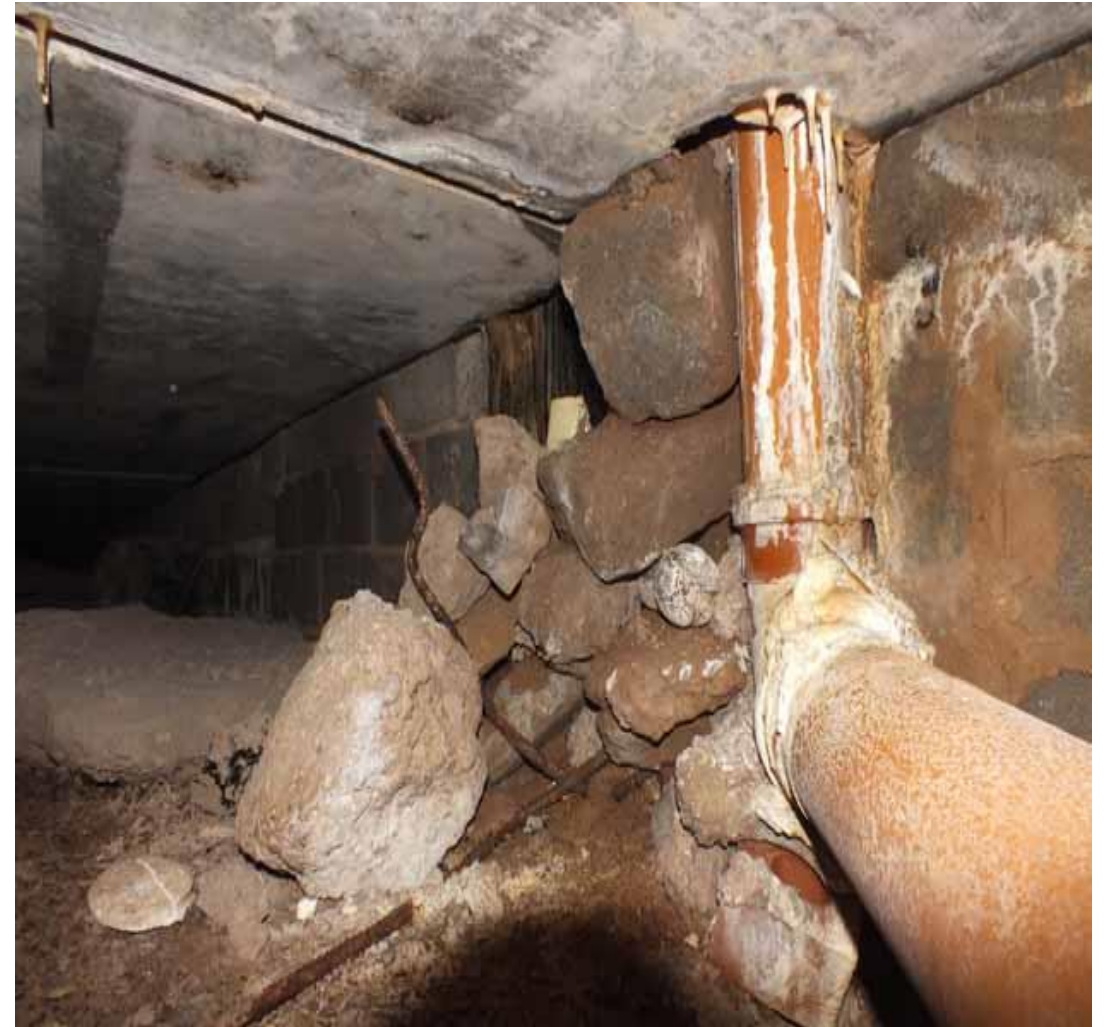
Examples of inadequately joined, supported and sealed drainage in the building voids under DG One

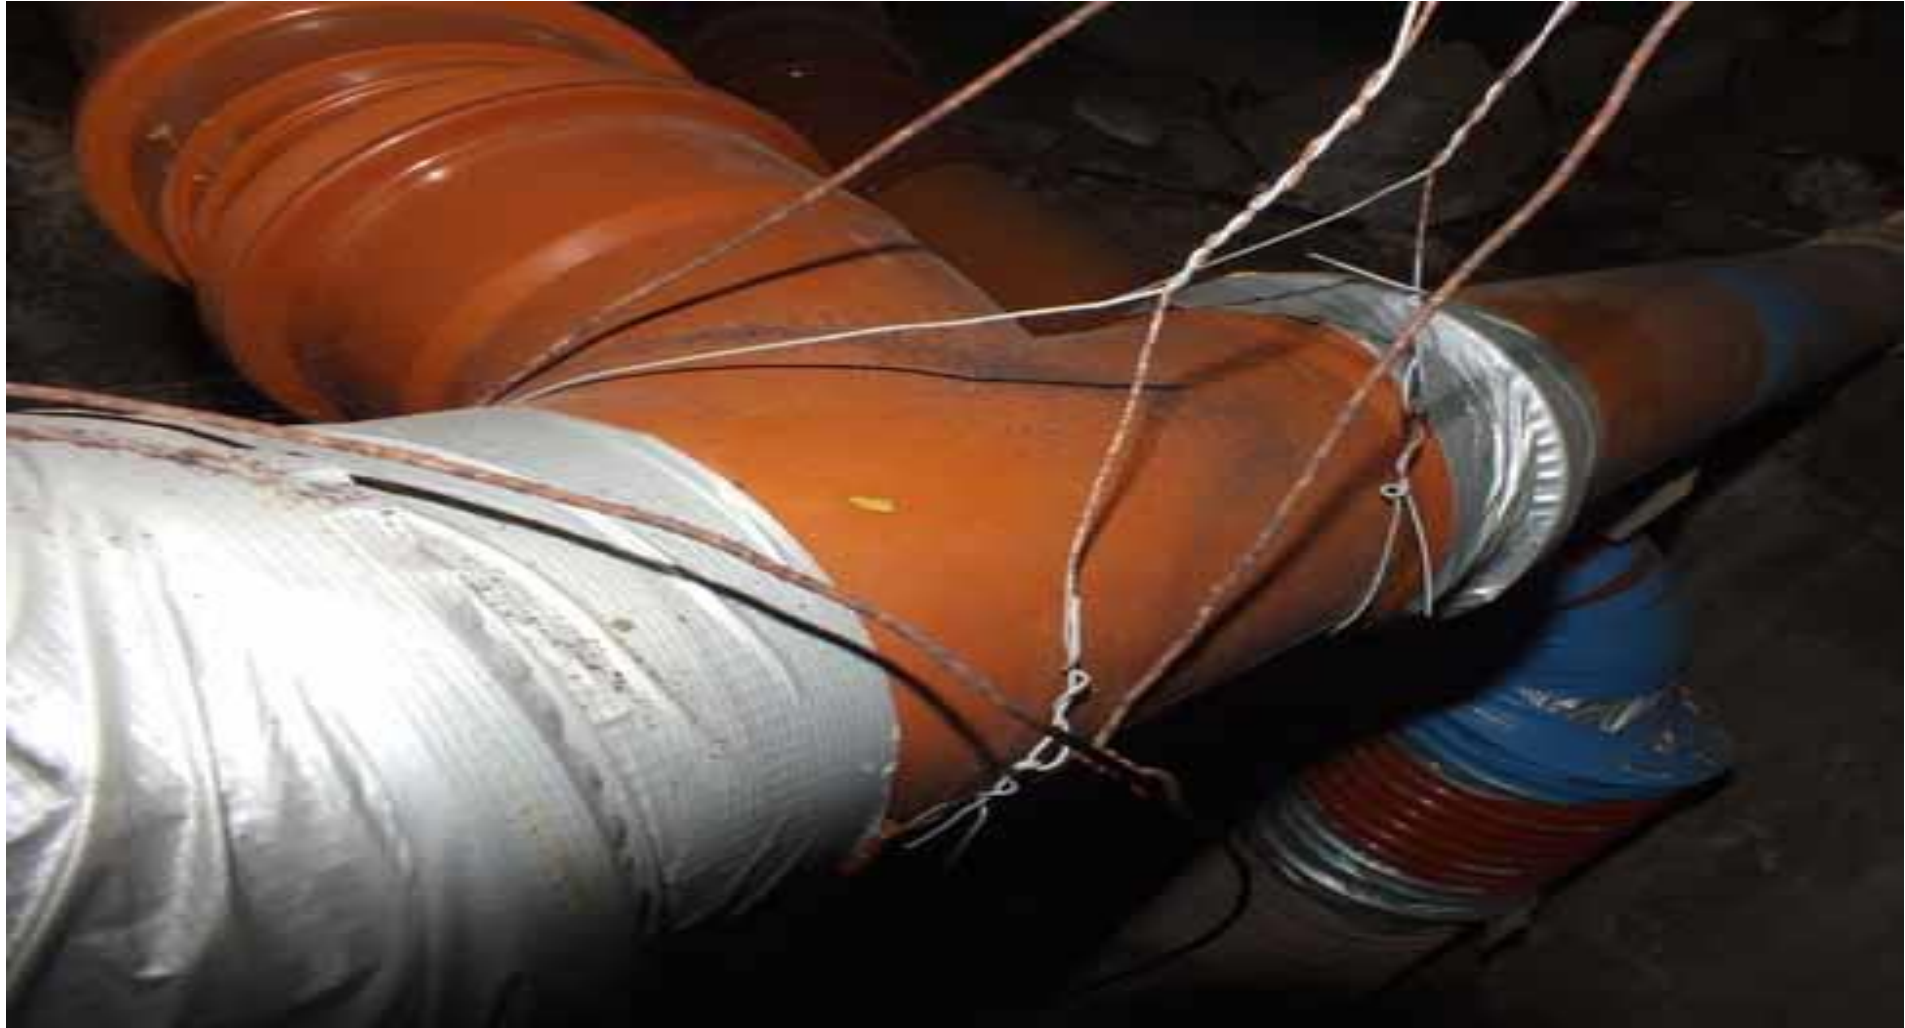
An example of the condition of underfloor drainage found

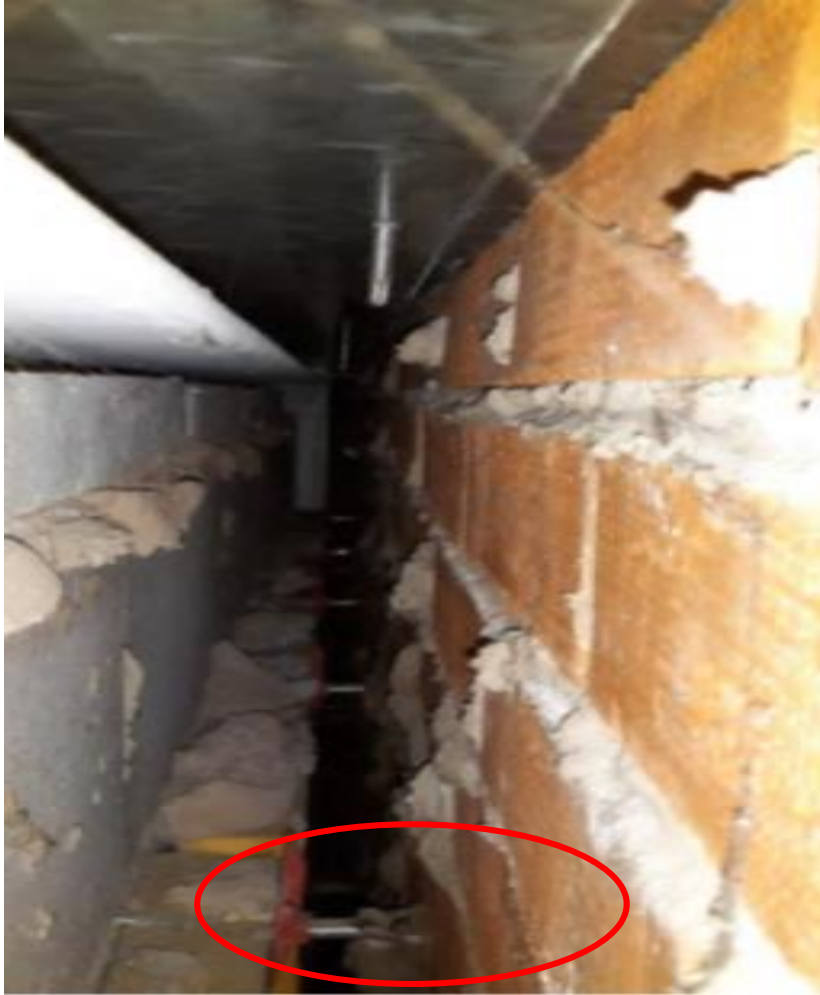
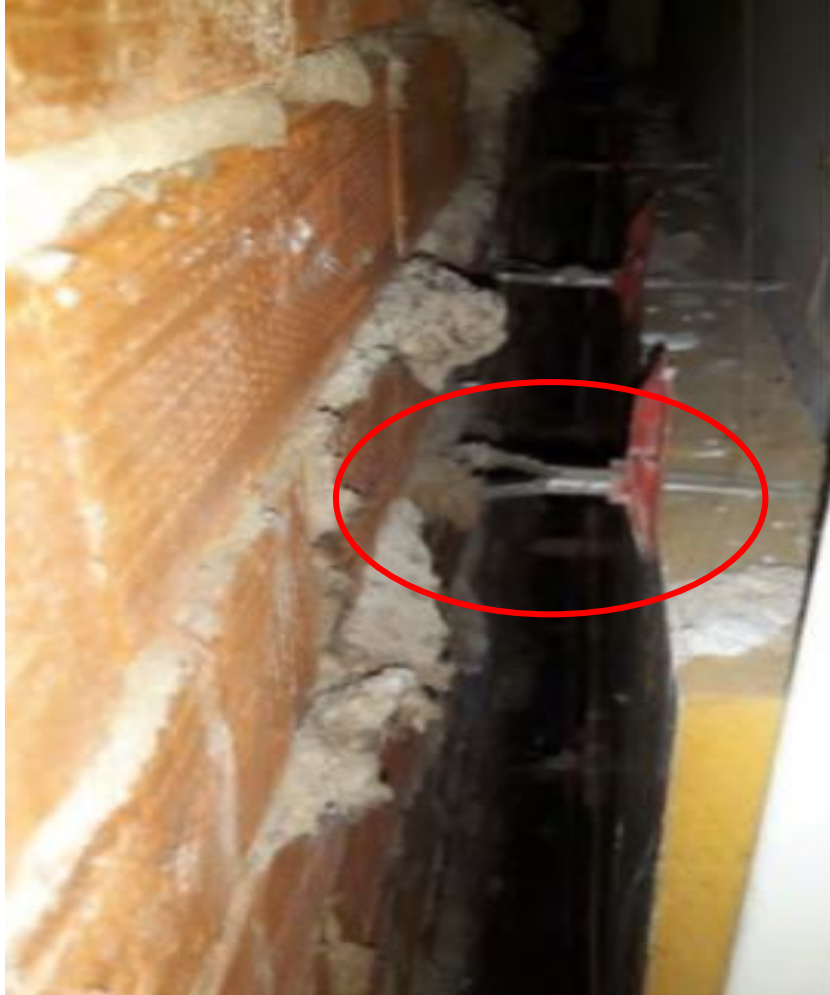
Wall ties not embedded in outer face and insulation missing

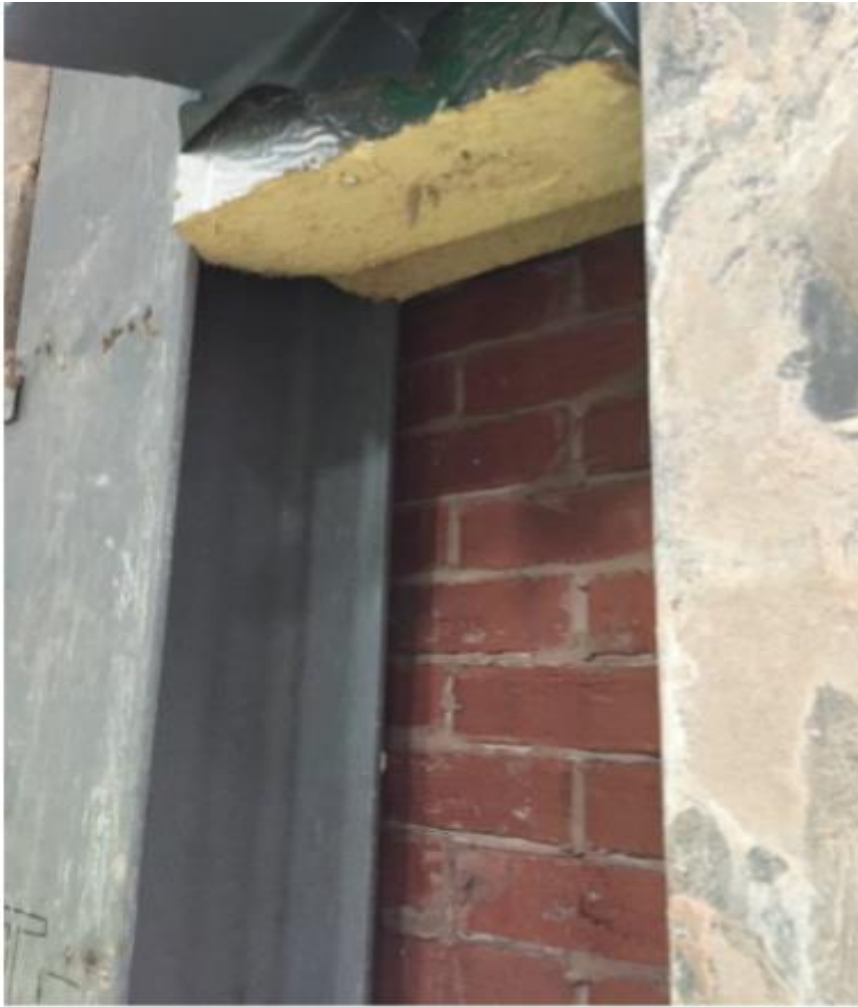
No inner leaf blockwork between Kallwall glazing panels and column. External brickwork has no tie back

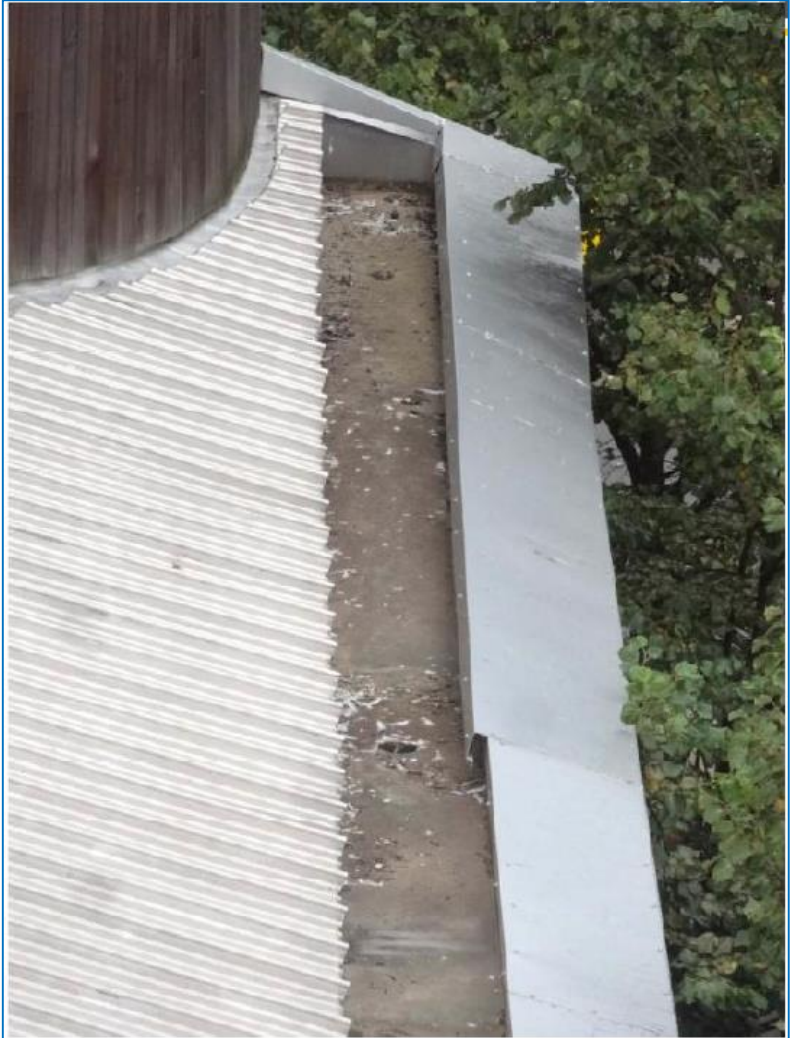
Poorly fitted and sealed flashing
