SCOTTISH ASSOCIATION OF UNIVERSITY DIRECTORS OF ESTATES

September 2018

RESTORING CONFIDENCE: THE NEED FOR A FOCUS ON QUALITY

Prof. John Cole CBE RIBA

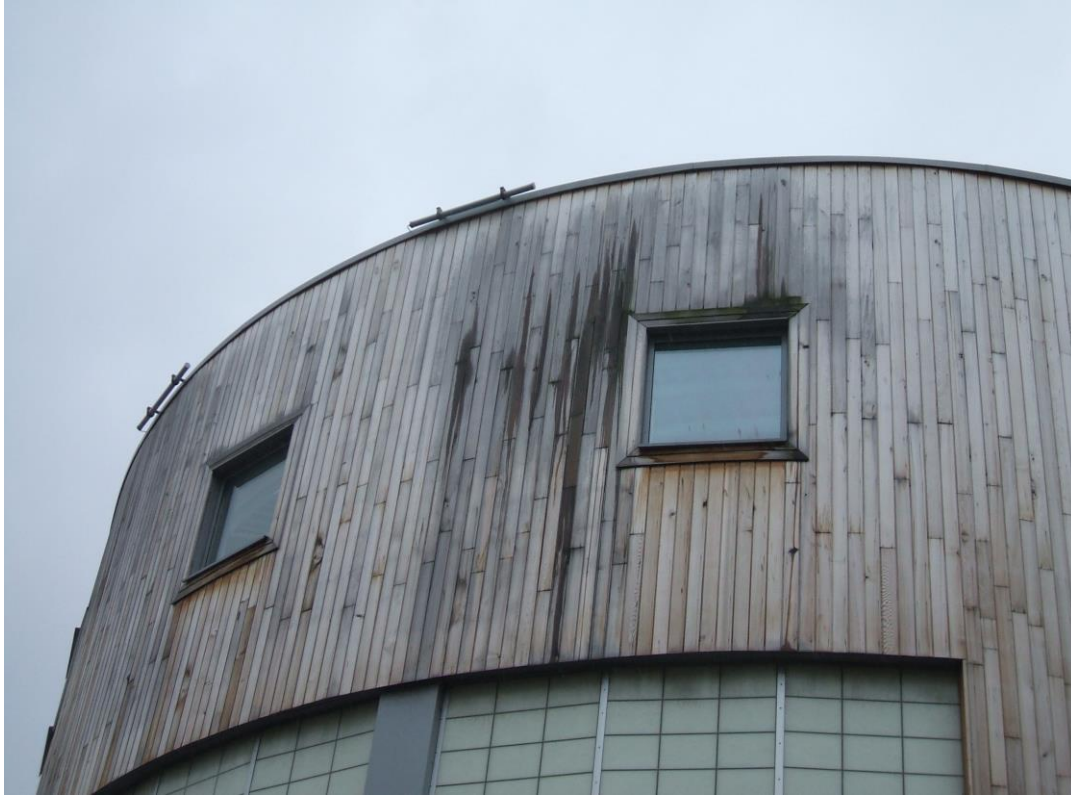
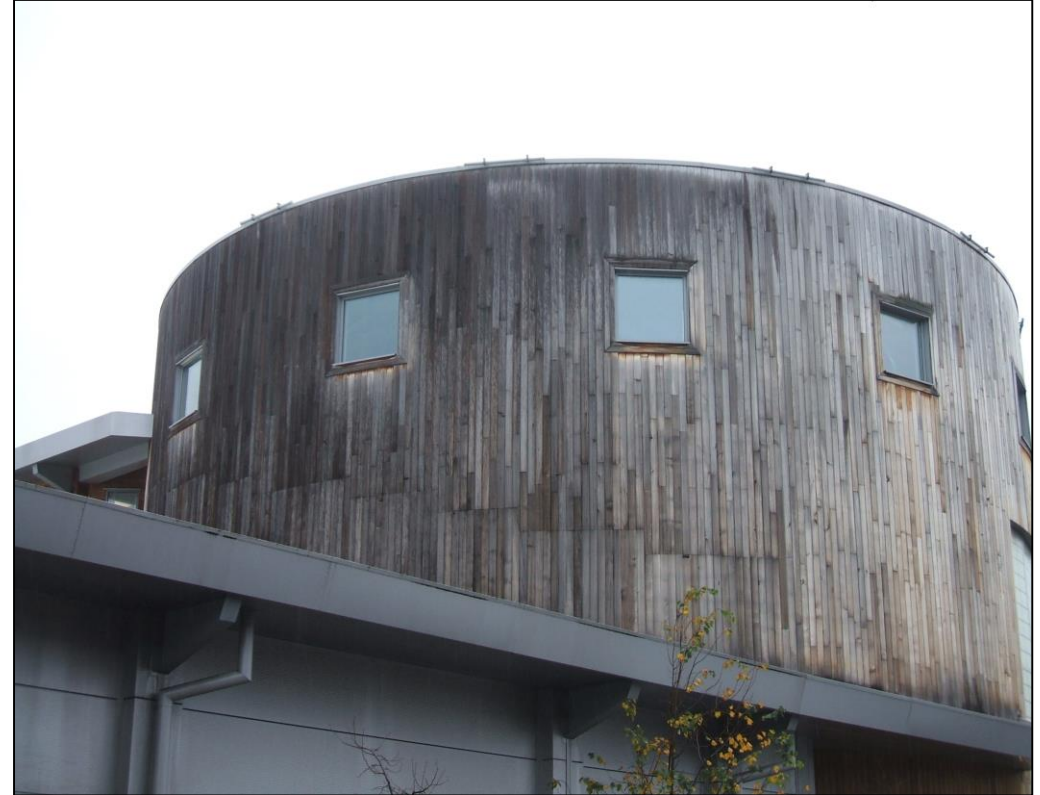
Uneven staining of timber cladding

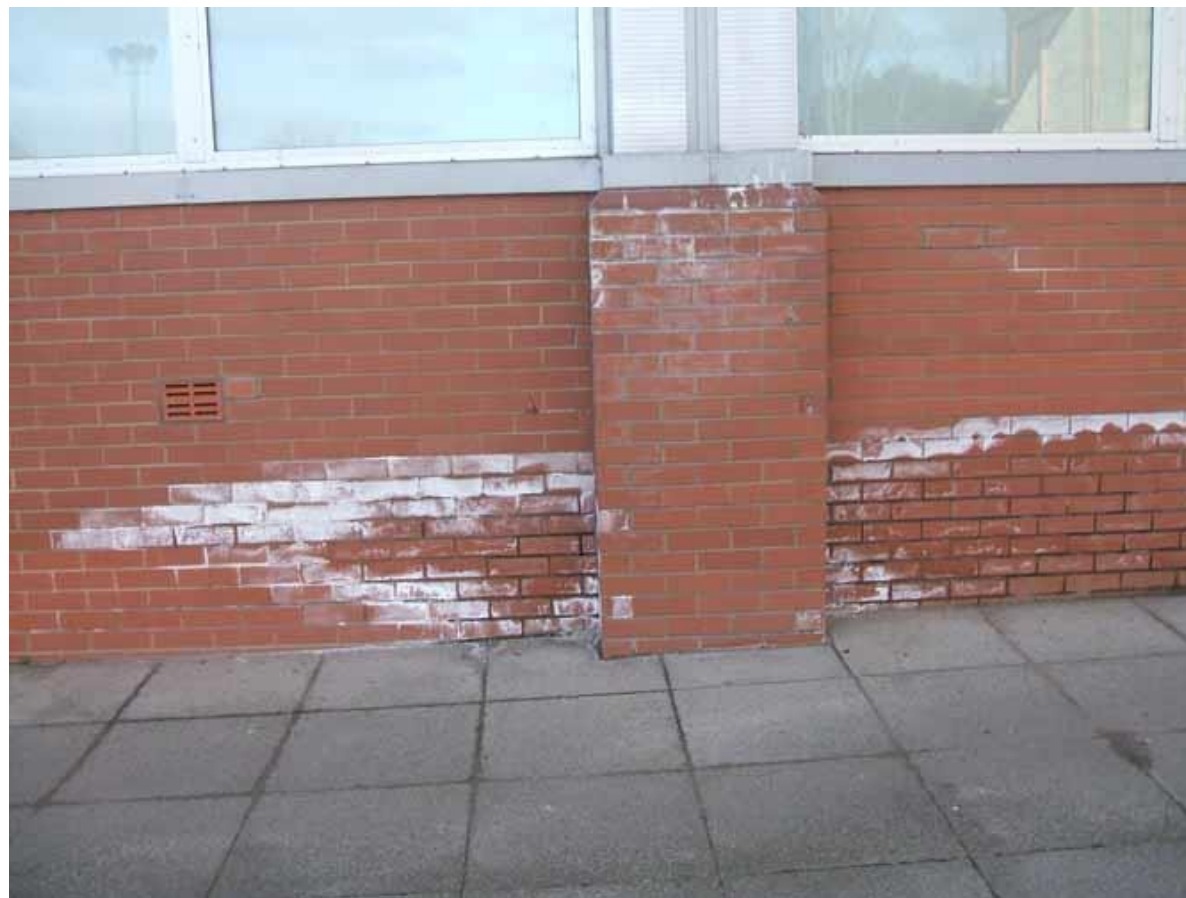
Impact on appearance of brickwork due to its saturation
