SCOTTISH ASSOCIATION OF UNIVERSITY DIRECTORS OF ESTATES

September 2018

RESTORING CONFIDENCE: THE NEED FOR A FOCUS ON QUALITY

Prof. John Cole CBE RIBA

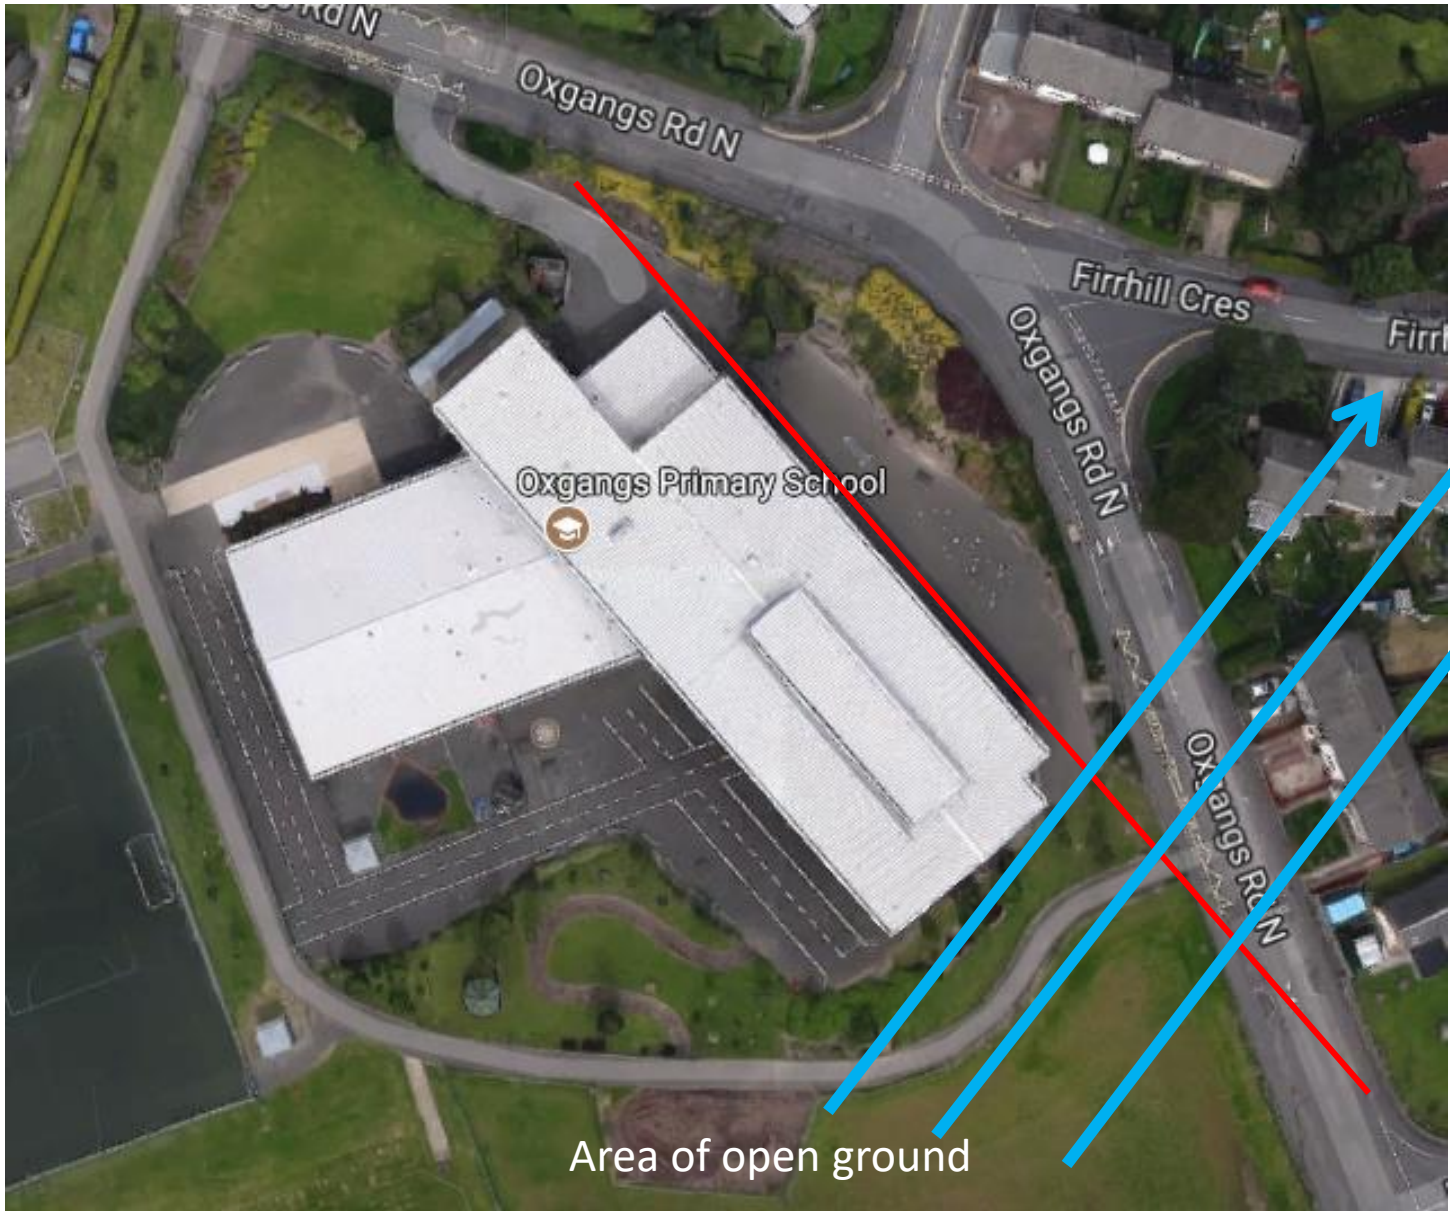
06.00 am:
Wind direction Southwest

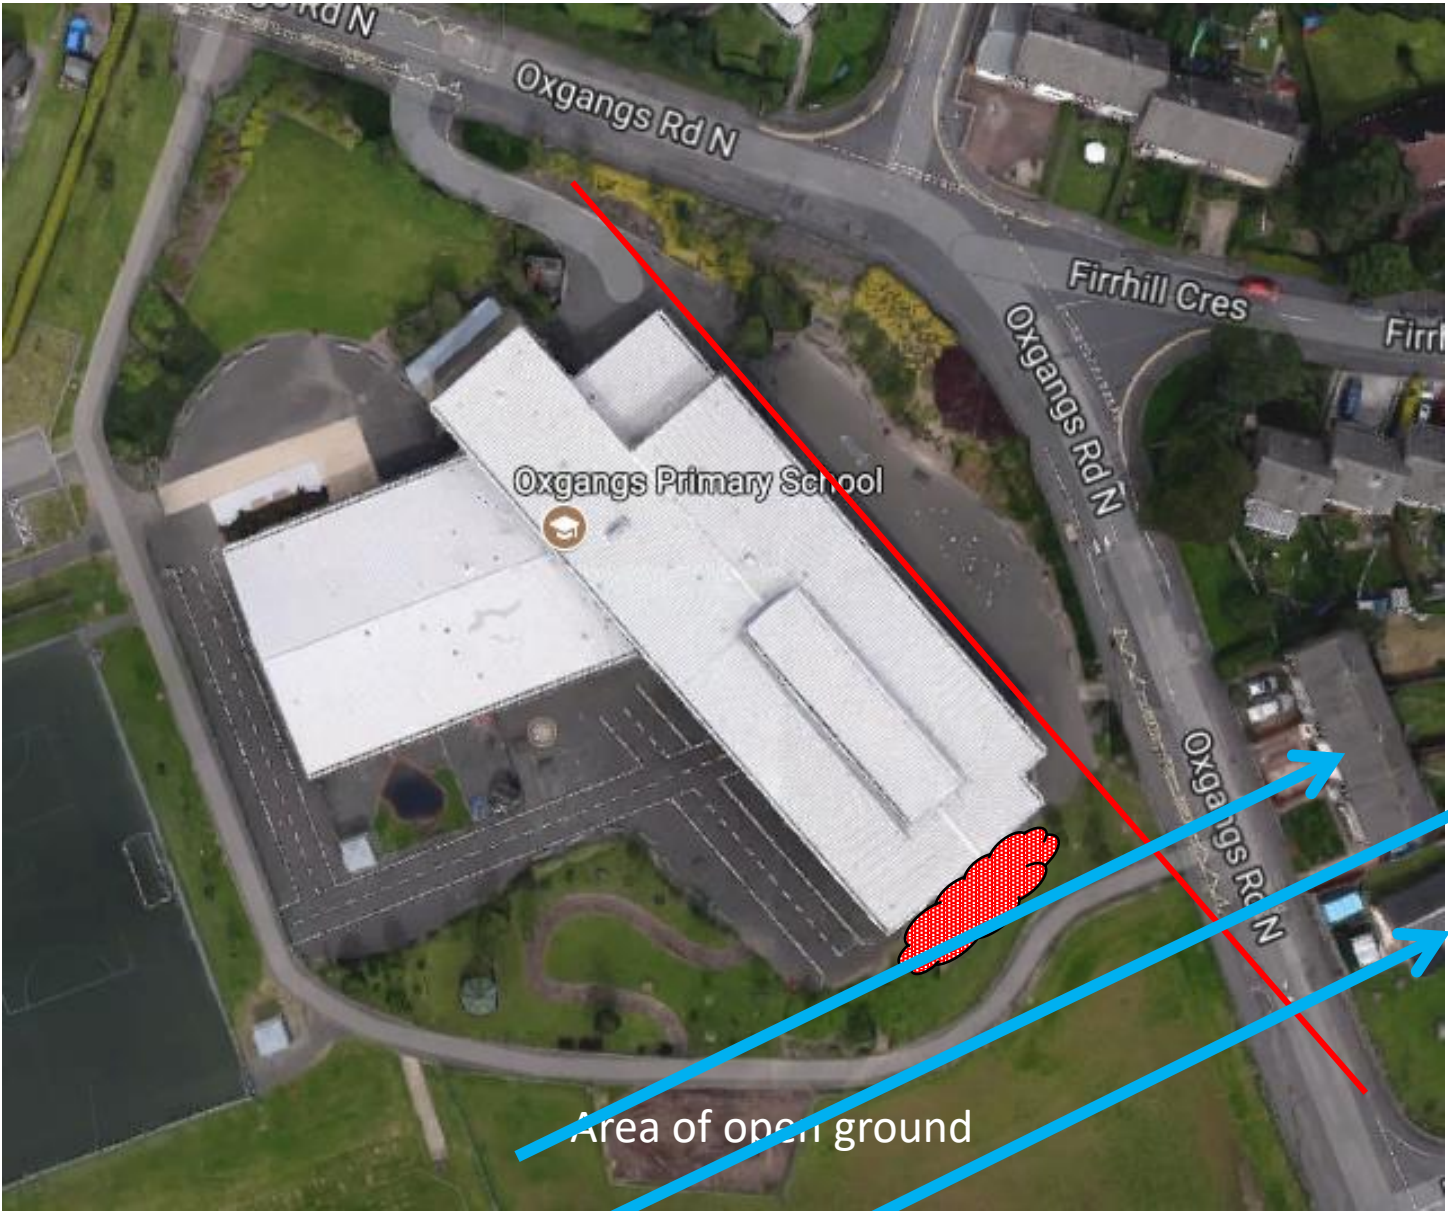
08.00 am:
Wind veers direction to West-Southwest and gusts up to 69 mph

The gable wall collapses

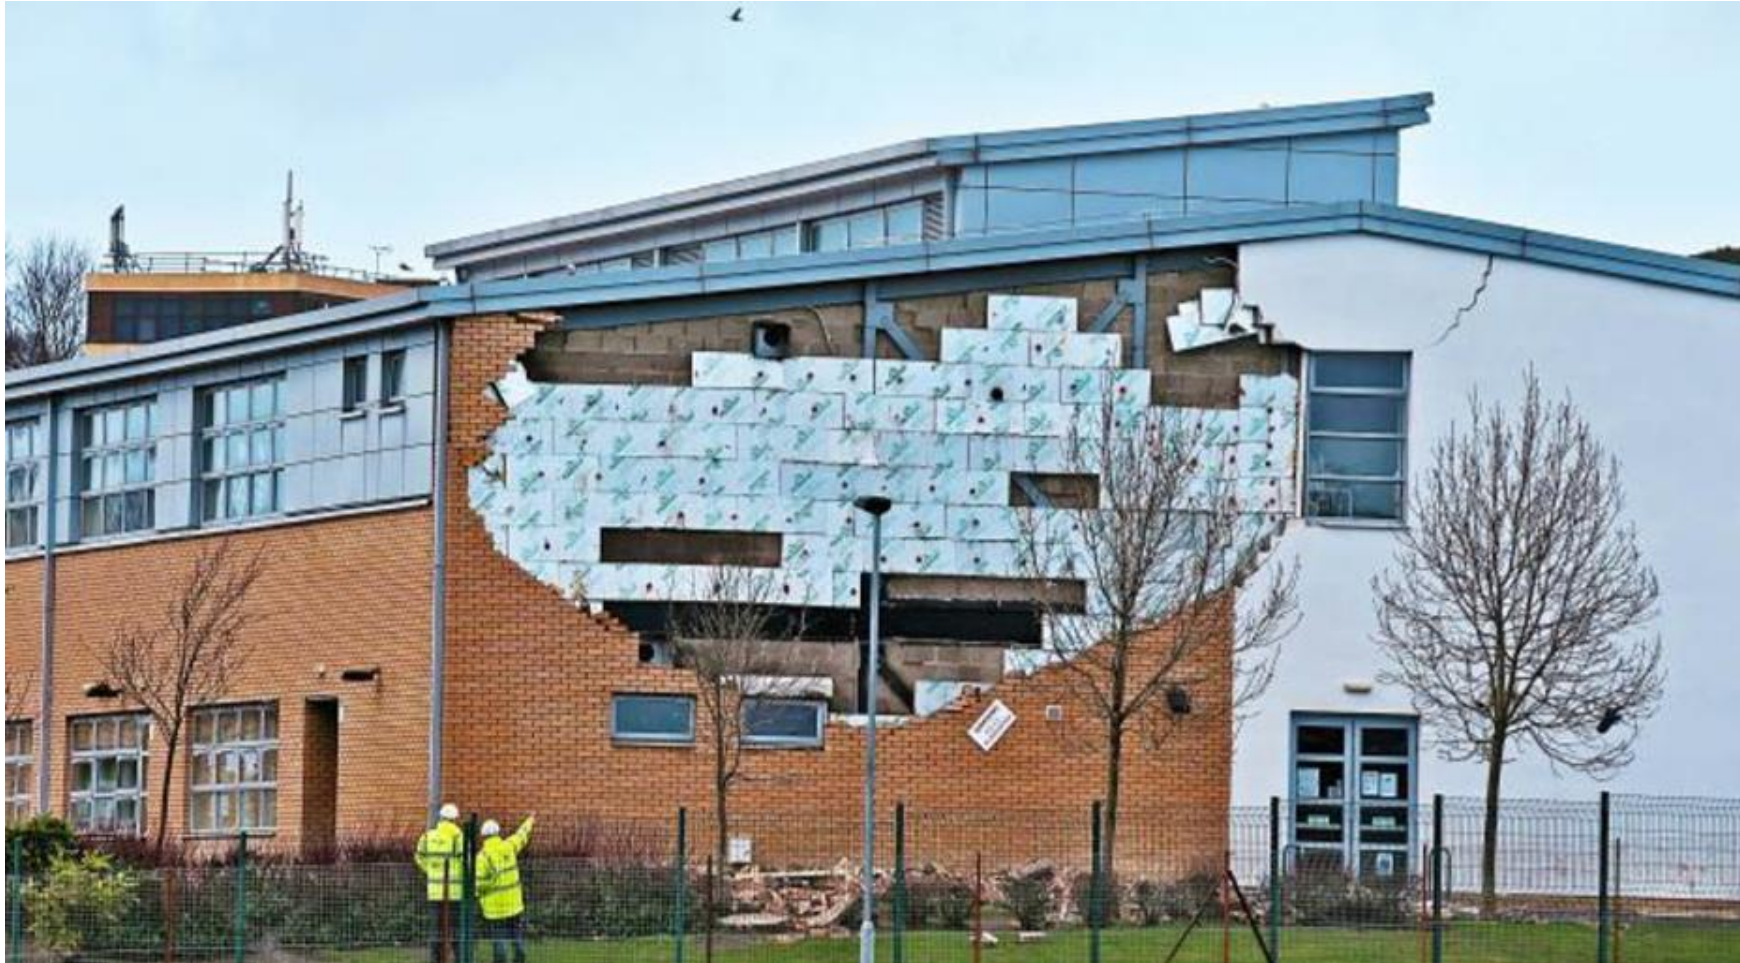
Oxgangs P.S. Edinburgh – one of seventeen schools built by 6 different contractors using D & B contracts as part of a single overarching PFI contract

- Width of cavity to the collapsed wall assessed to range between 15mm to 40mm wider than specified 120mm;
- Measurements of wall ties left in the inner leaf after collapse showed over 50% of these insufficiently long to provide minimum embedment of 50mm in outer leaf
- In bay containing diagonal steel bracing, blockwork to inner leaf was reduced from 140mm to 100mm locally around the bracing increasing cavity width to 160mm and making 50 mm embedment either side impossible with 250 mm tie
- Report recommended precautionary investigations of the remaining walls in the school

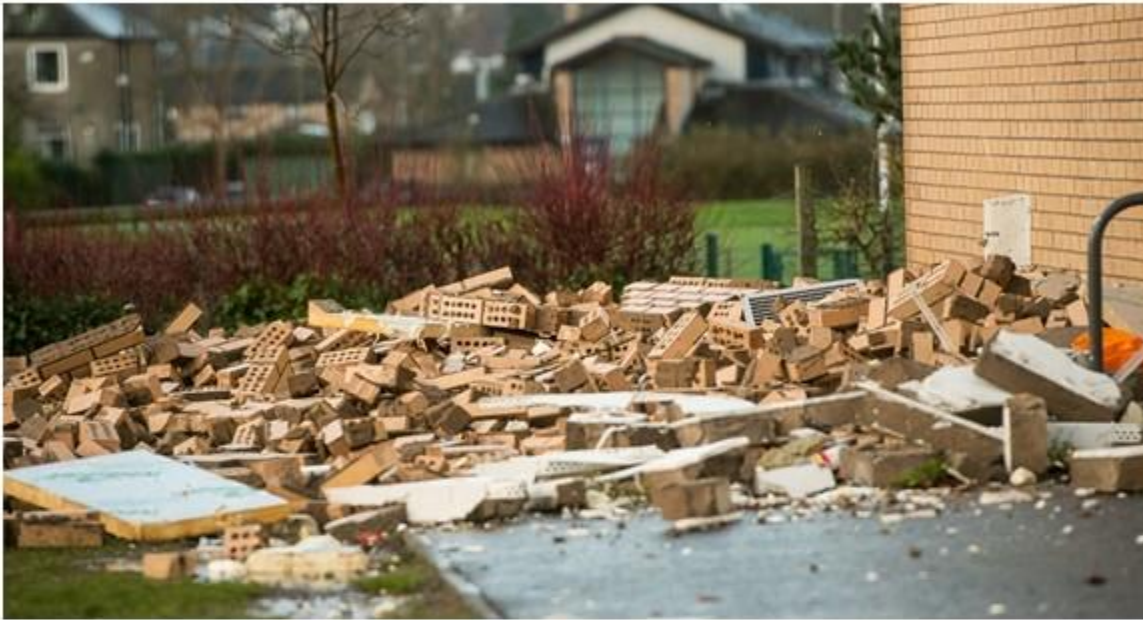
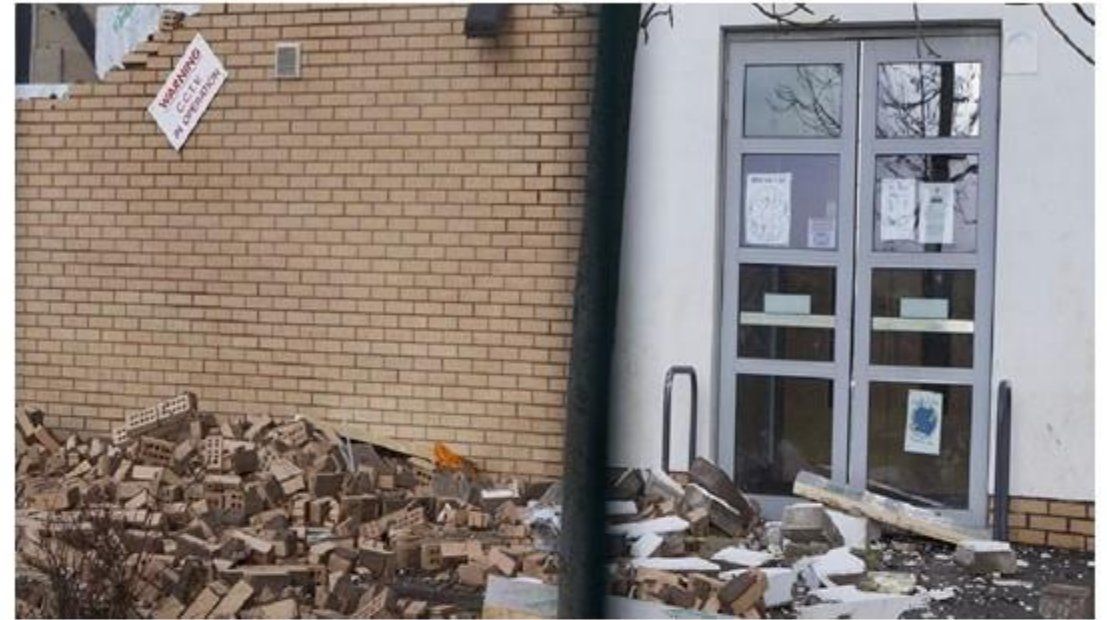
8.00 am on morning of collapse

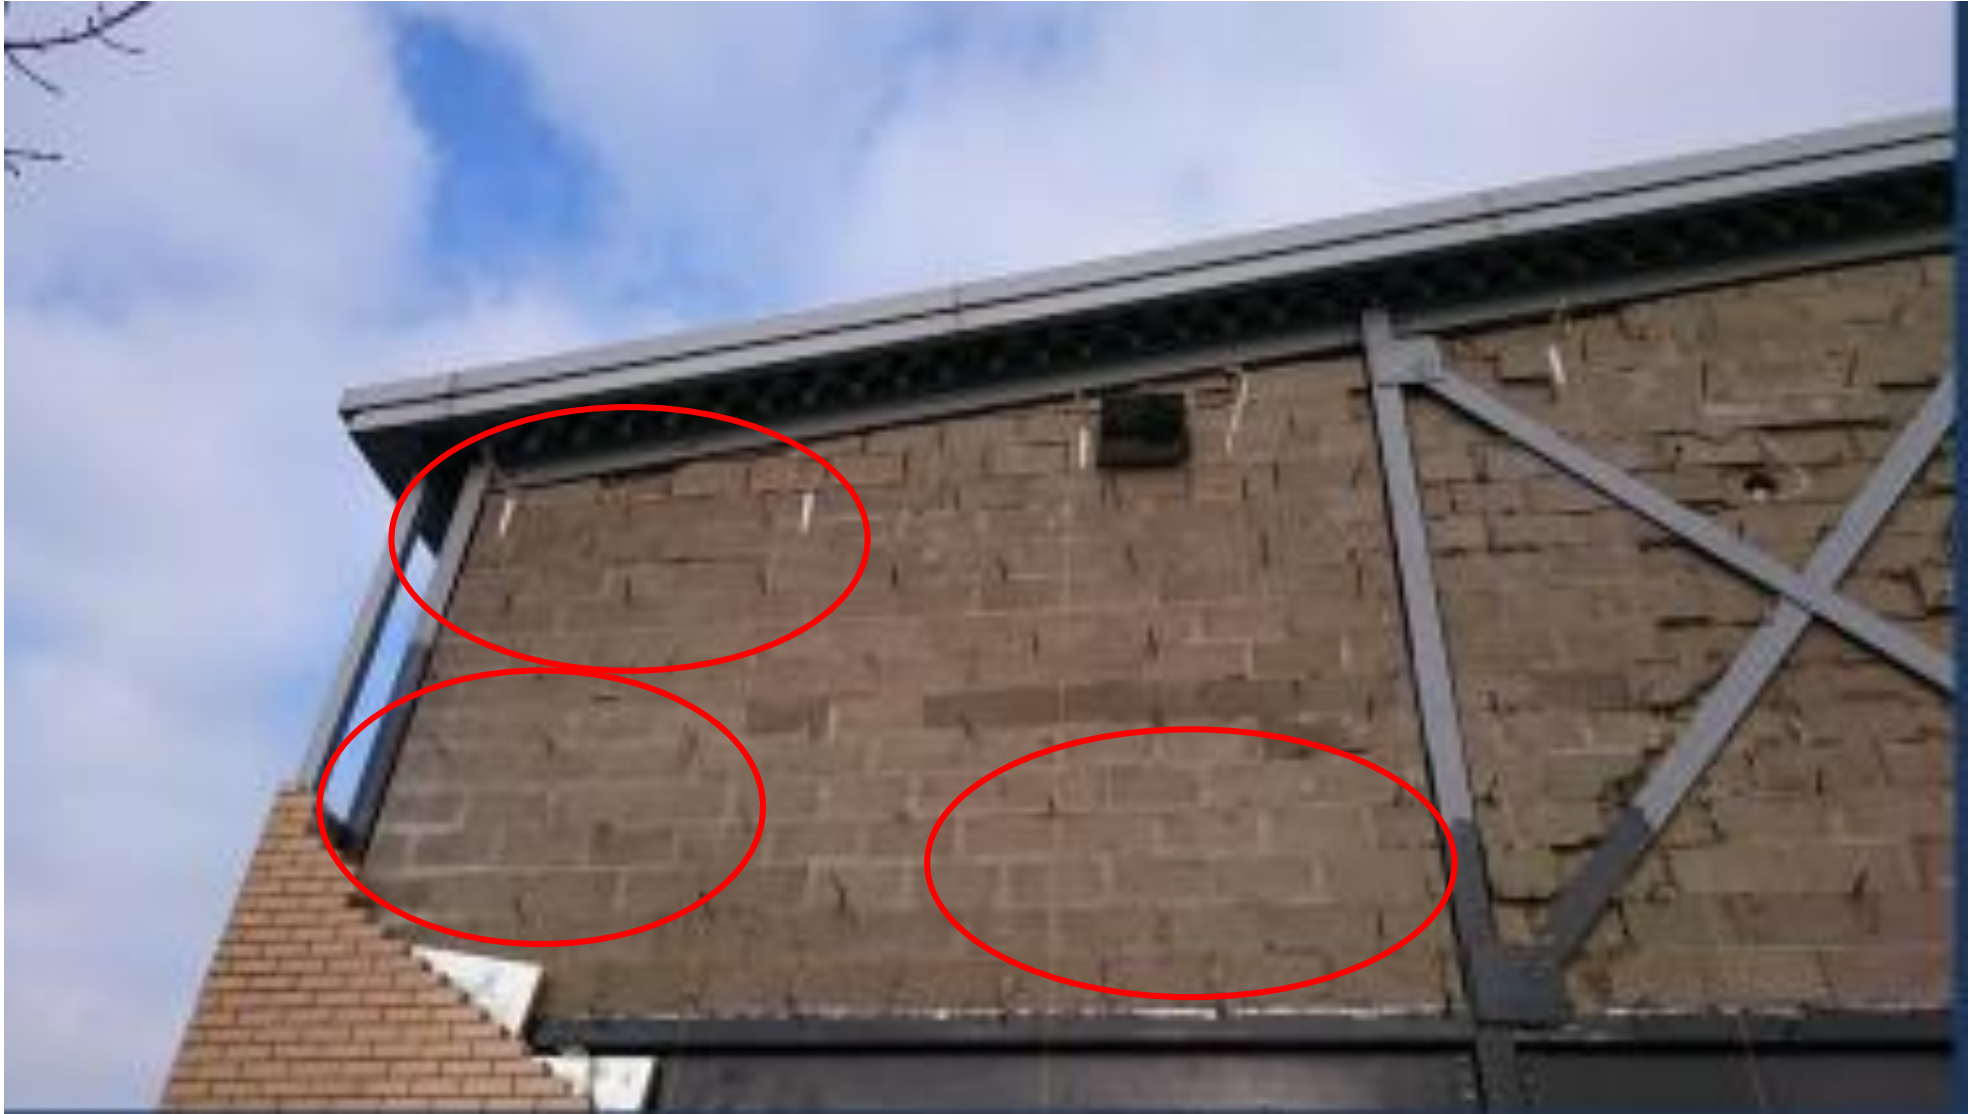
Bay with diagonal steel bracing showing part of blockwork reduced from 140 mm to 100 mm increasing width of cavity to 160 mm although the same 250 mm long wall ties were used

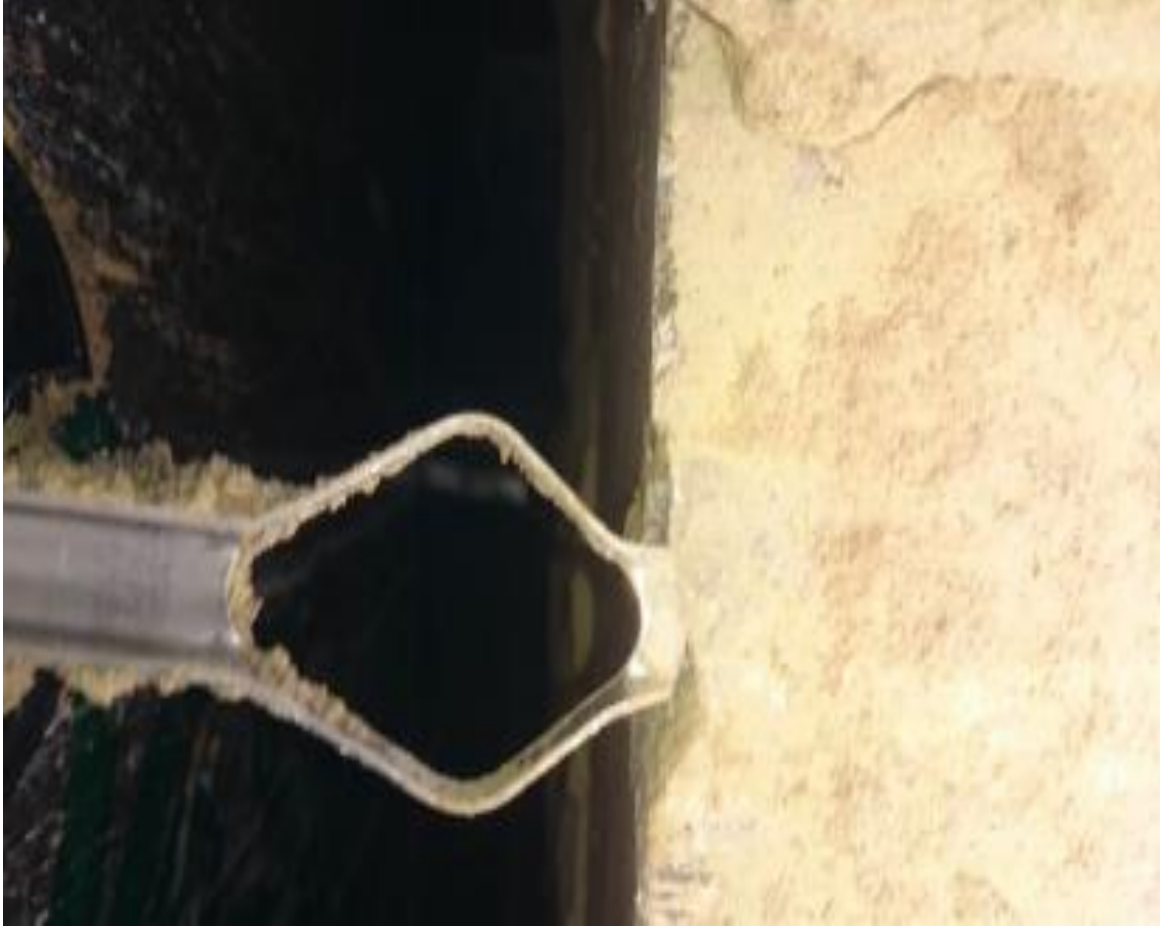
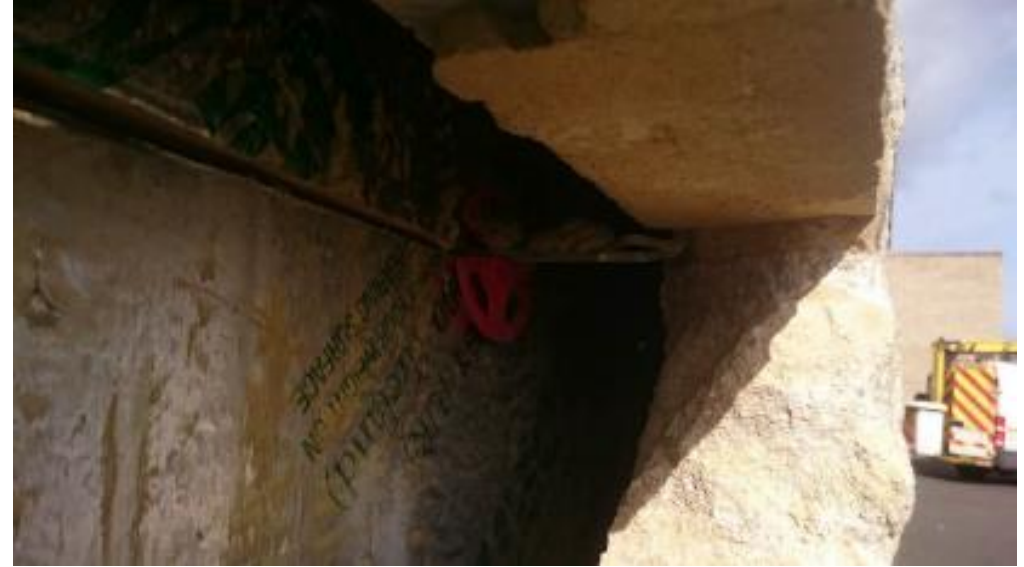
Areas of wall-tie spacing not as it should be with ties pulled out or not there in first place

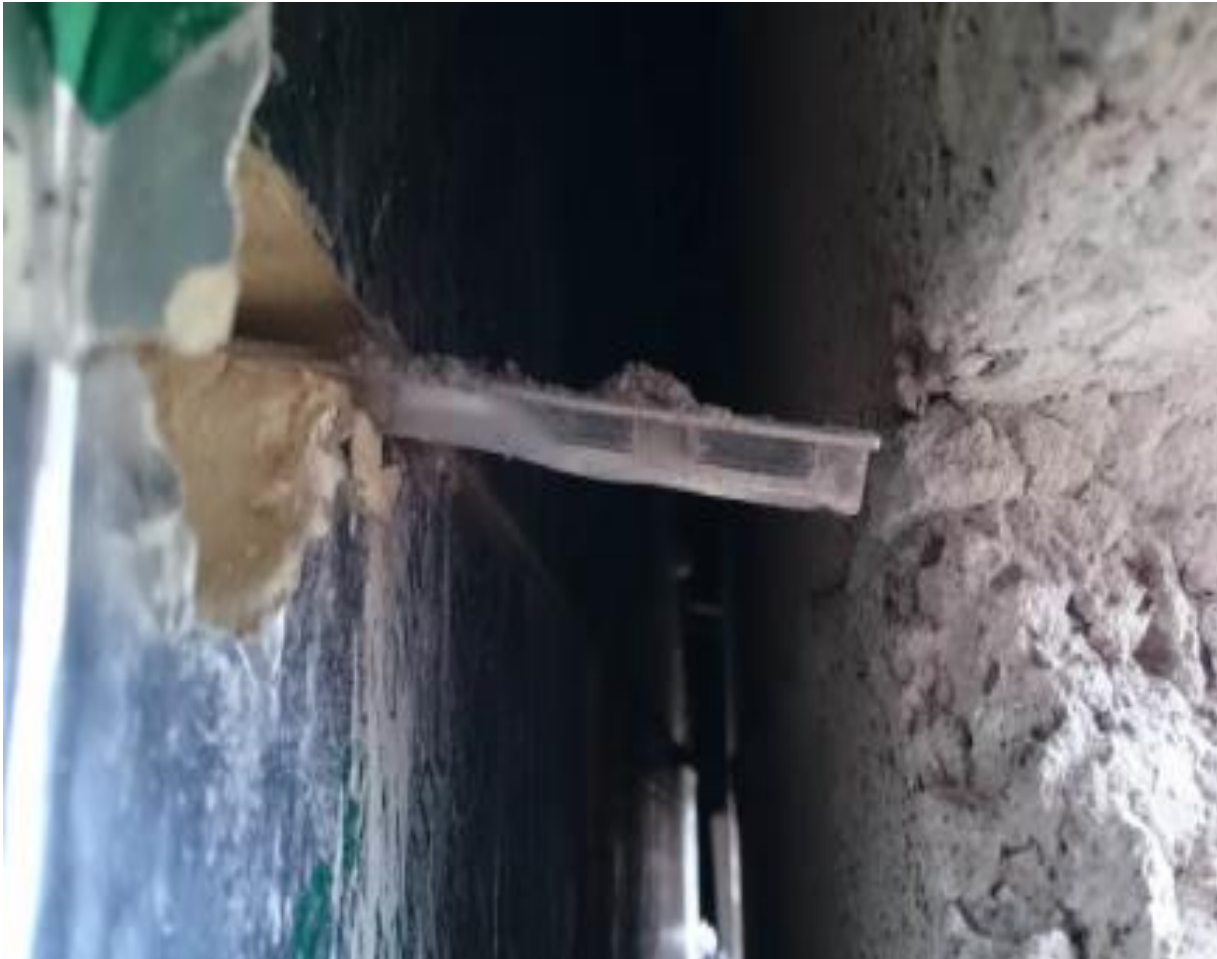
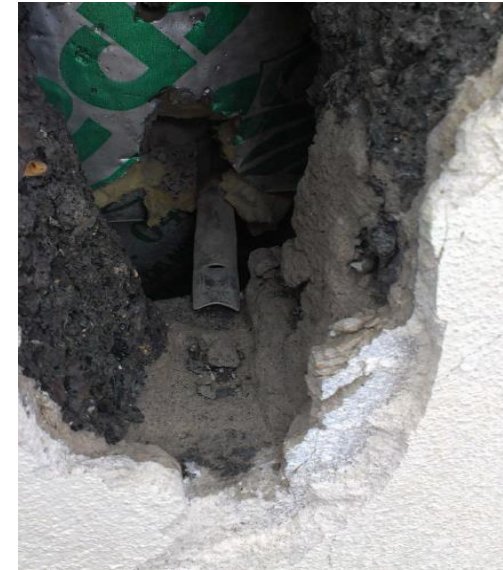
EXAMPLES OF NIL OR LITTLE
EMBEDMENT AS RECORDED BY
THE REMEDIATION CONTRACTOR
FOR EDINBURGH SCHOOLS

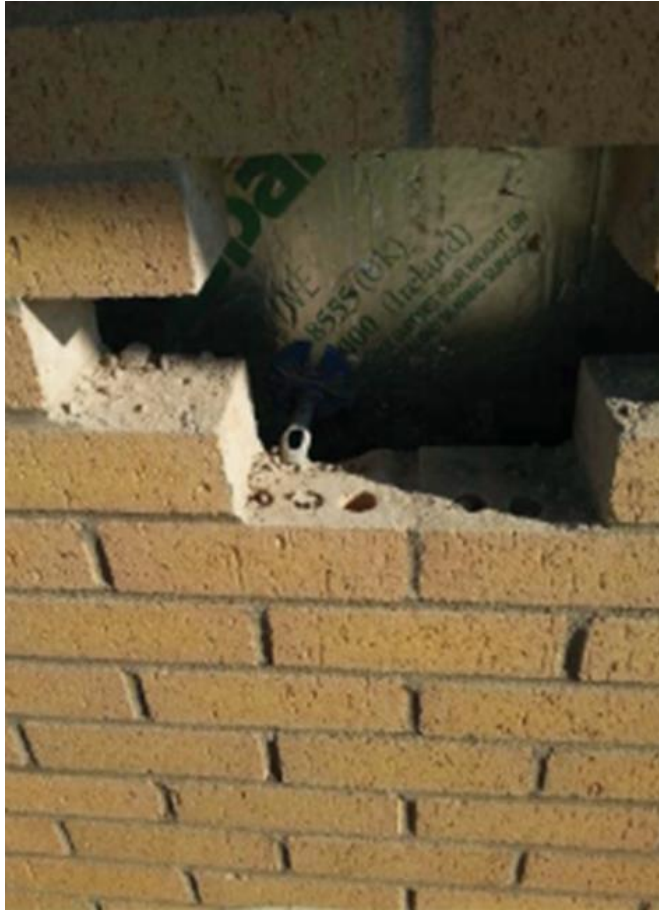
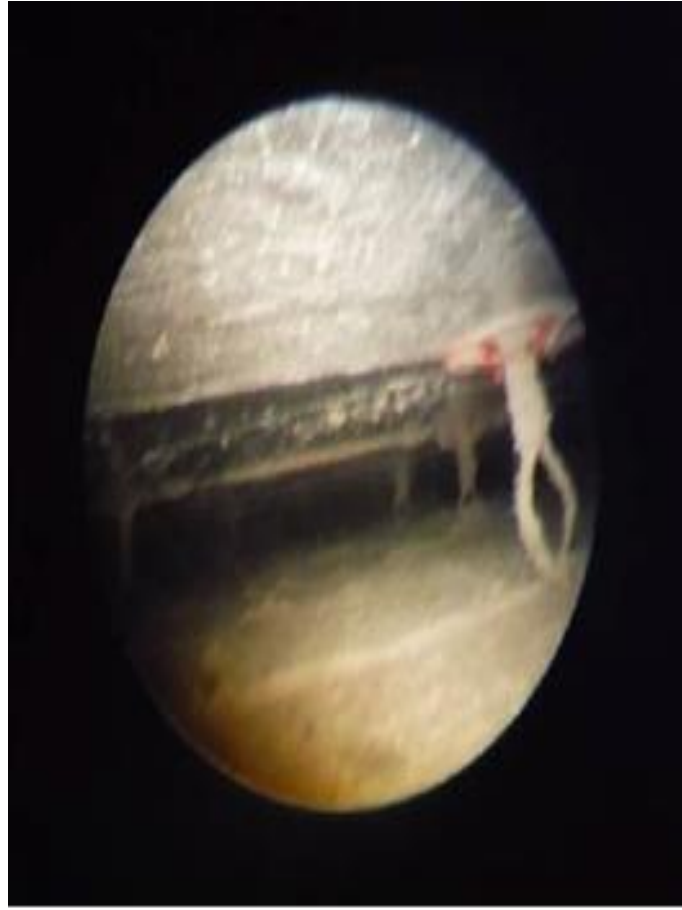
EXAMPLES OF NIL OR
LITTLE EMBEDMENT AS
RECORDED BY THE
REMEDIATION
CONTRACTOR FOR
EDINBURGH SCHOOLS

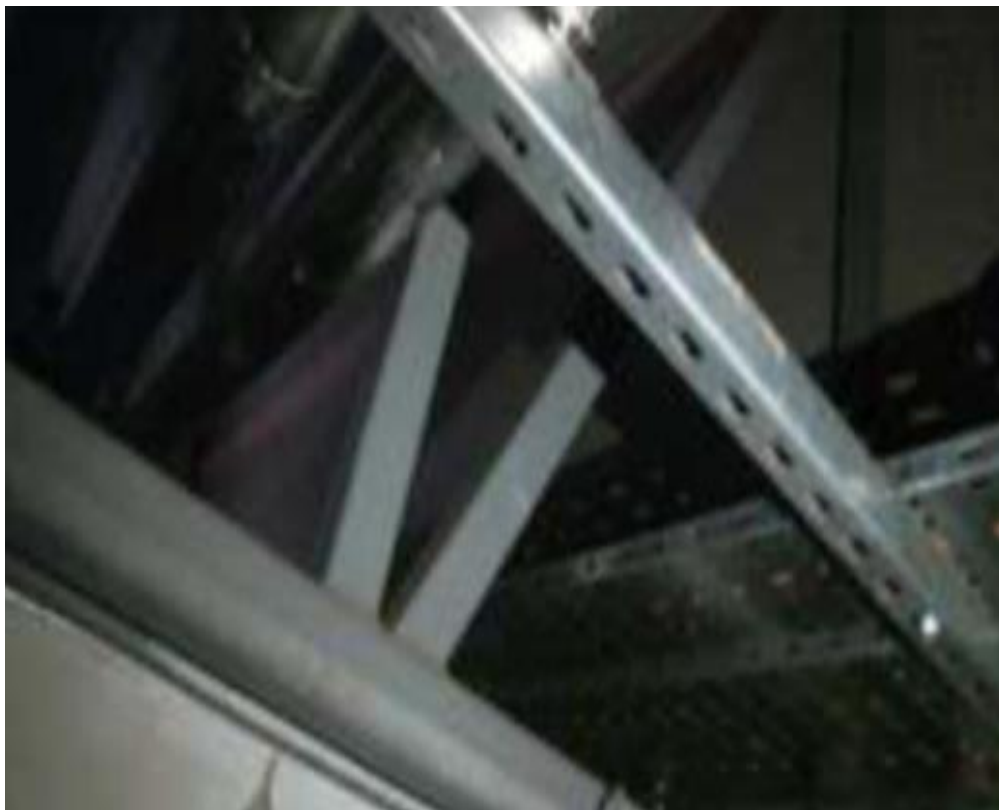
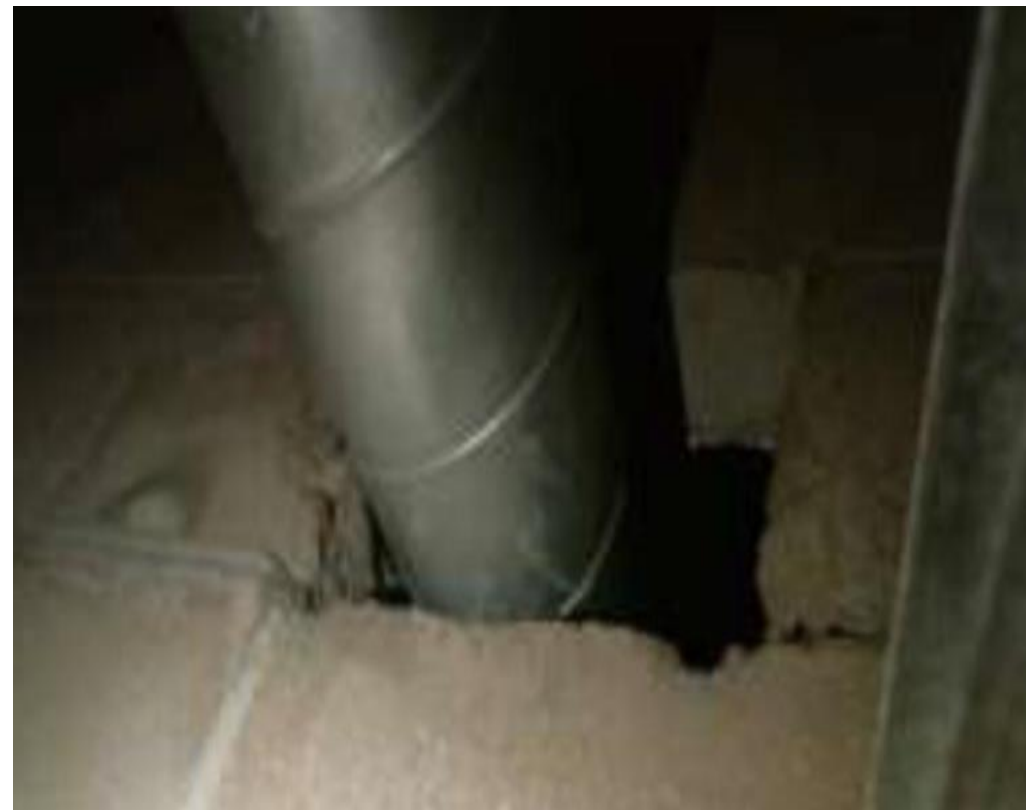
EXAMPLES OF MORE THAN 300 BREACHES OF FIRE COMPARTMENTATION IN 17 EDINBURGH SCHOOLS

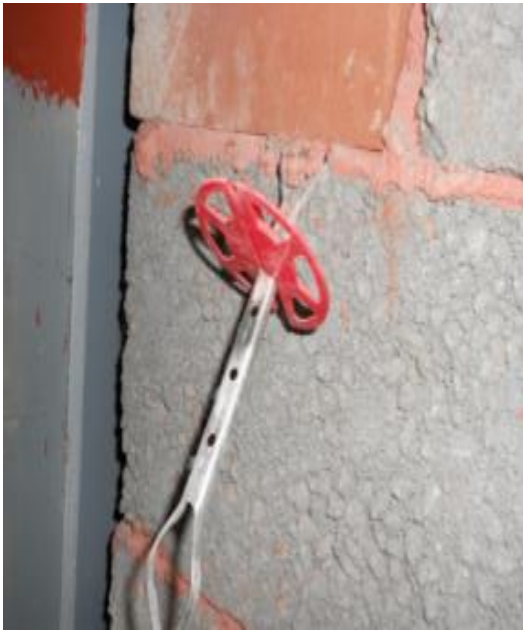
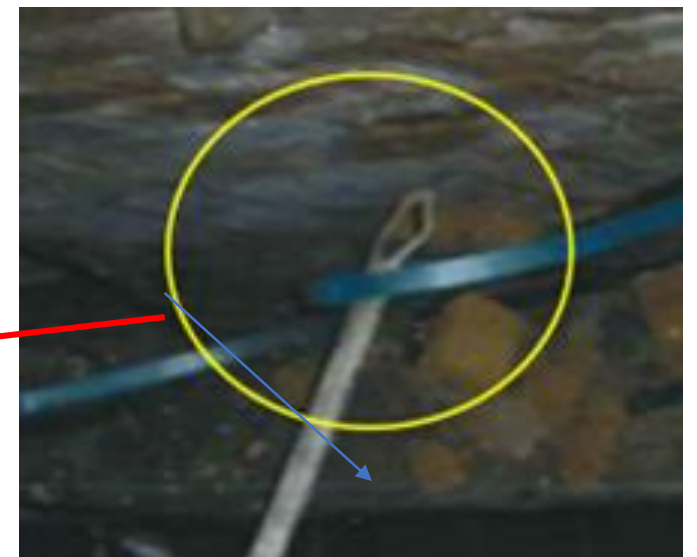
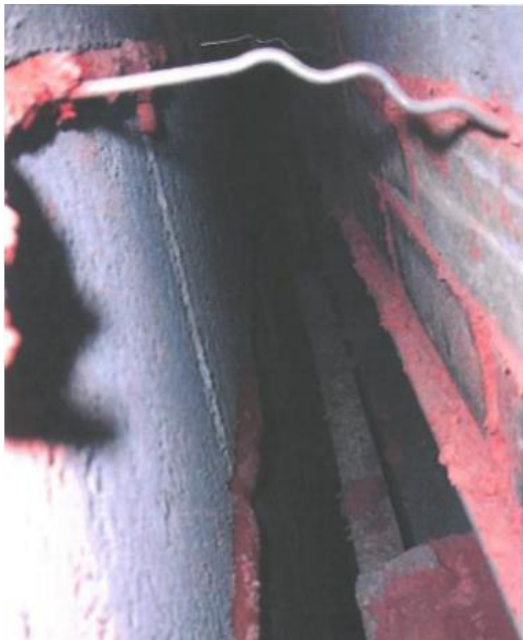
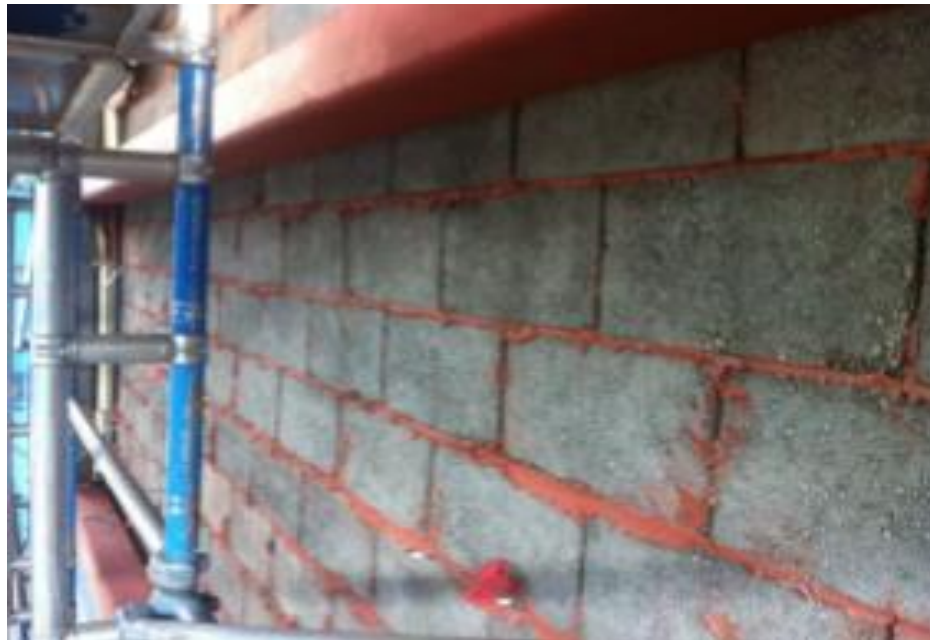
Photographs from 4 different recently built schools from outside Edinburgh showing examples of:

- no embedment of wall ties;
- deformation of wall-ties due to misalignment of coursing;
- a total absence of wall ties

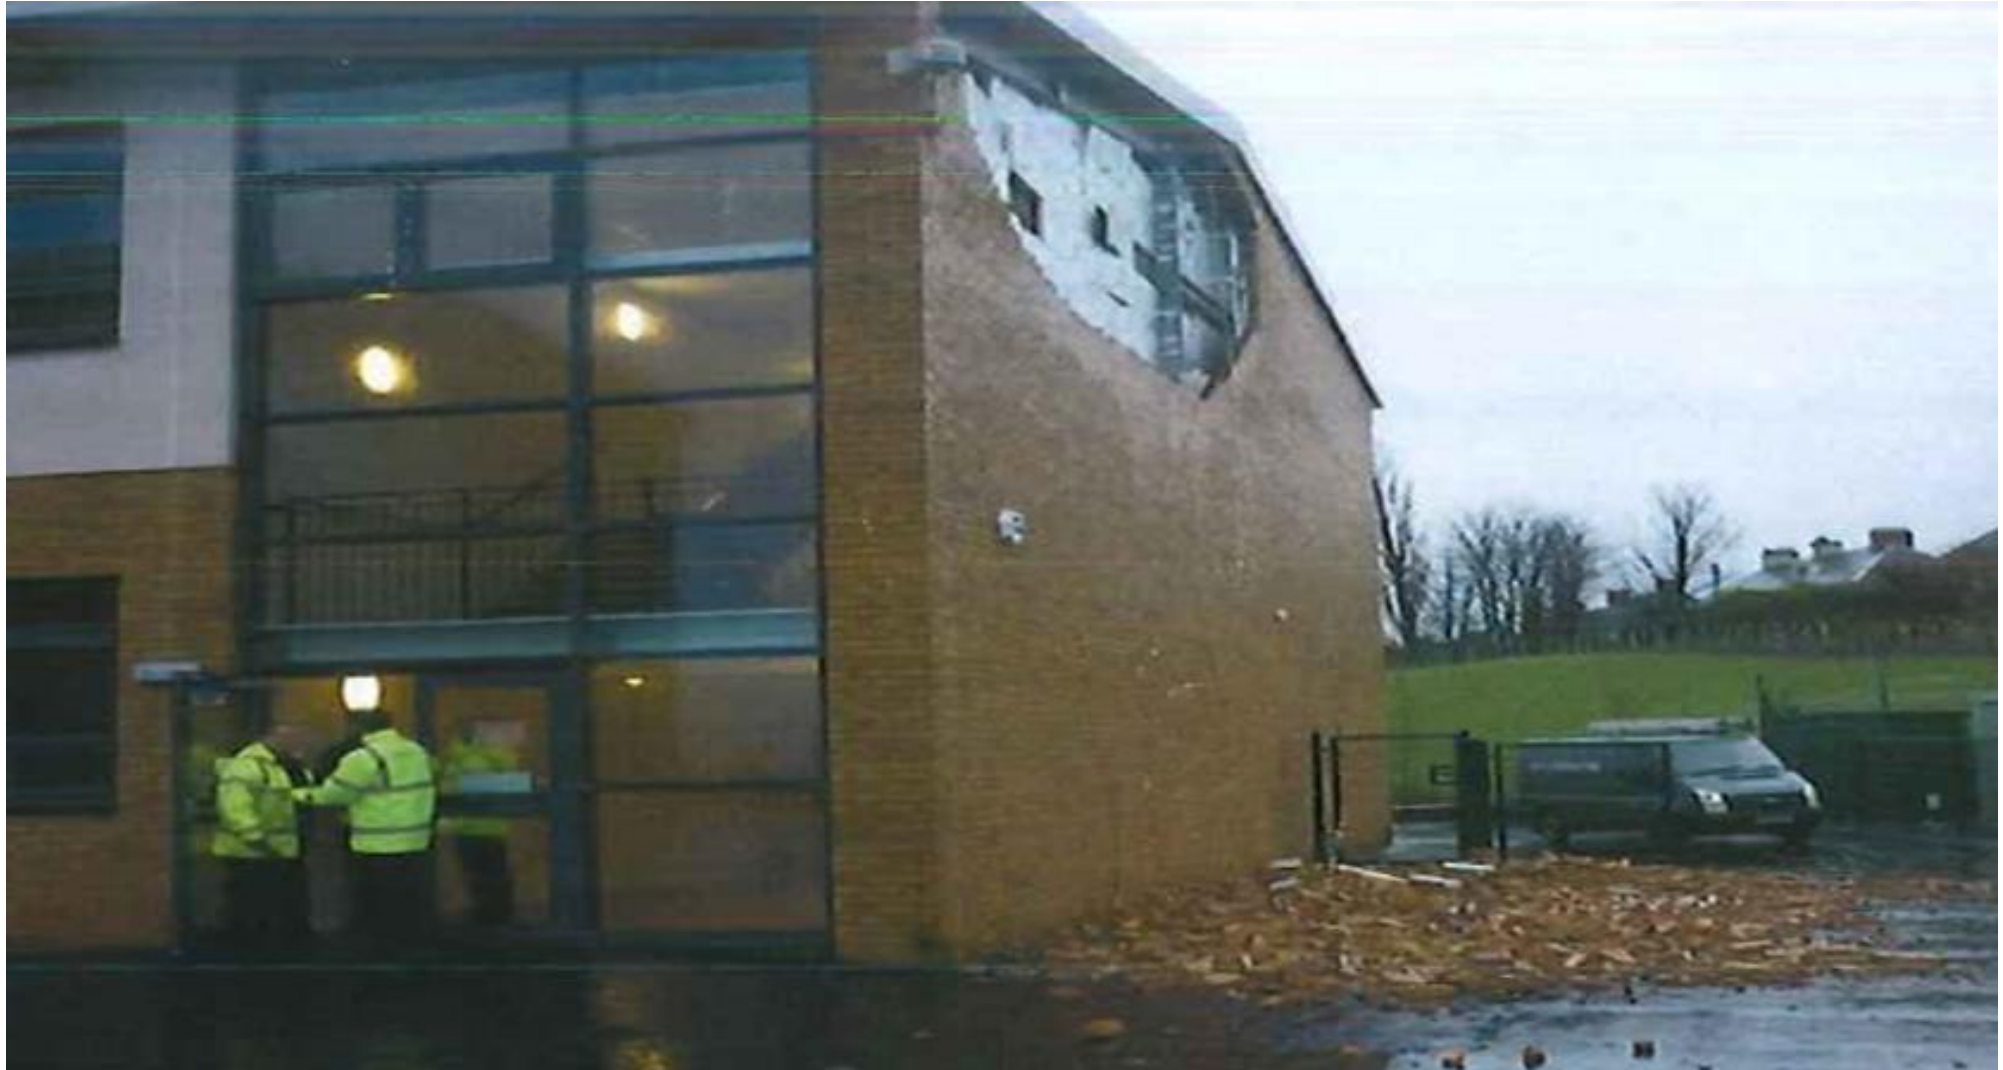
Trinity High School South Lanarkshire completed in 2009 as part of a PFI contract. It has the same pattern of collapse as at Oxfangs P.S. and also occurred in a period of high wind

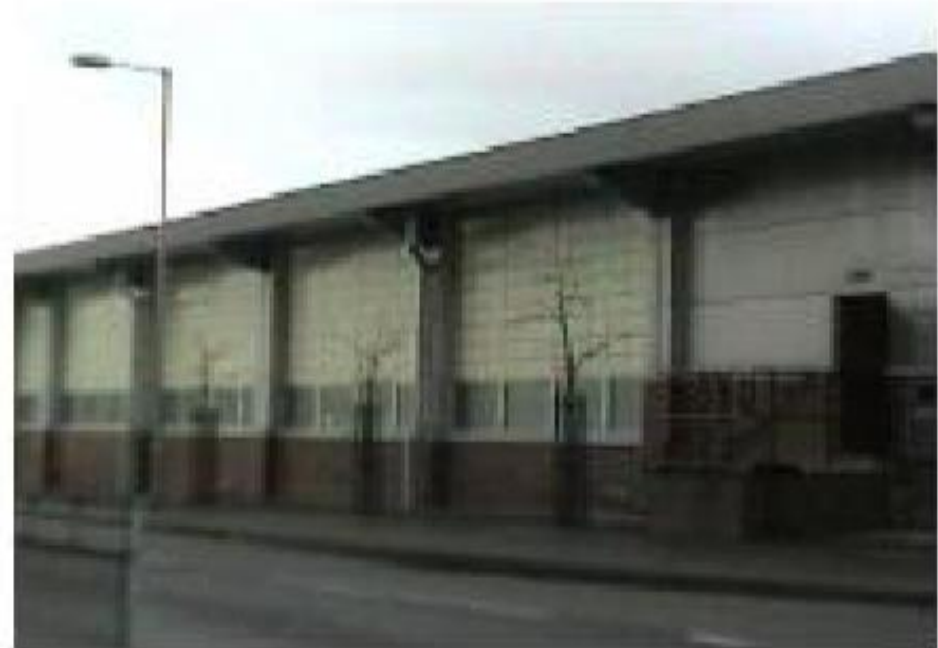
The east façade to the pool hall exhibits significant heat losses across the base walling and around junctions between wall heads and soffits indicating missing and poor installation of insulation panels

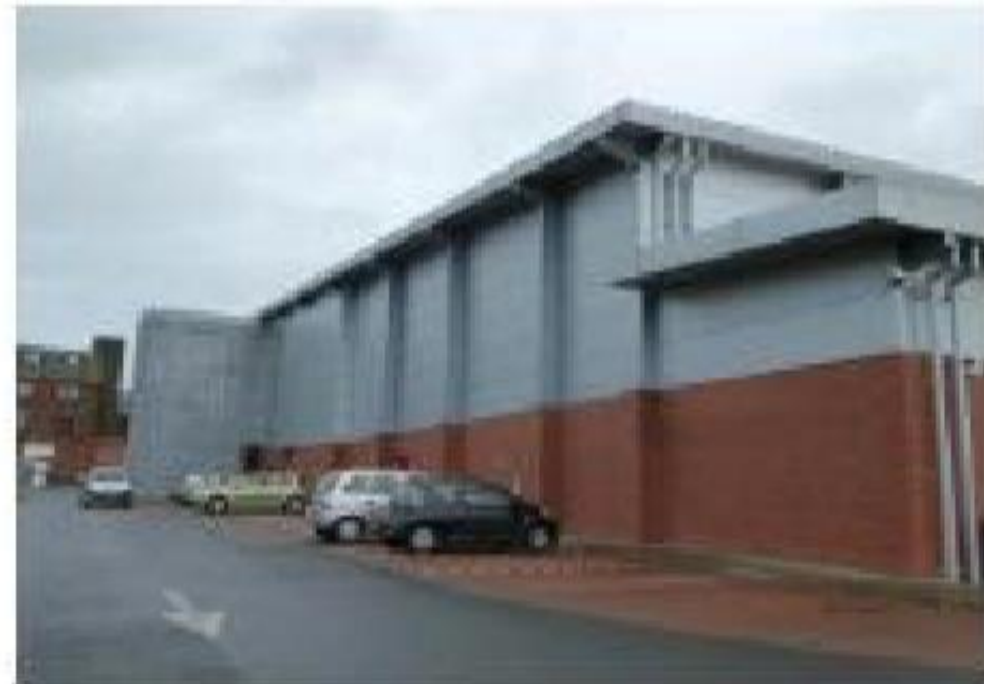
West façade showing excess heat loss through column cladding locations and at roof junctions evidencing poor detailing, cold bridging and missing insulation

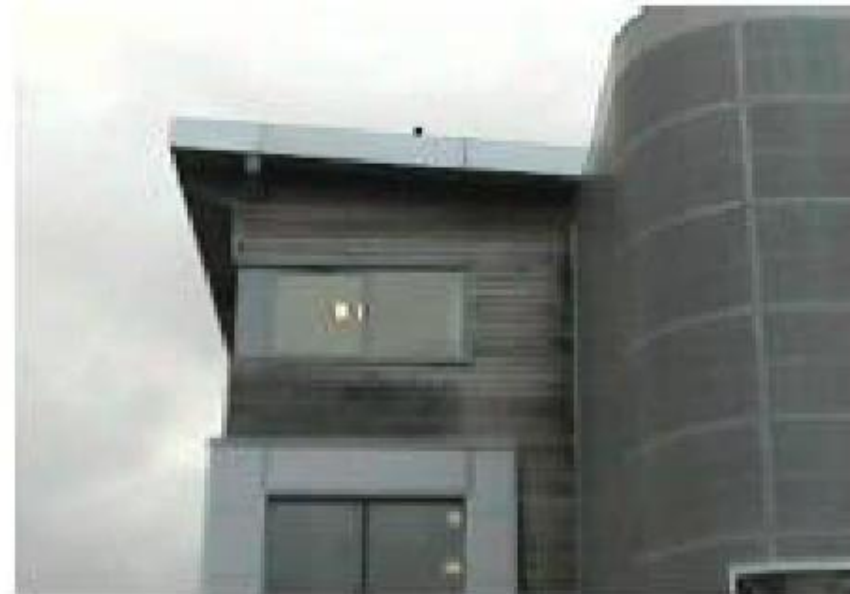
North end showing excess heat loss to wall head area and inadequate wall head/roof junctions seals , seals around windows and insulation behind timber cladding

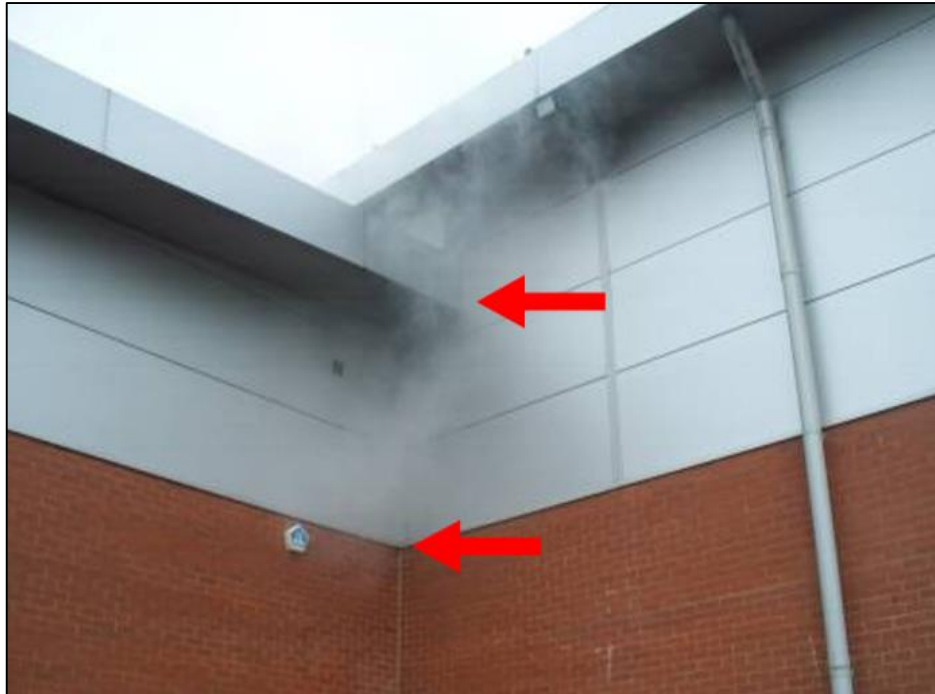
Test smoke rapidly escaping through eaves junction demonstrating lack of air-tightness

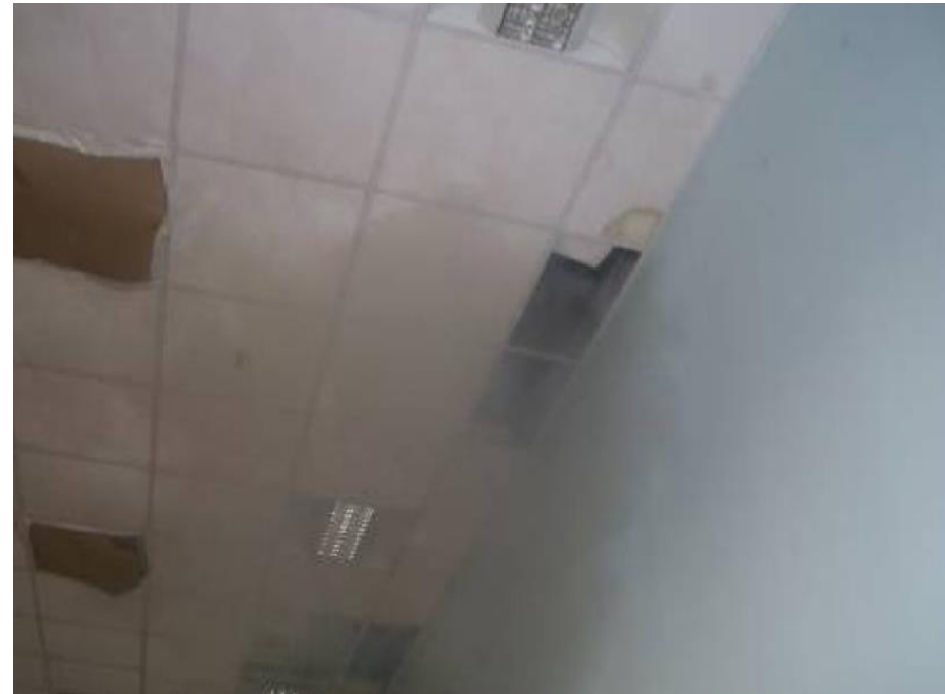
Test smoke pouring into dance studio from Wet area of building
