SCOTTISH ASSOCIATION OF UNIVERSITY DIRECTORS OF ESTATES

September 2018

RESTORING CONFIDENCE: THE NEED FOR A FOCUS ON QUALITY

Prof. John Cole CBE RIBA

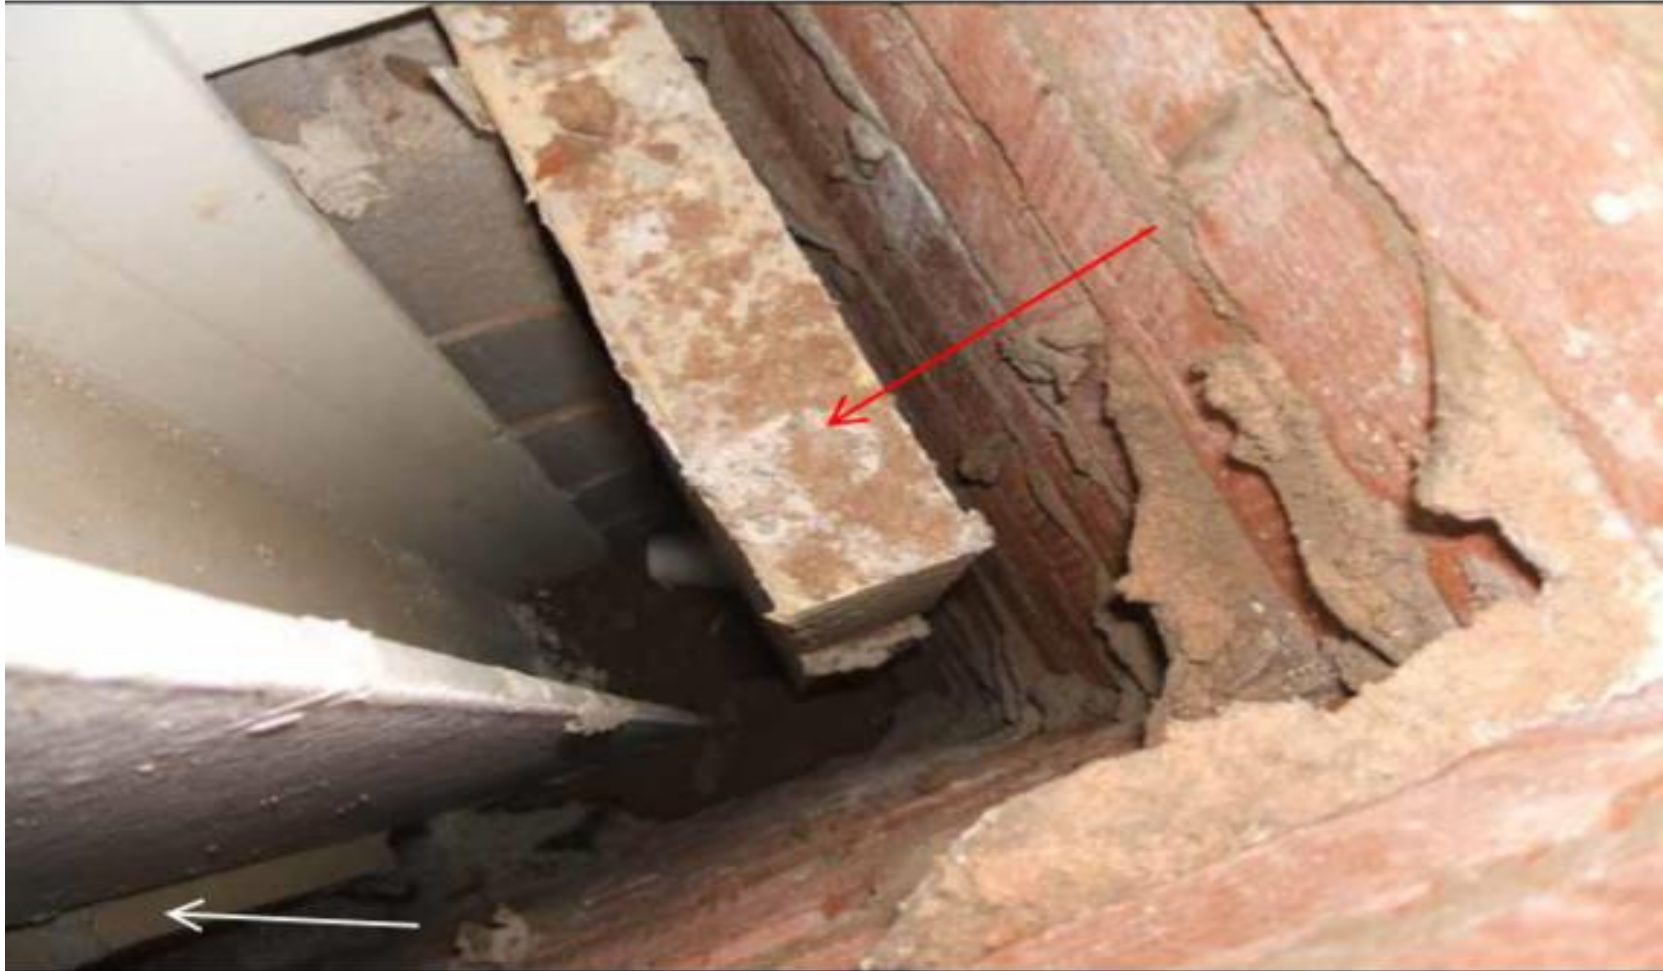
Isolated pieces of insulation below floor level but none above and through corner where cold bridge occurs at steel column

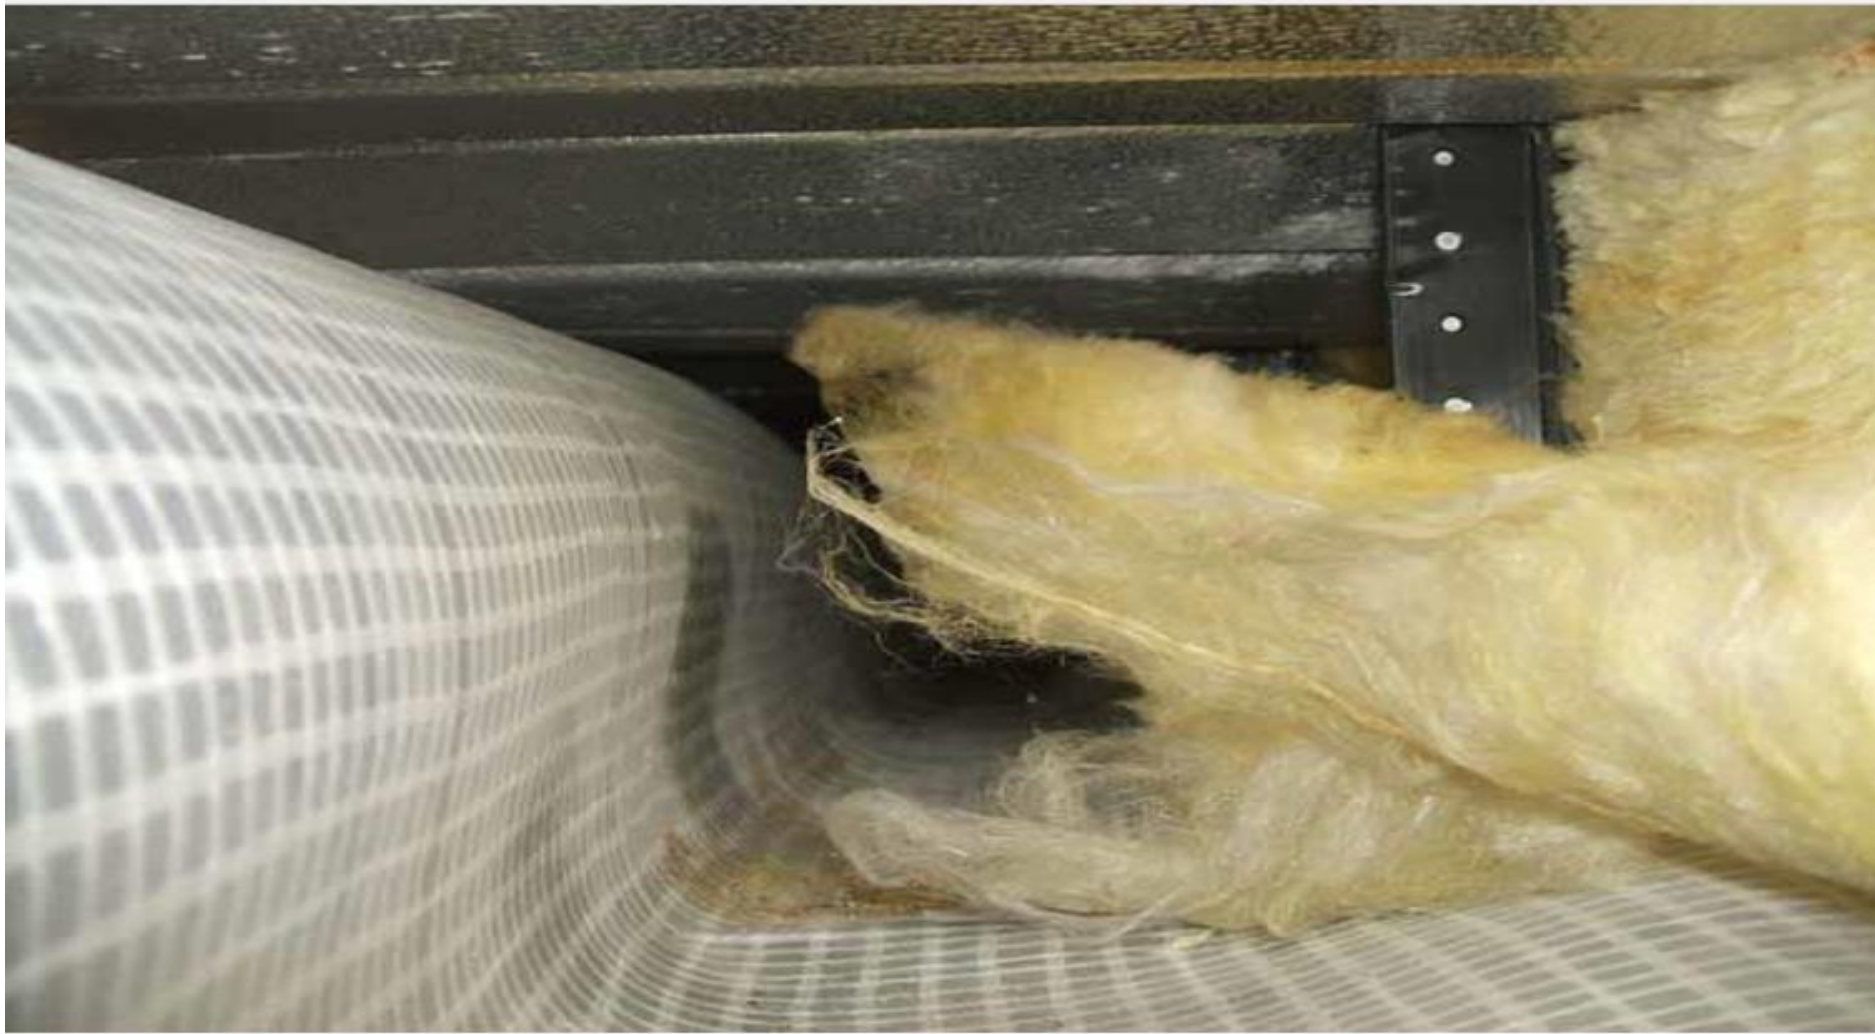
Continuous gap of insulation at eaves

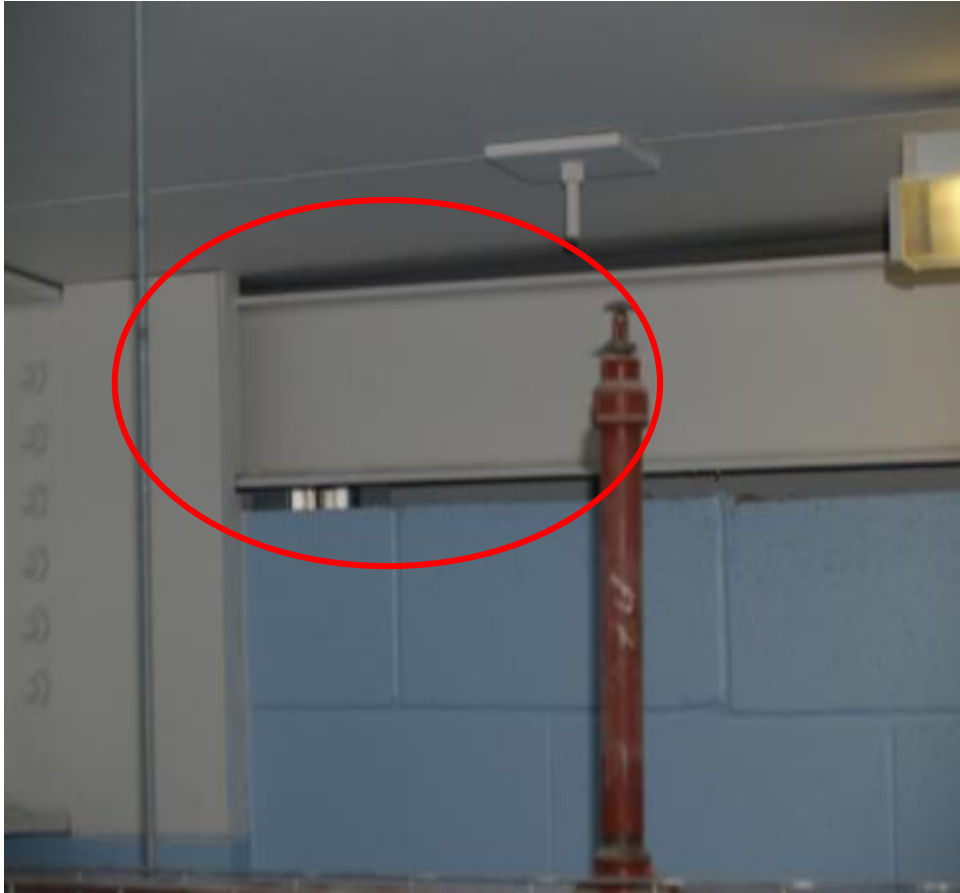
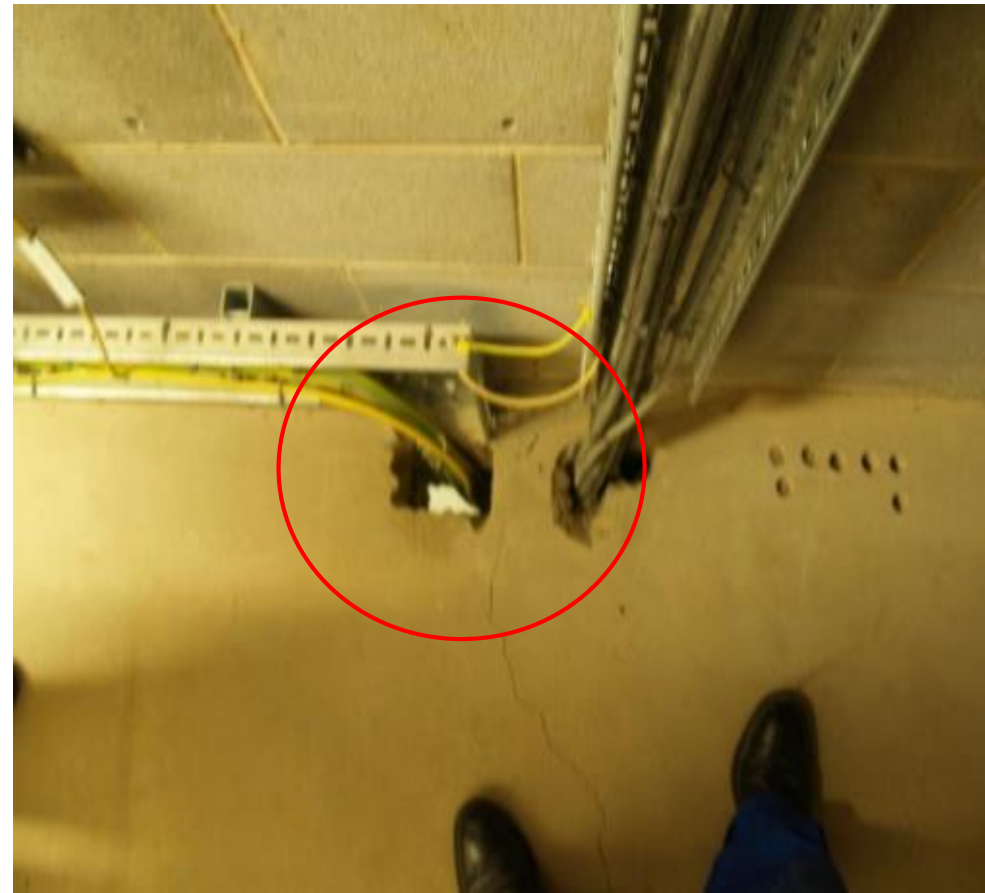
Two examples of the many major omissions of essential fire-stopping, one in an escape corridor and second in the floor slab of a first-floor plant room

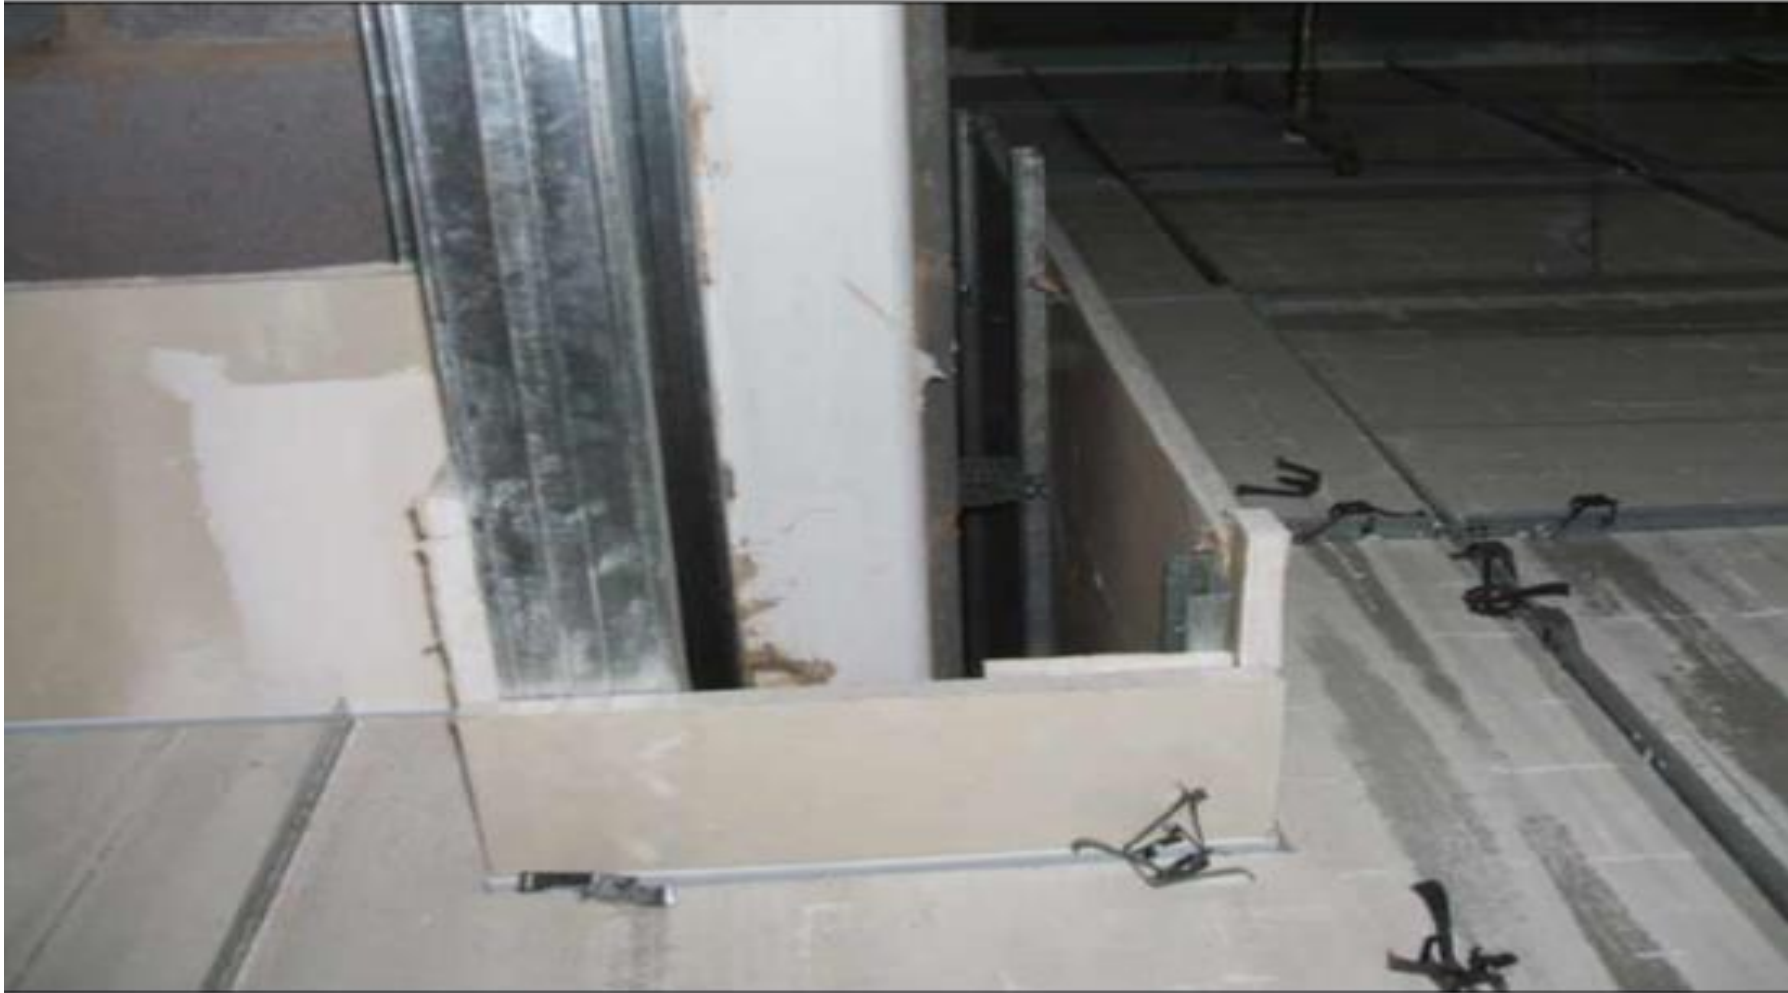
Void to lift shaft and floor below not fire or smoke sealed

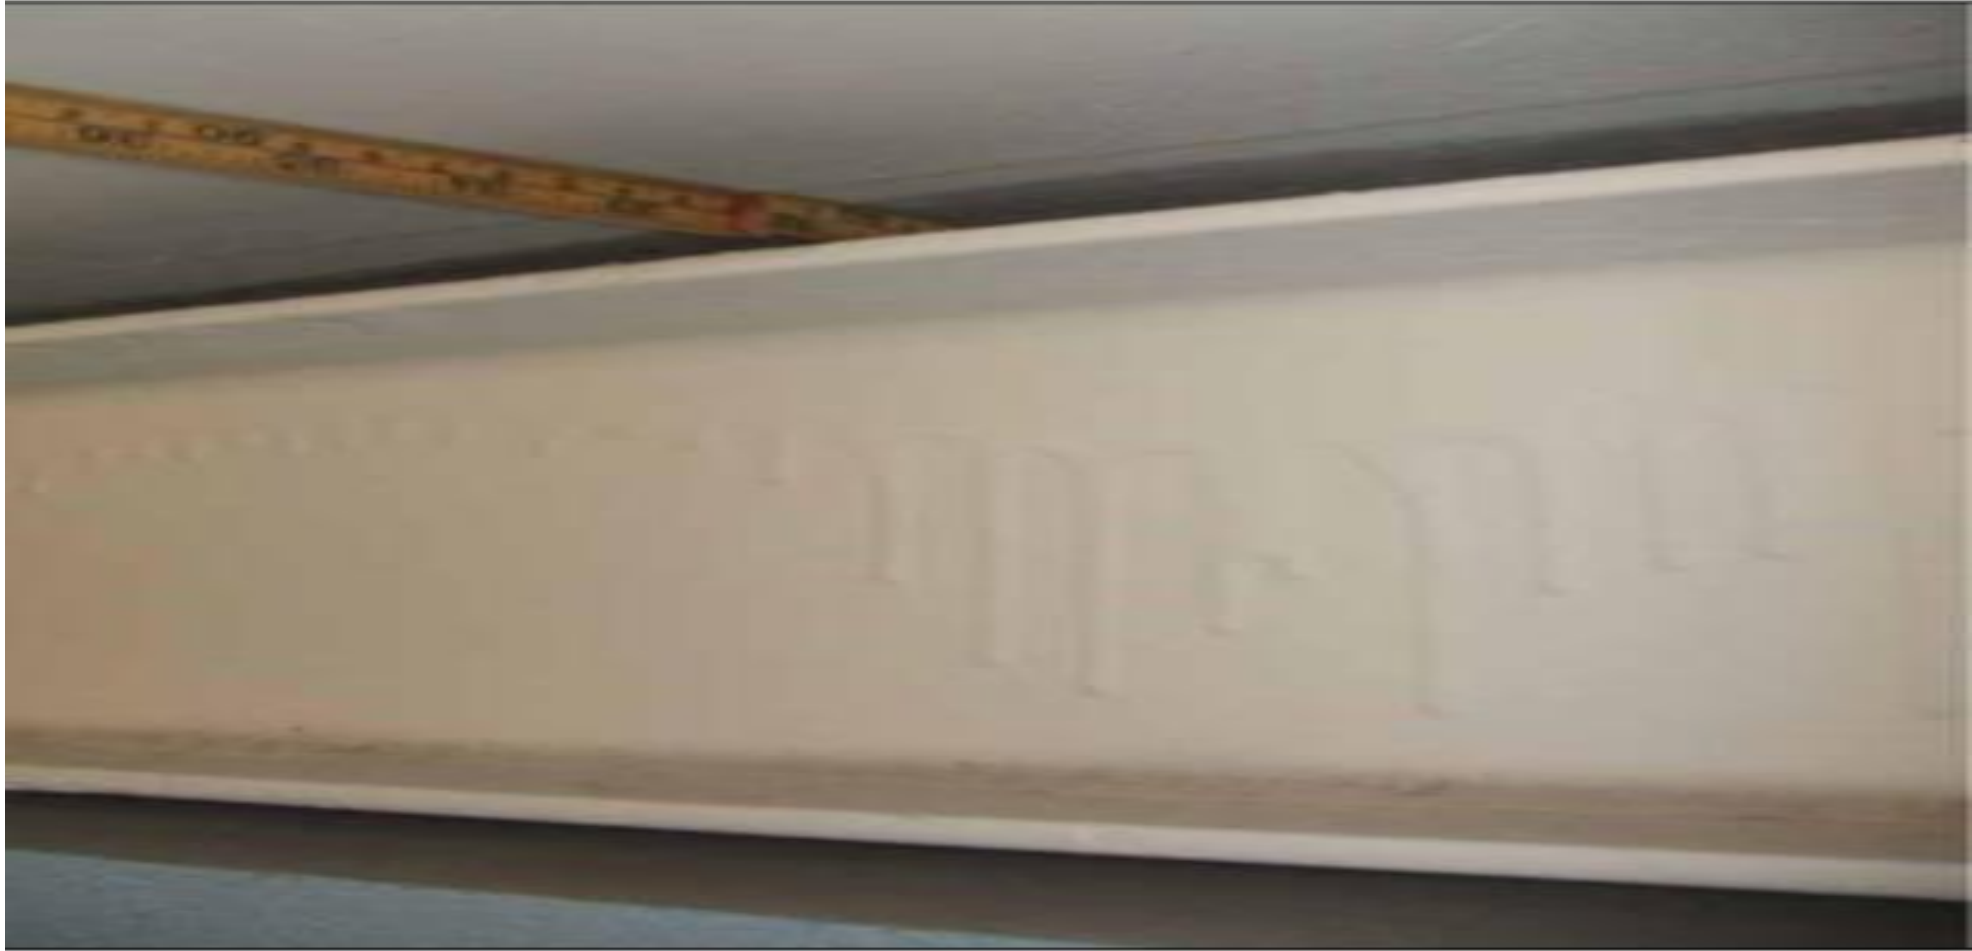
Void above beam in wall to escape route without fire or smoke seals

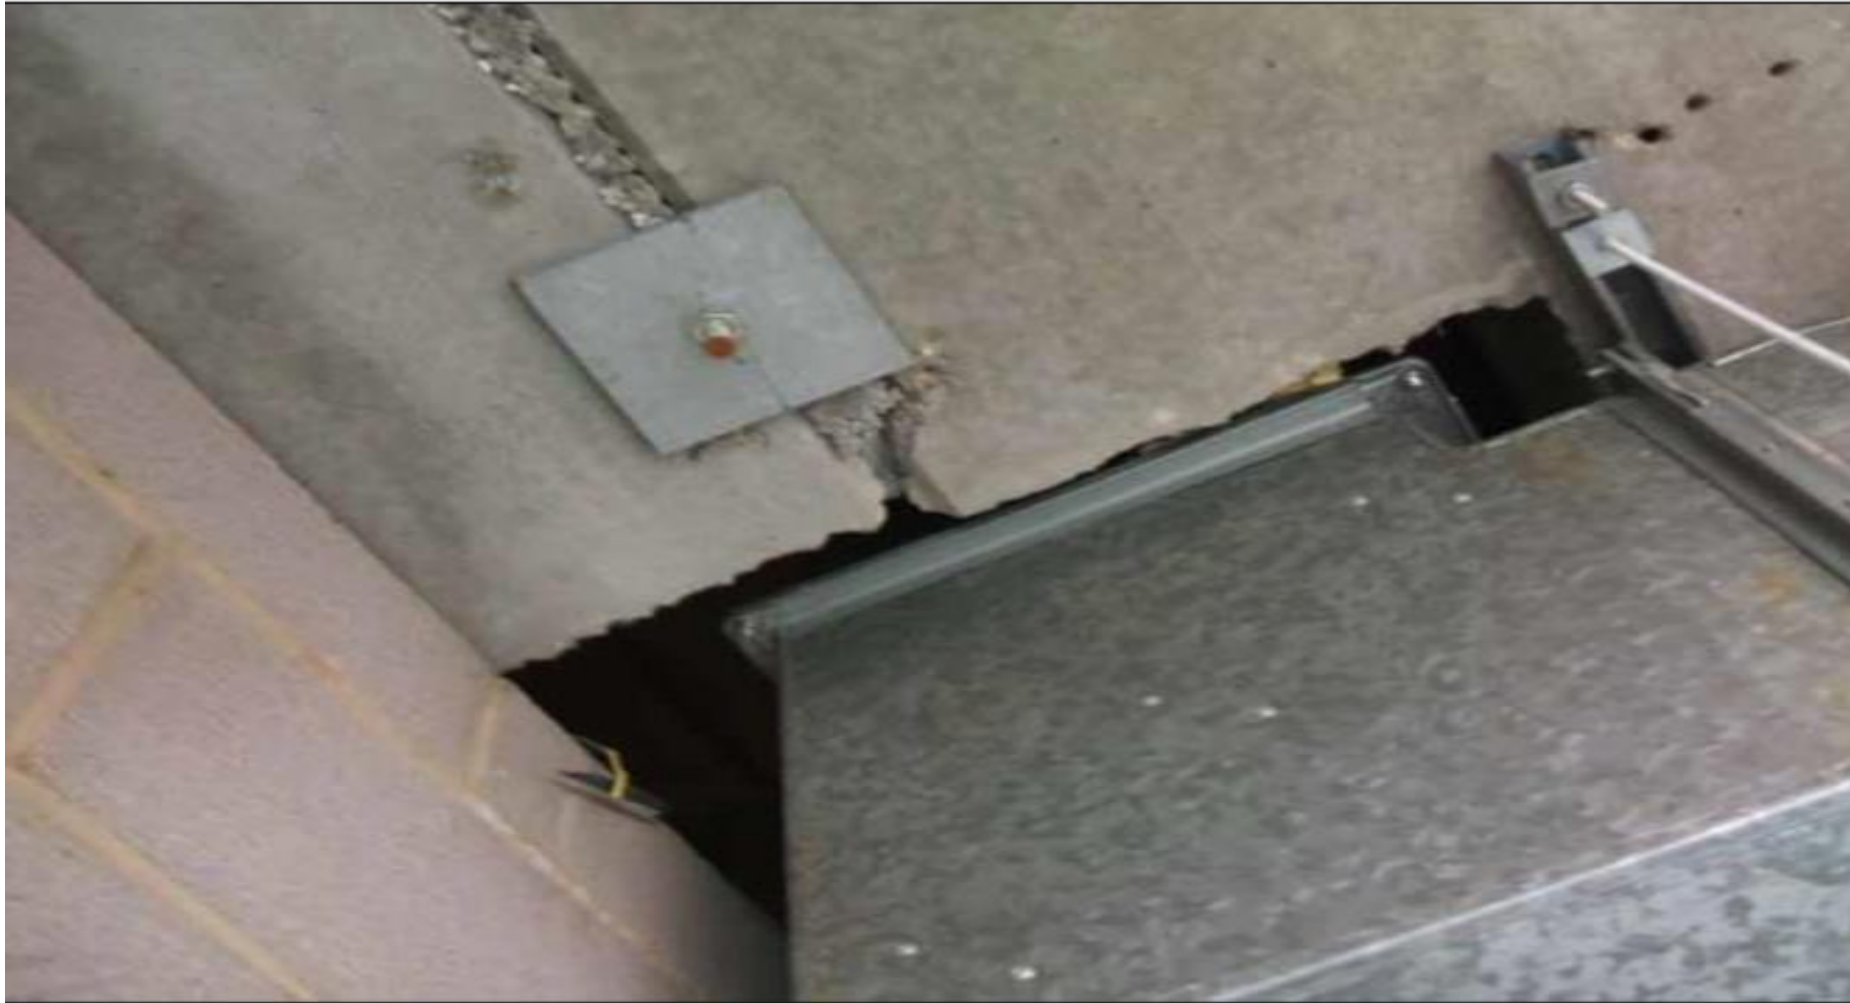
Ducts passing through plant room walls without fire or smoke seals

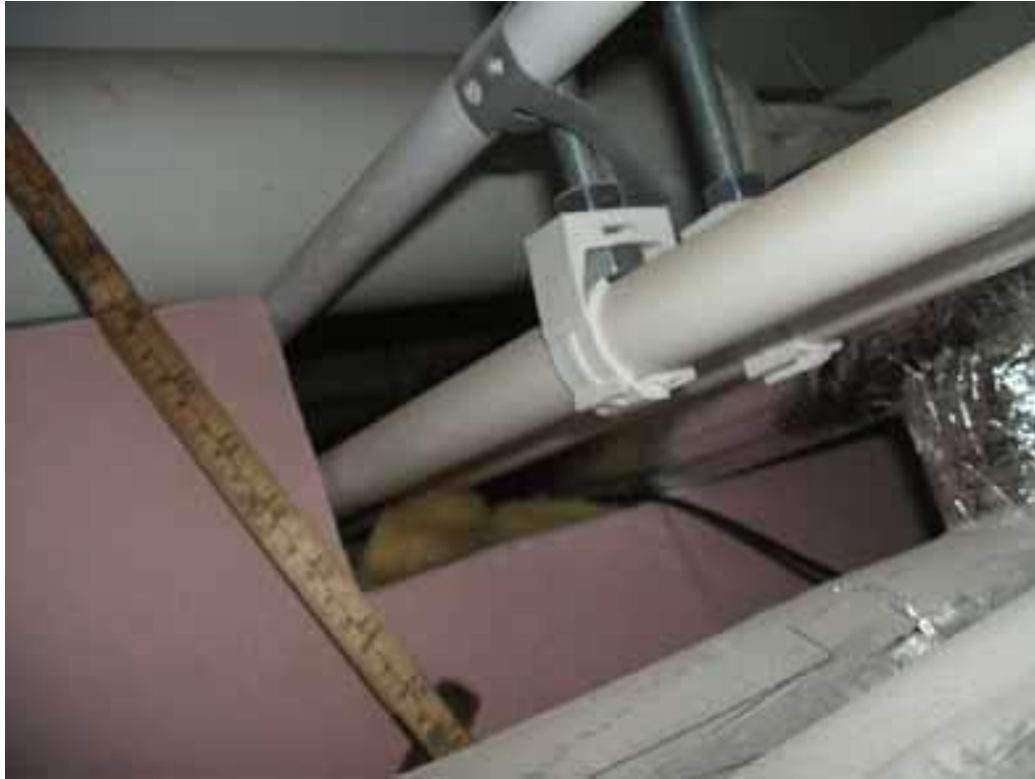
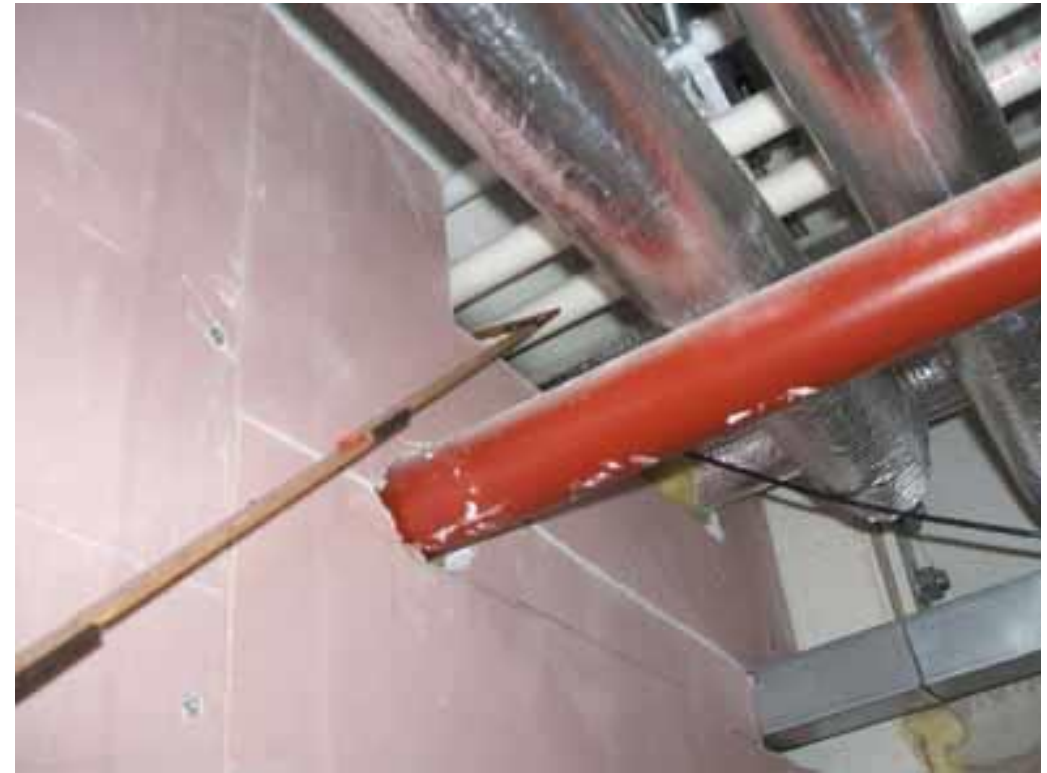
Major gaps in firestopping

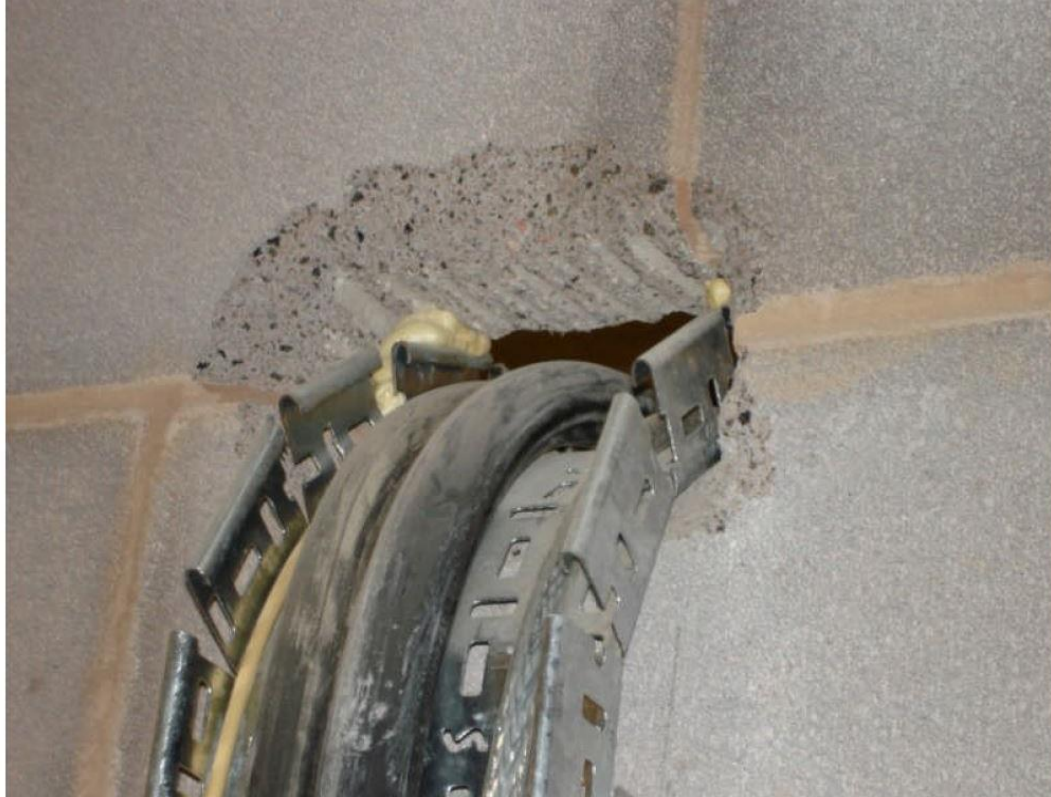
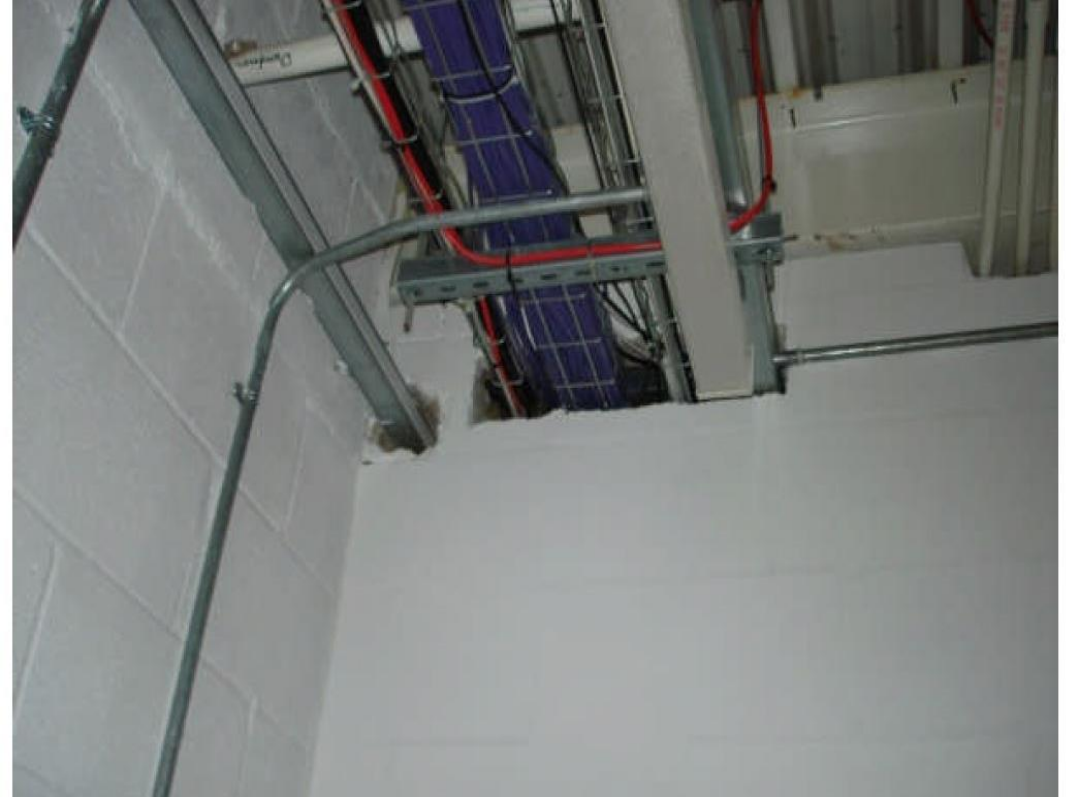
Major gaps in firestopping

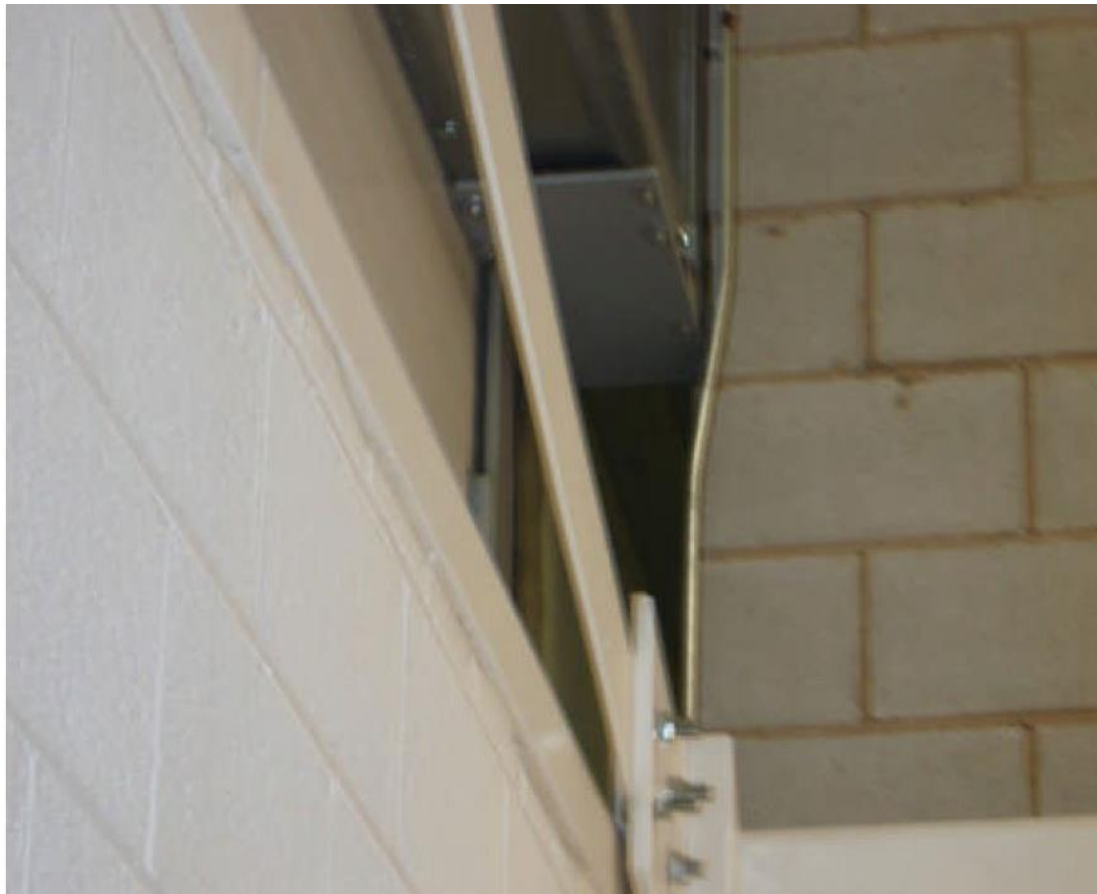
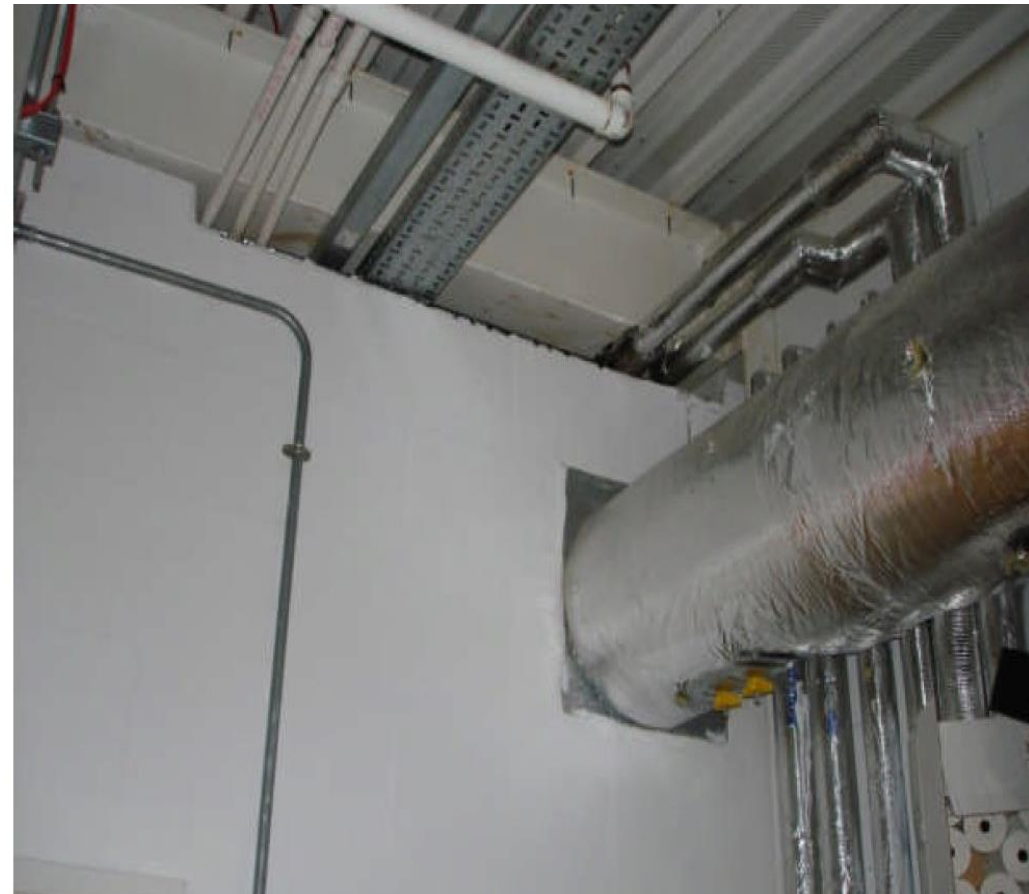
Major gaps in firestopping

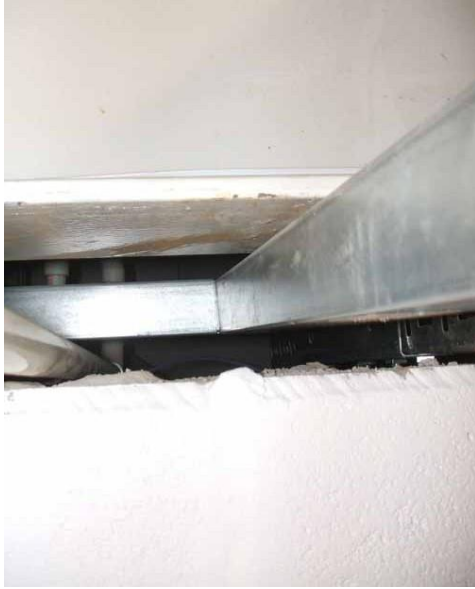
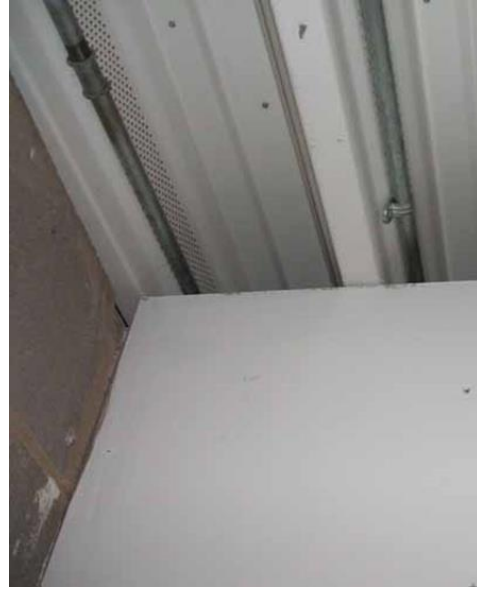
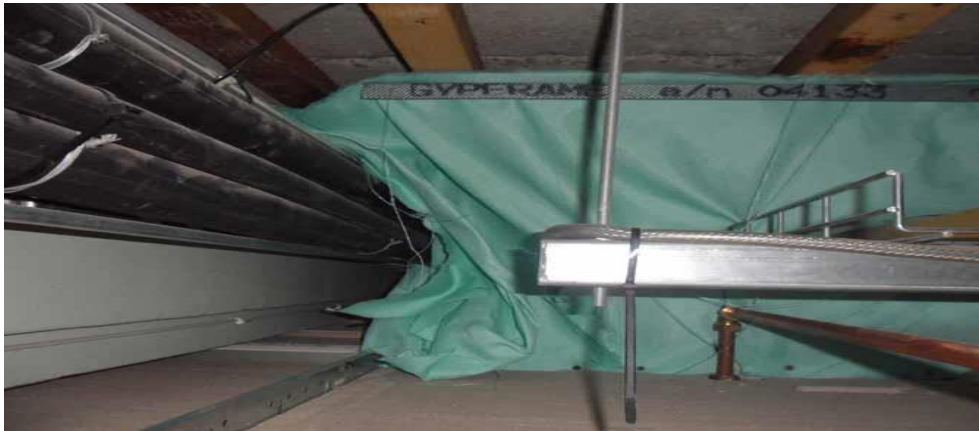
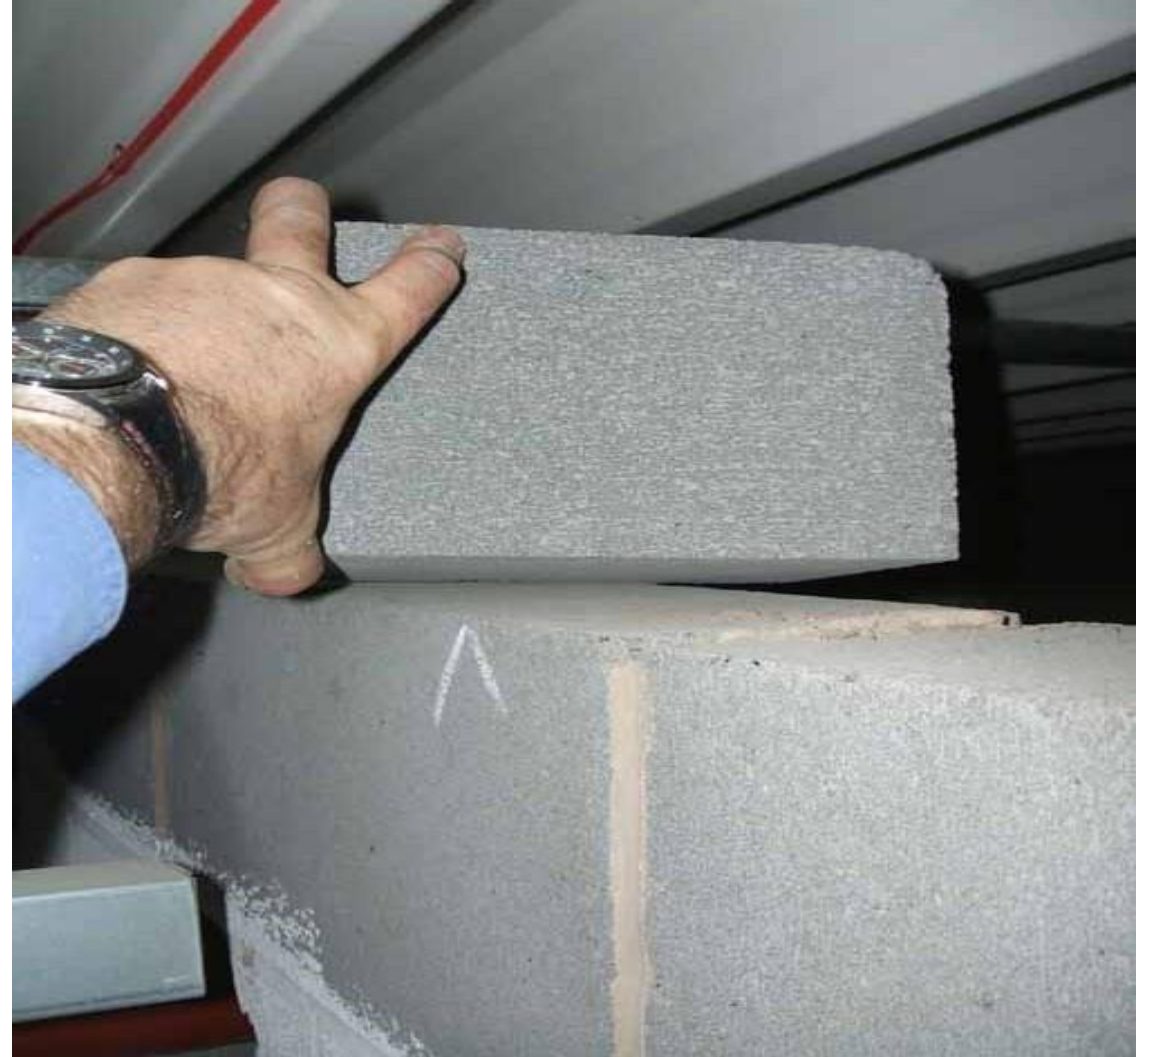
Major gaps in firestopping

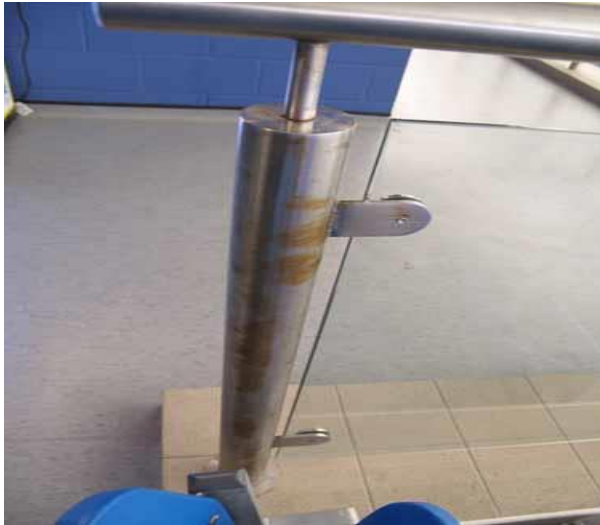
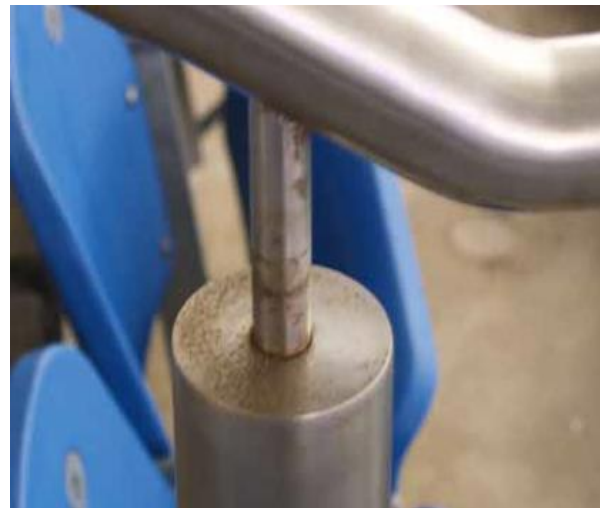
Examples of corrosion to steel fittings throughout the wet area found to be 304 grade steel as opposed to specified grade 316

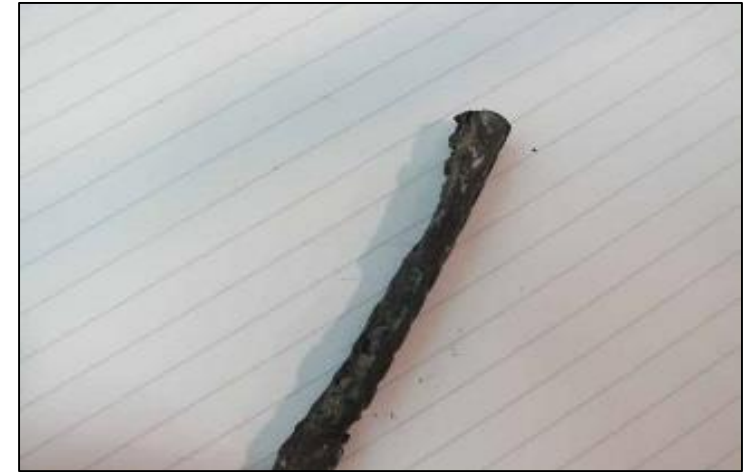
Corrosion of steel reinforcement and staining of surrounding concrete in pool walls. Above is an example of a corroded bar removed from the pool tank wall showing depleted section as a result of corrosion

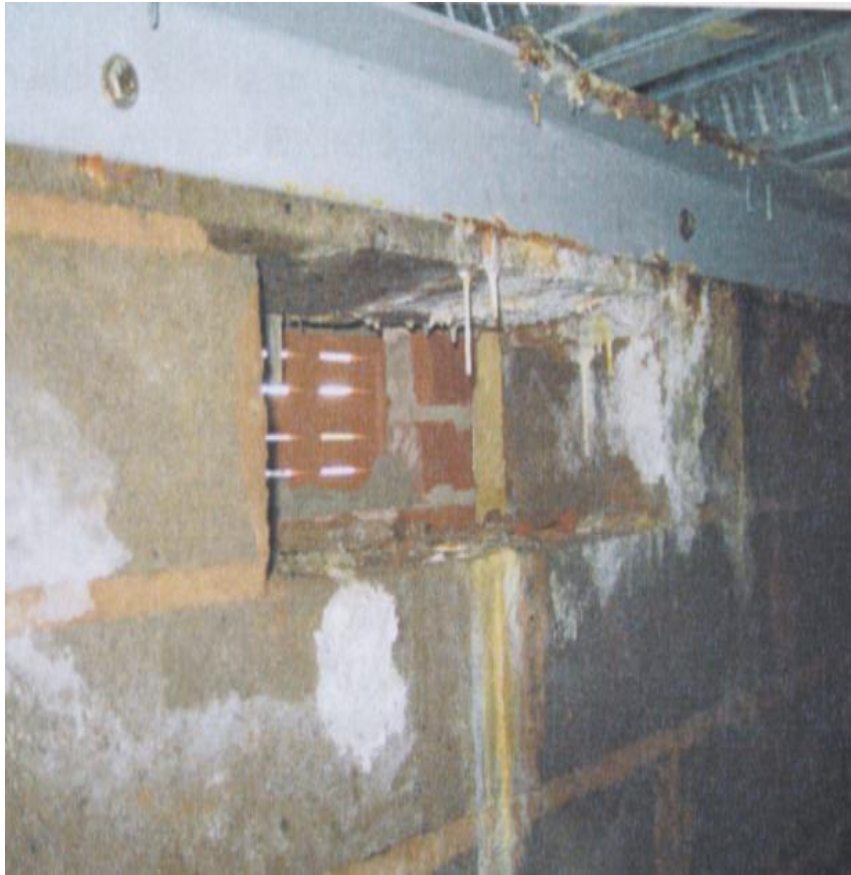
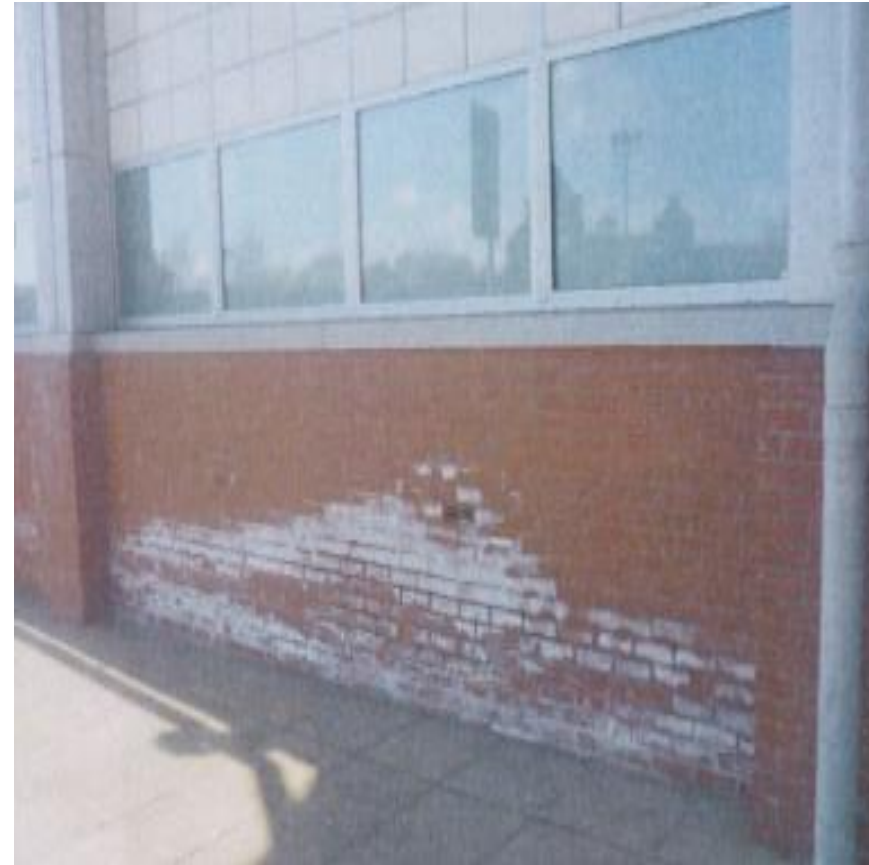
External and internal faces of saturated cavity wall

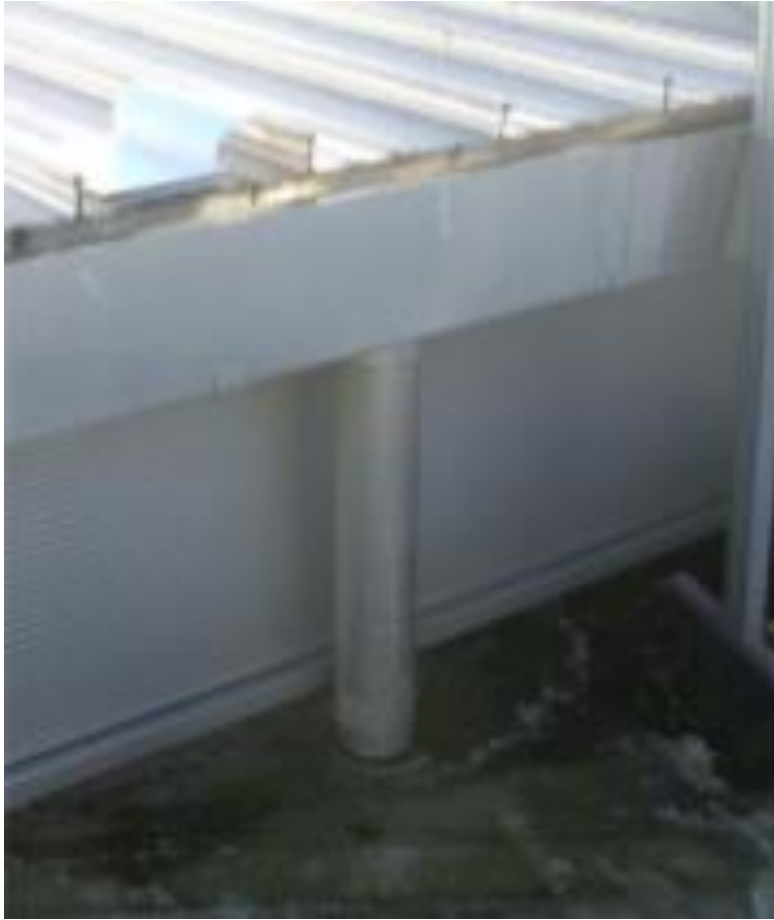
Discharge from dance studio roof directly onto pvc membrane and ponding due to ineffective drainage

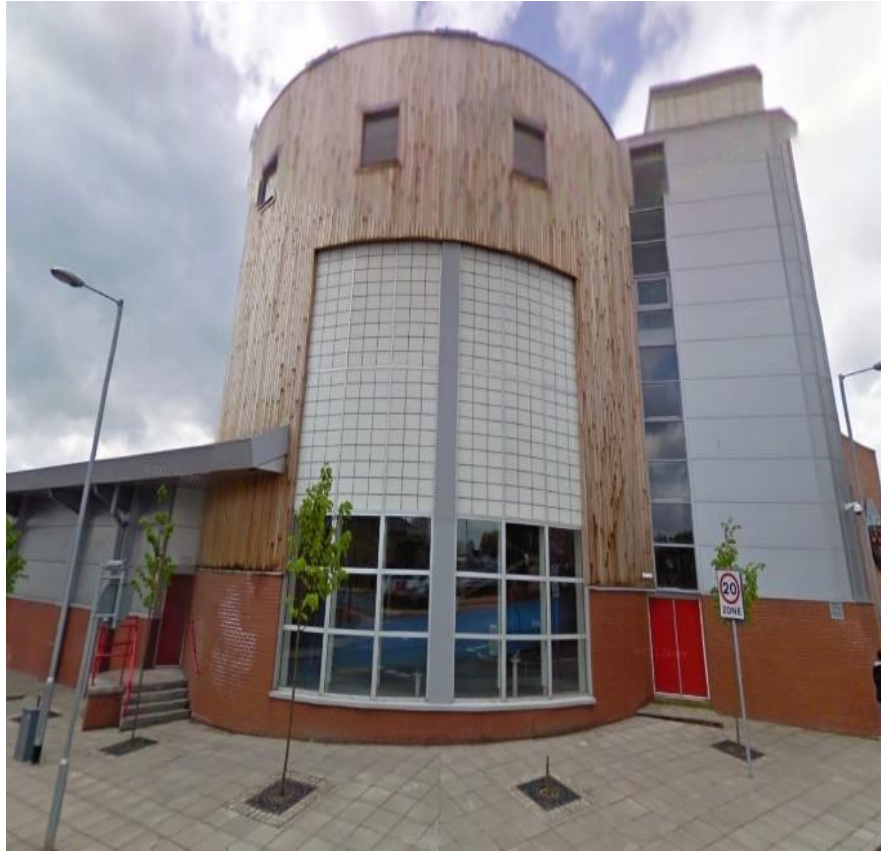
BEFORE

Defective
construction of
masonry walls
