SCOTTISH ASSOCIATION OF UNIVERSITY DIRECTORS OF ESTATES

September 2018

RESTORING CONFIDENCE: THE NEED FOR A FOCUS ON QUALITY

Prof. John Cole CBE RIBA

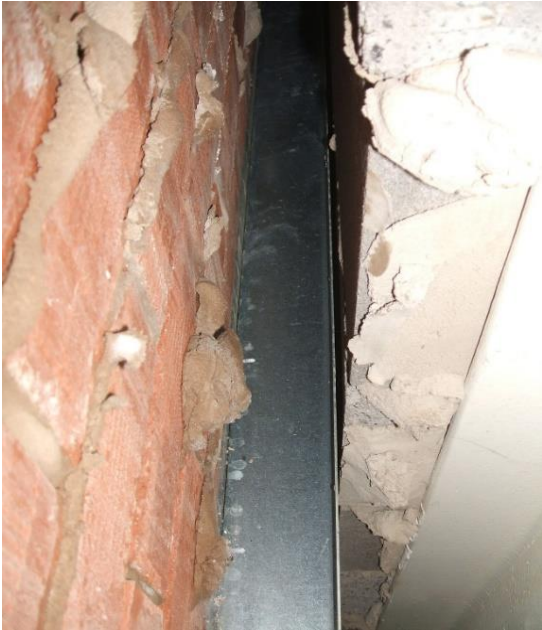
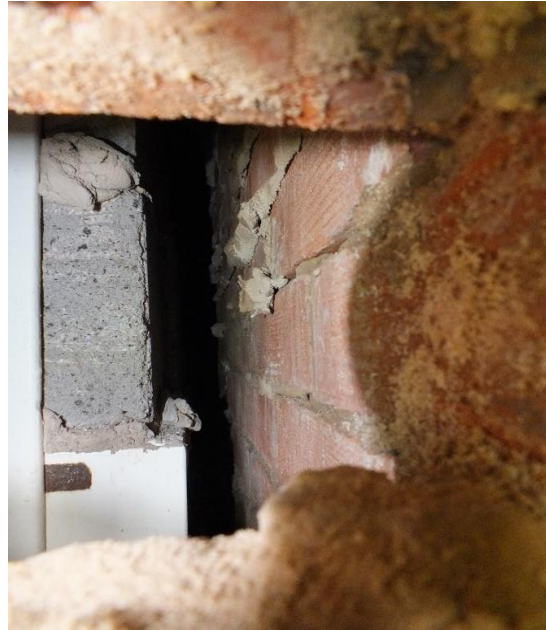
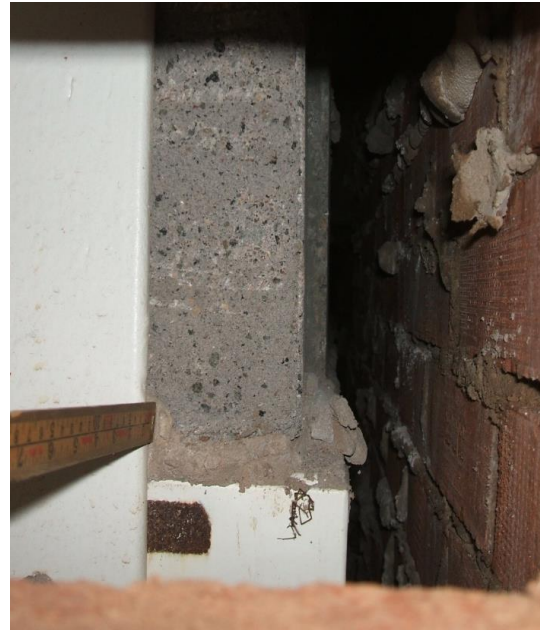
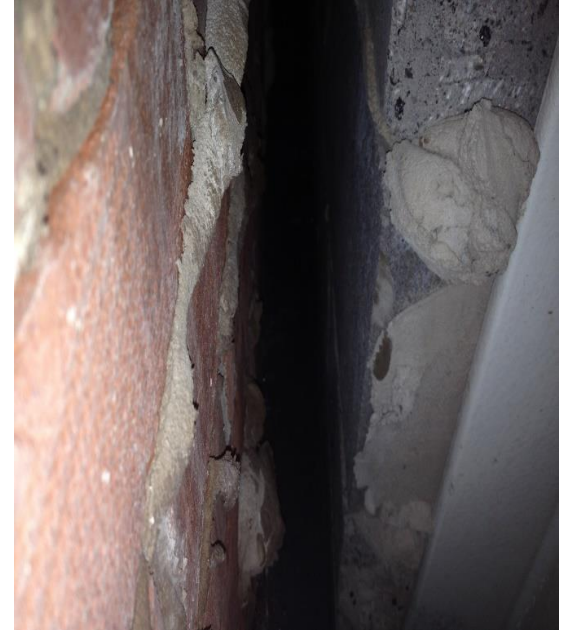
Nov 2011 photographs – no visible evidence of wall ties

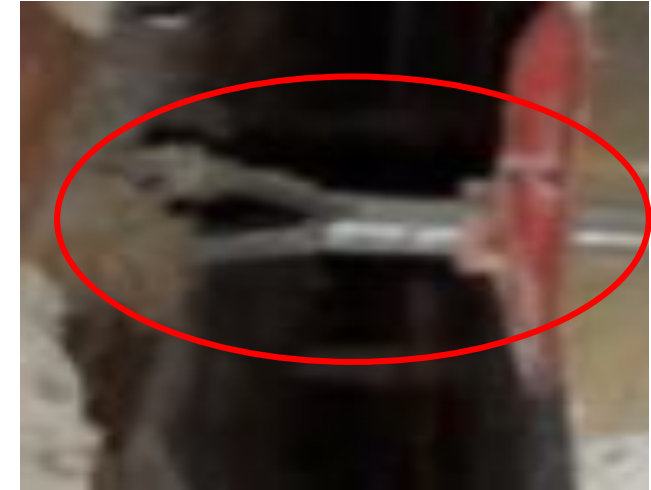
Wall ties not embedded in outer face and insulation missing

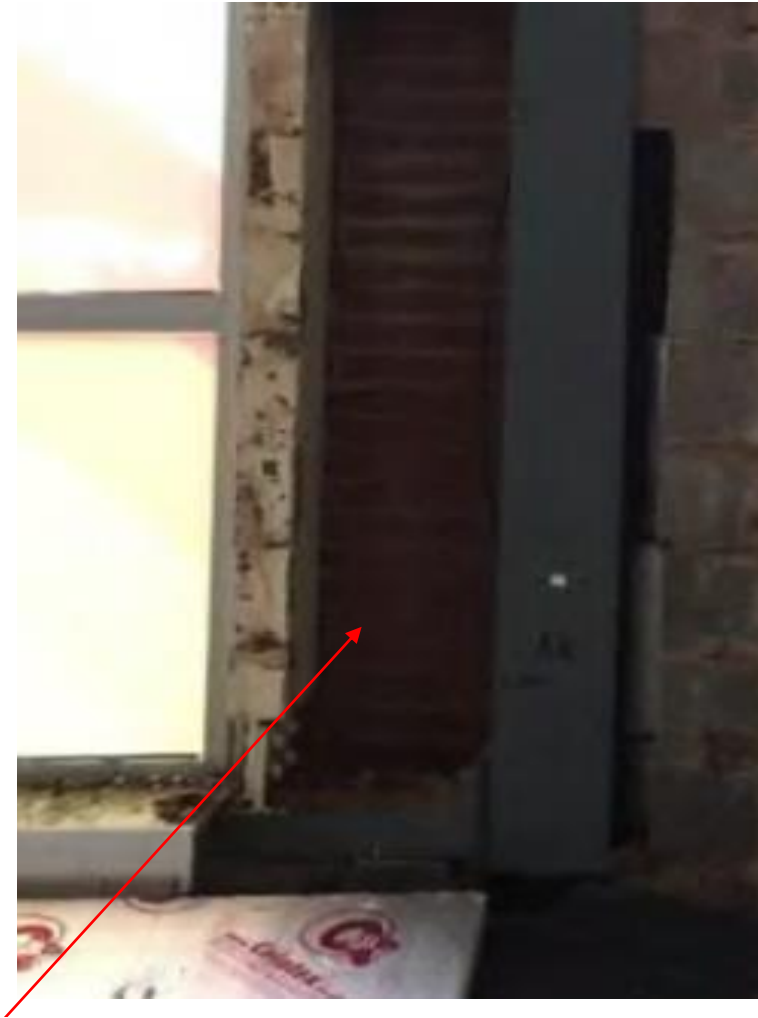
No inner leaf blockwork between Kallwall glazing panels and column. External brickwork has no tie back

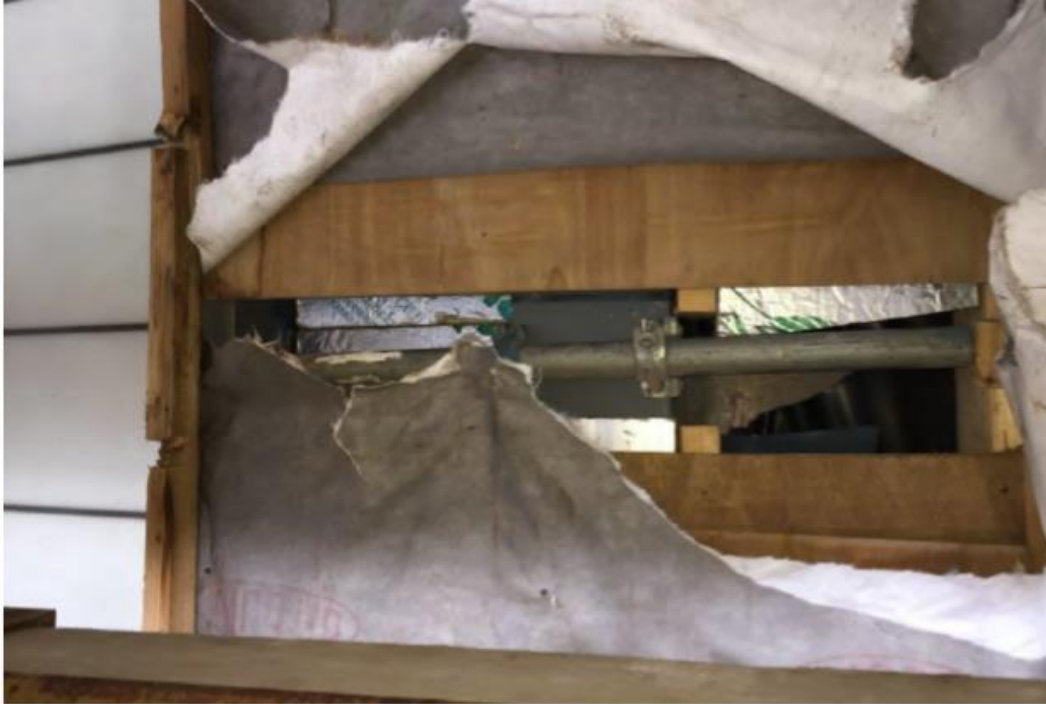
Scaffold tube remaining from original construction revealed on removal of cladding. Timber and insulation boded around tube

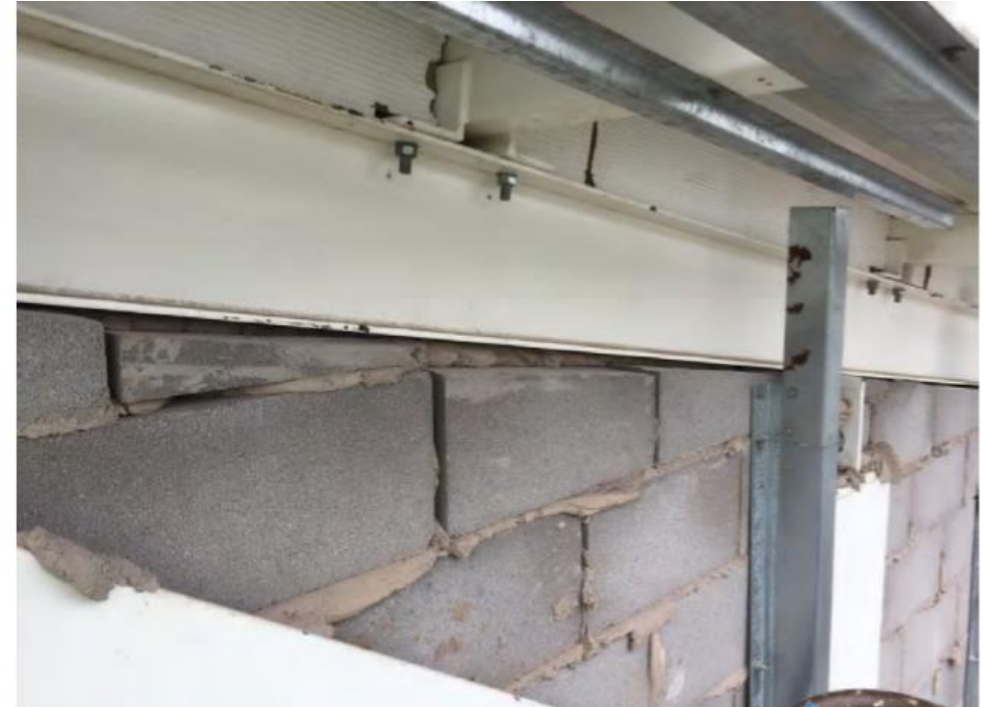
No supports to head of blockwork and inadequate supports for external cladding

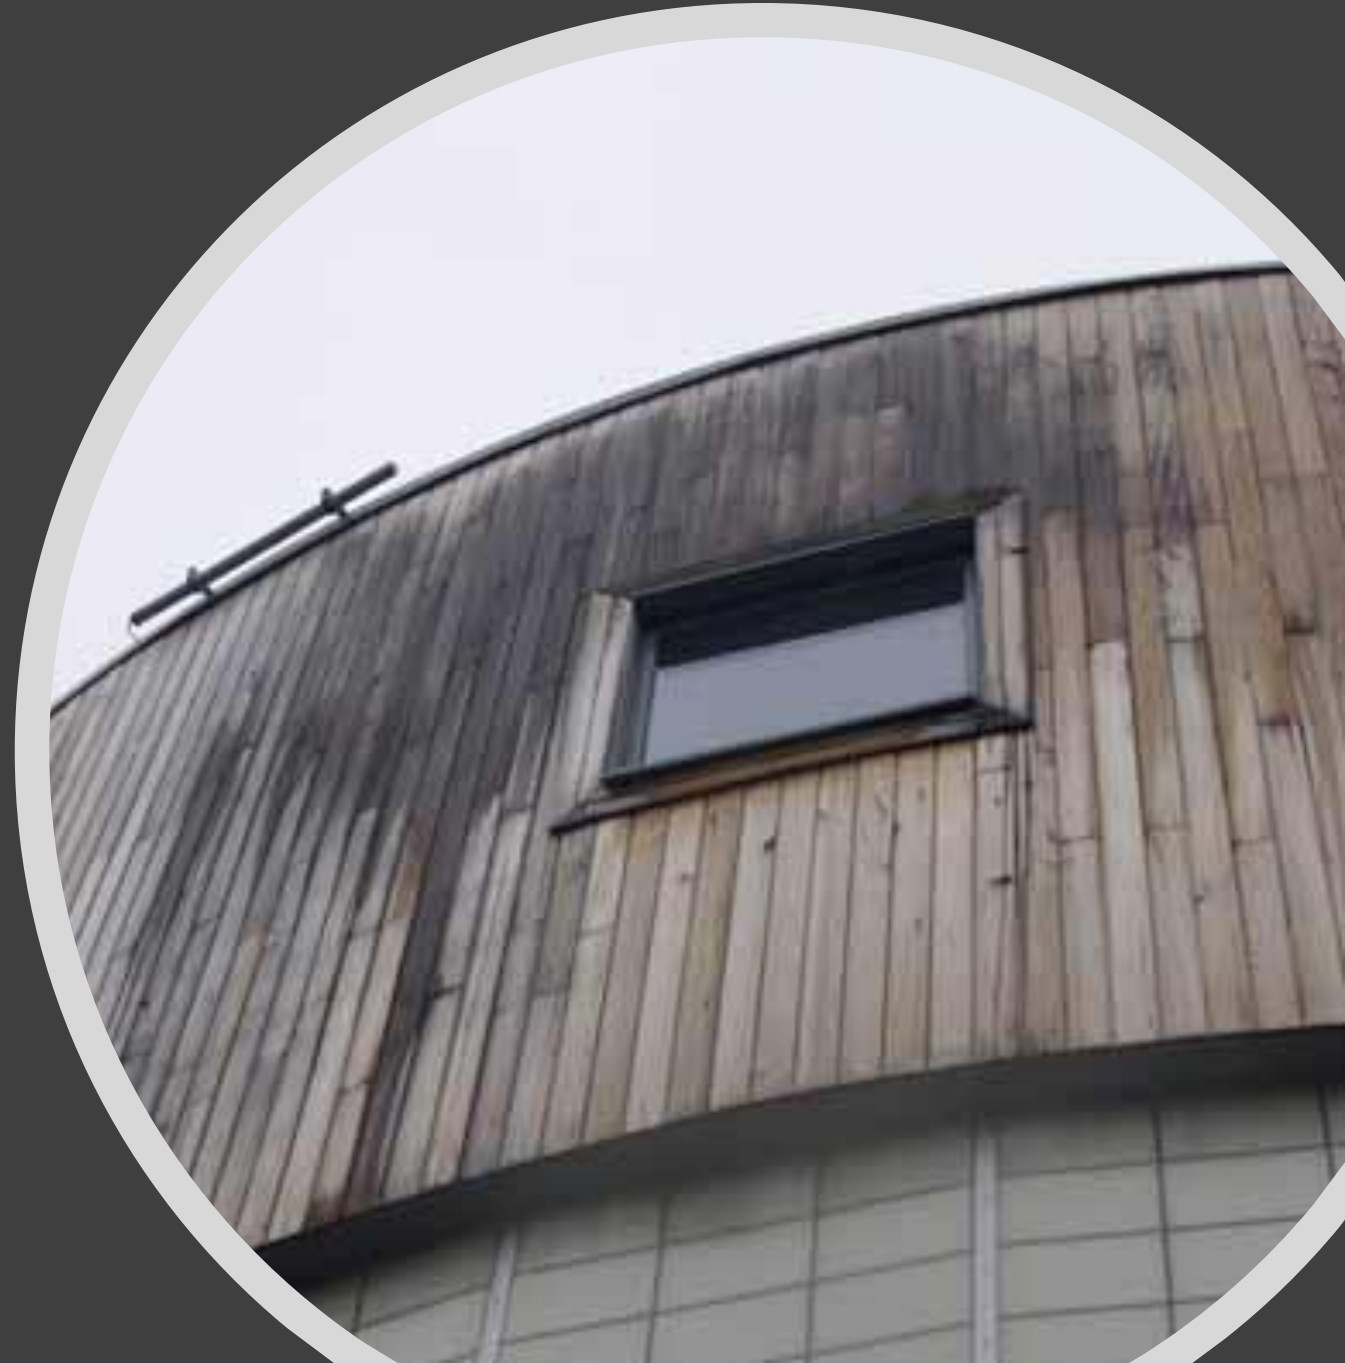
Poorly fitted and sealed flashing

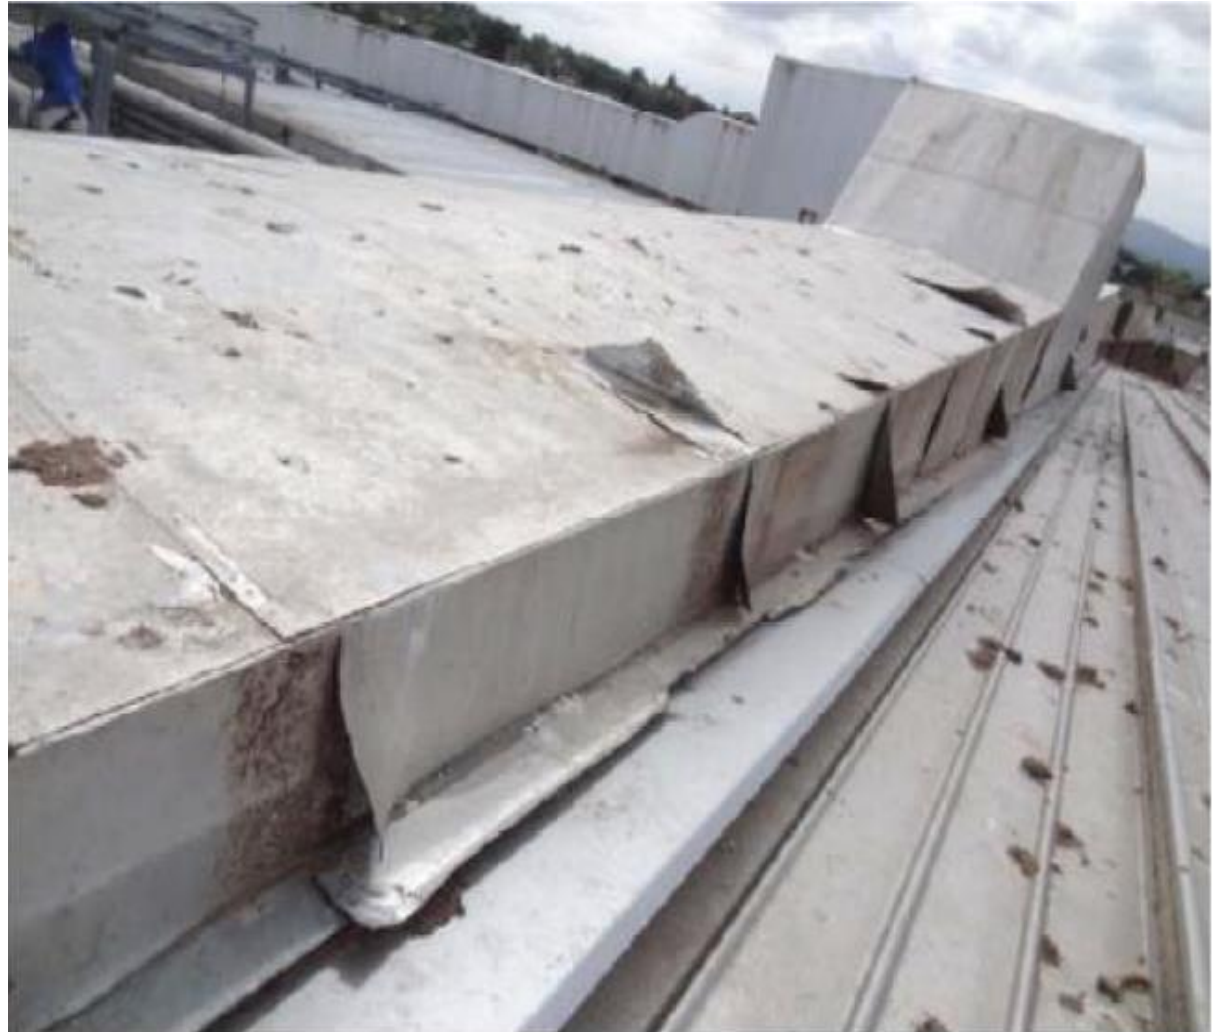
Potentially dangerous delaminating coverings to roof ducts

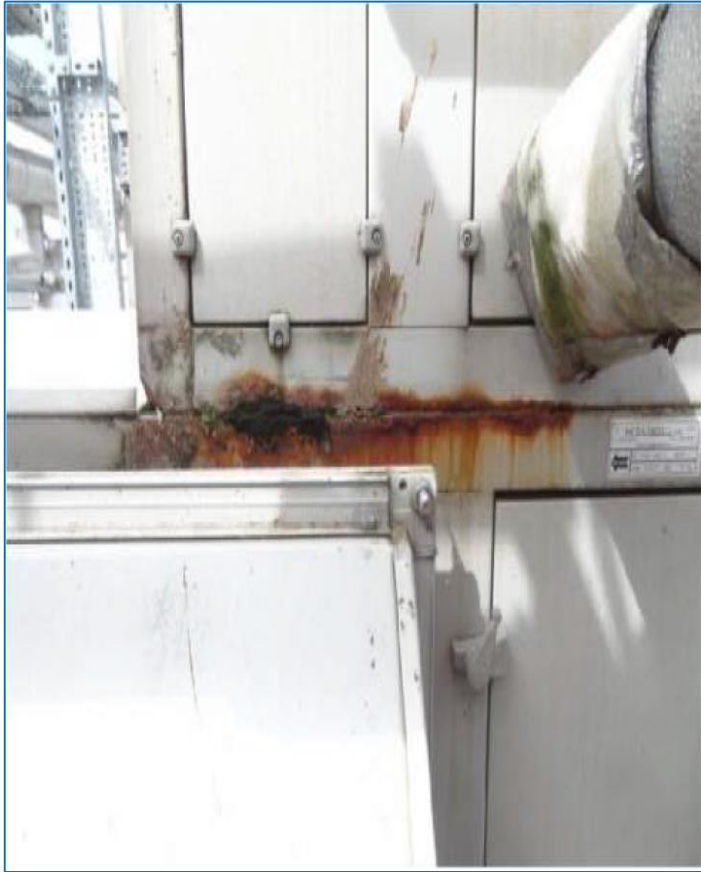
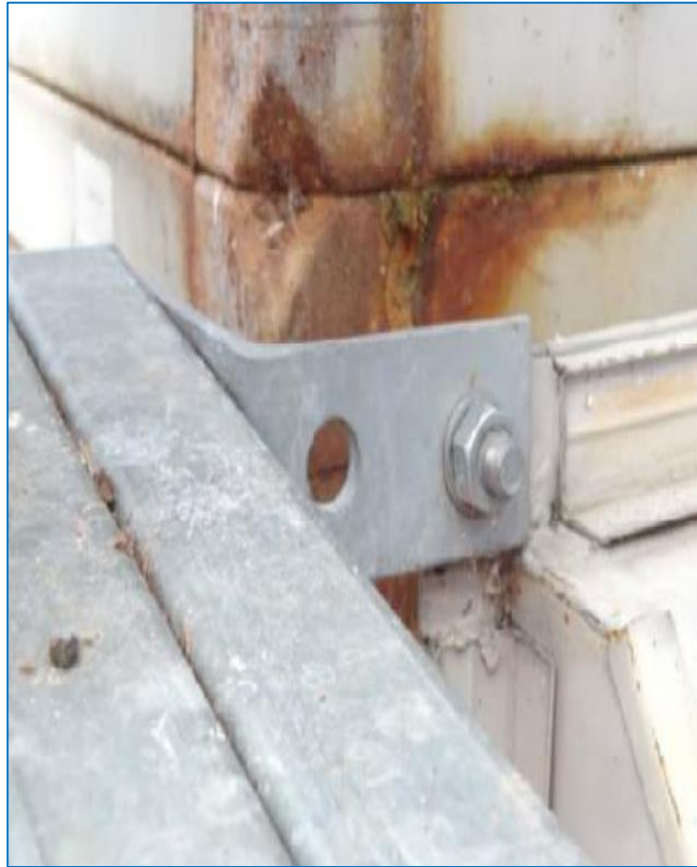
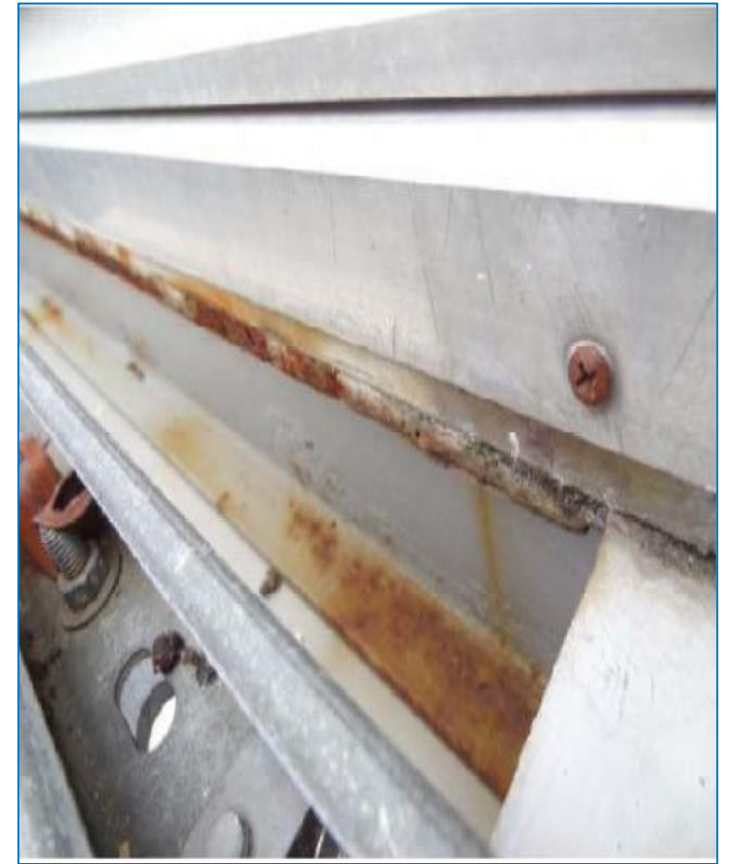
Examples of widespread corrosion to plant fittings including AHUs on roof

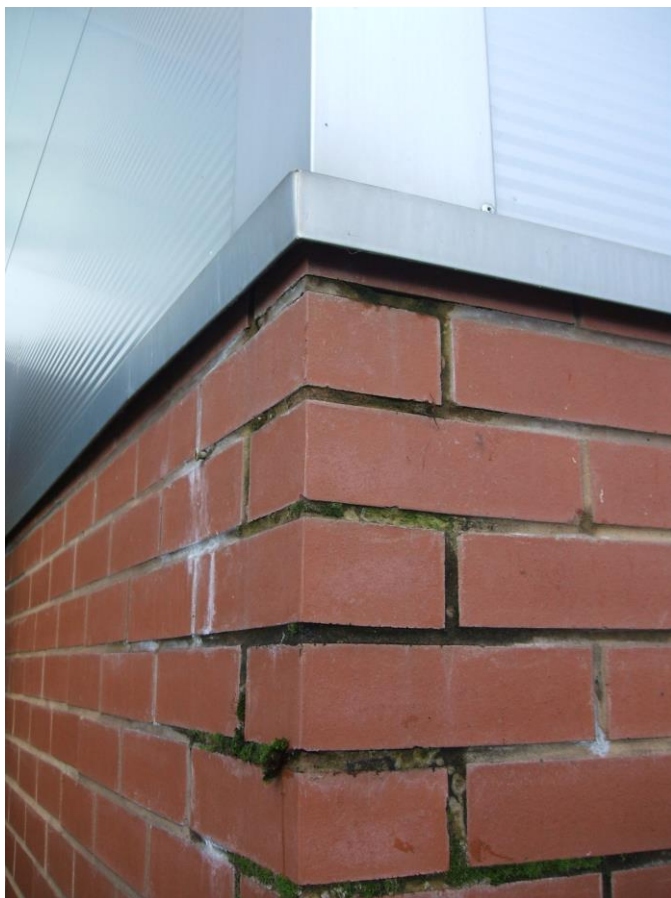
Impact on appearance of brickwork due to its saturation

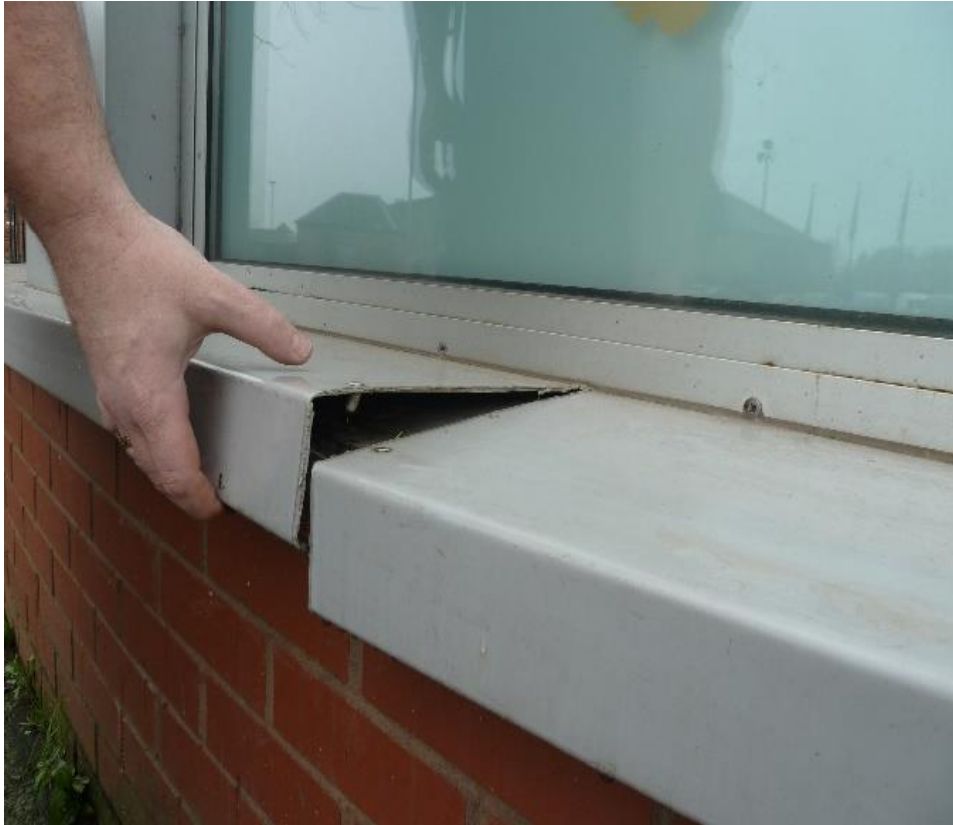
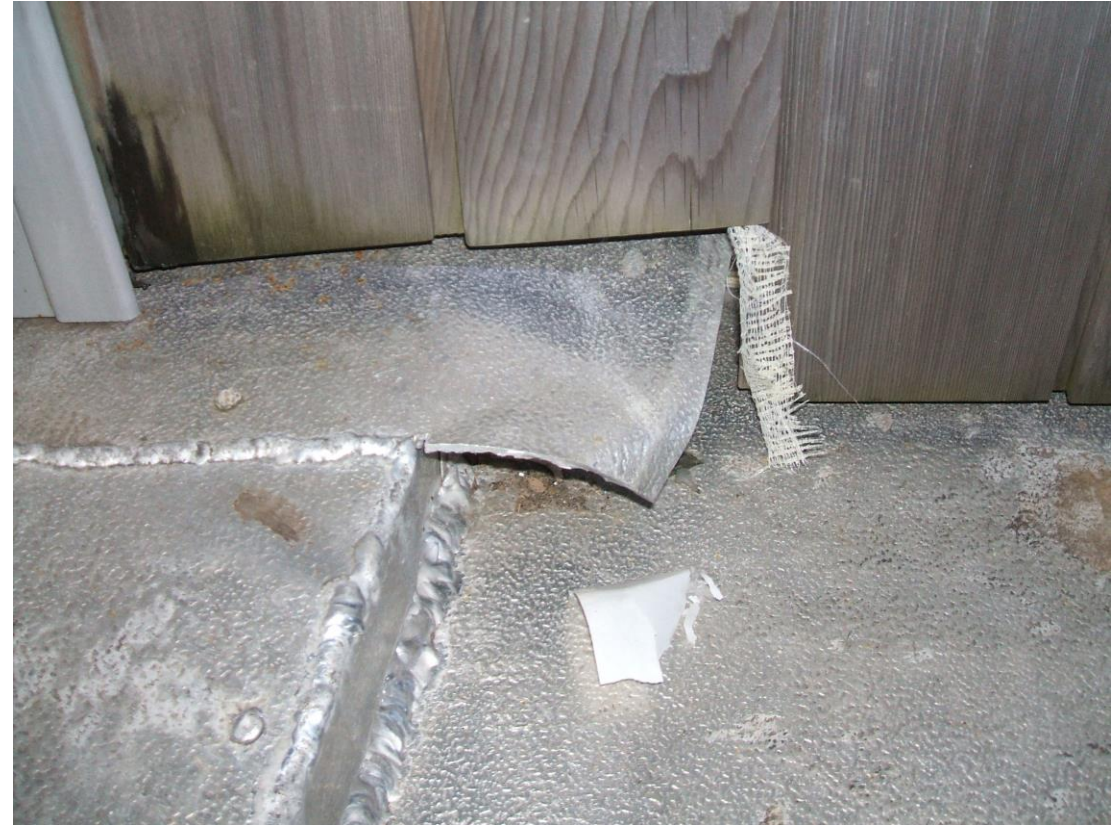
Poor external workmanship and detailing

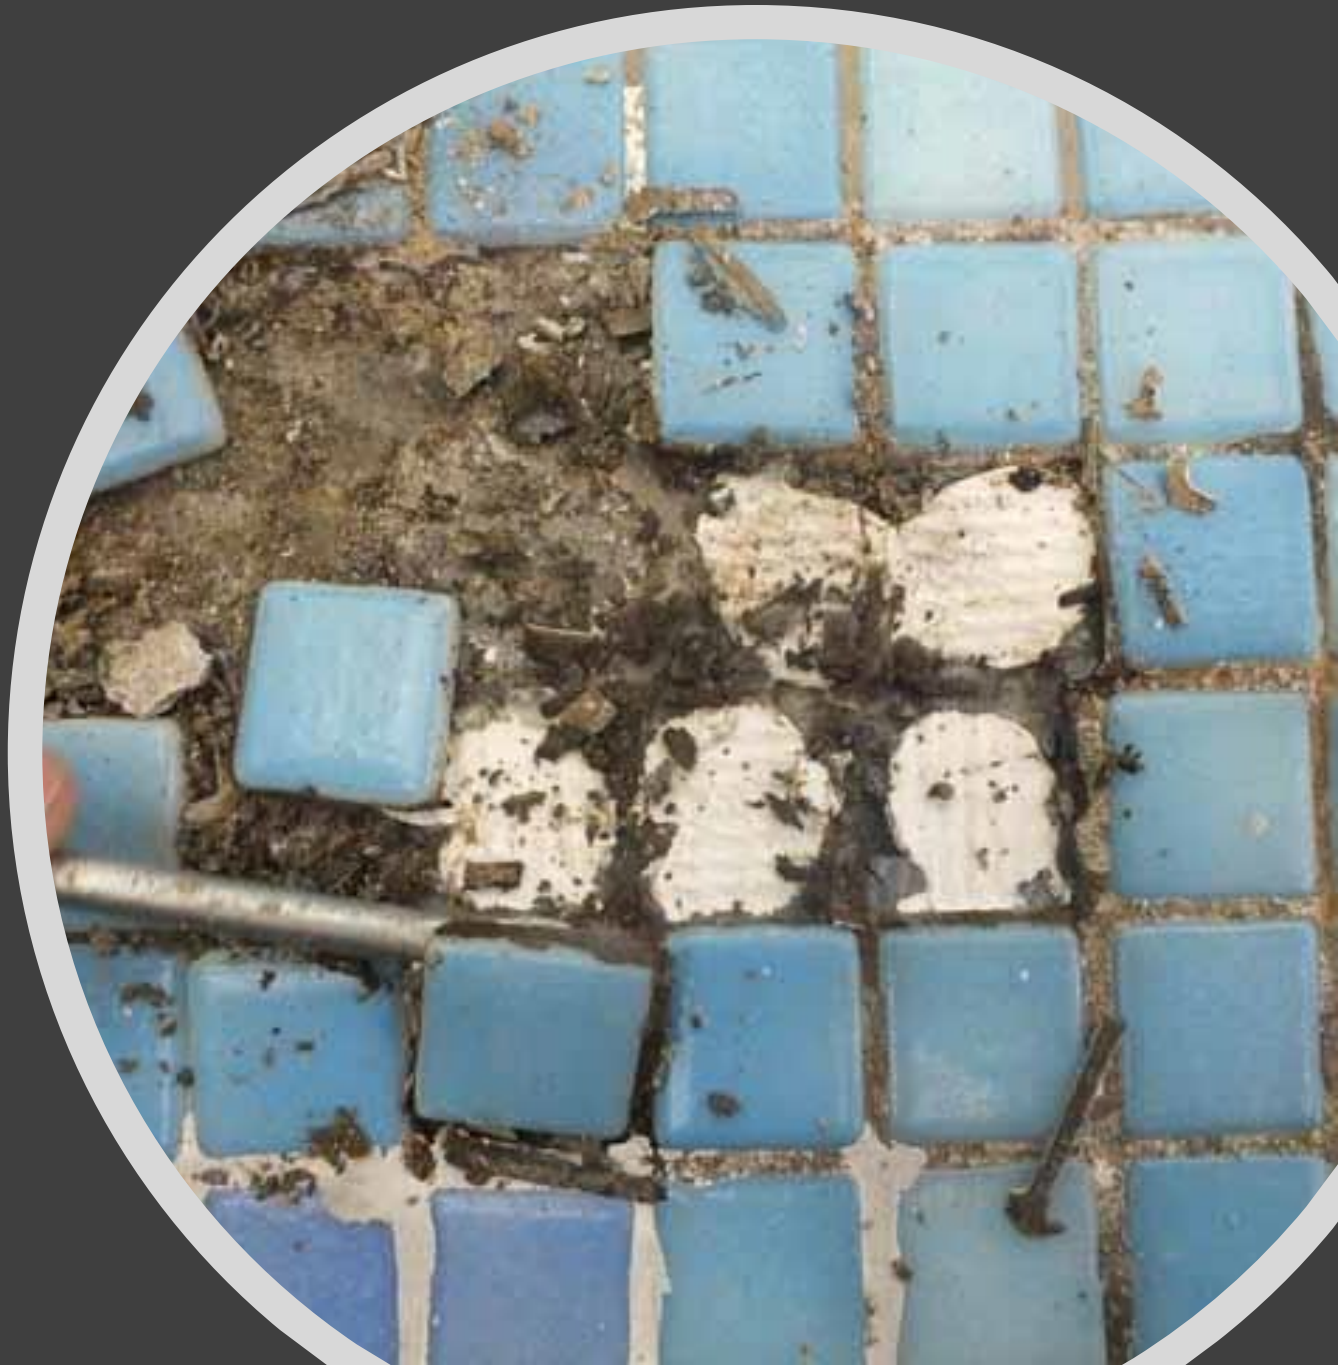
Defects in tiling
